**Rowel Branch Tract:
Year Five Monitoring Report**

Brunswick County, NC

Prepared by:
Land Management Group, Inc.
Wilmington, NC

January 2006

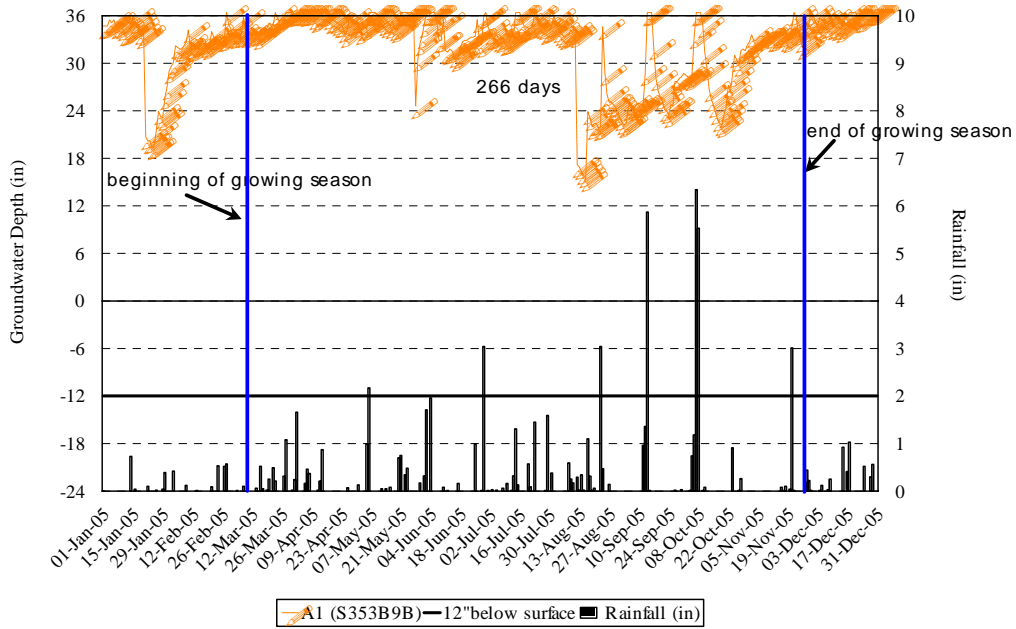
Figure 1. Hydrology Monitoring, Gauge A1
Rowel Branch Tract; Restoration
2005

As in previous years, it was observed throughout 2005 that beavers were building dams in several locations within the creek, causing water levels near these dams to increase. Because of concern raised by neighbors that these dams were backing up water onto their property, the dams were periodically monitored and removed.

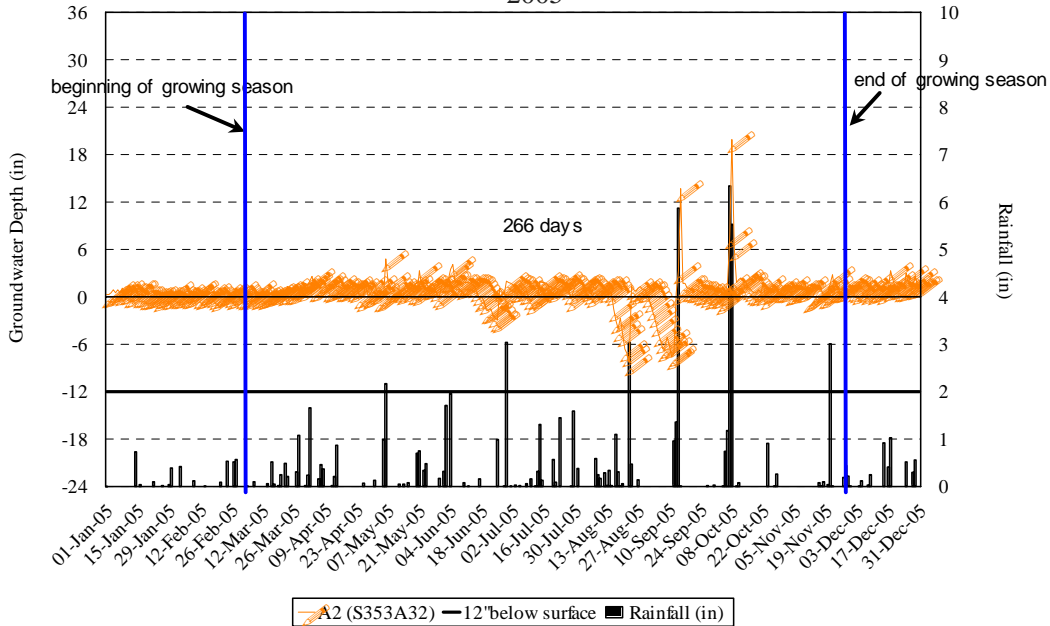
Figure 2. Hydrology Monitoring, Gauge A2
Rowel Branch Tract; Restoration
2005

From year to year, no clear pattern has been observed for the gauges located 50' from the stream. In 2005, Gauge A2 documented more flooding events than R2 but with shorter average duration. Gauge B2 documented fewer flooding events with shorter duration and Gauge C2 documented fewer flooding events with a longer average duration. In 2004, Gauges A2 and C2 (B2 malfunctioned) documented fewer flooding events than R2 yet with longer average durations. In 2003, A2, B2, and C2 documented more or the same number of flooding events with longer average durations than R2. In 2002, A2 and C2 recorded more flooding events with a shorter duration and B2 recorded fewer flooding events with a longer average flooding duration.
