# **Russell Gap Stream Mitigation Project Year 1 (2020) Monitoring Report FINAL**

DMS Project ID No. 100003, DEQ Contract No. 6980

MY1 Data Collection Period: September – November 2020

Submission Date: December 2020

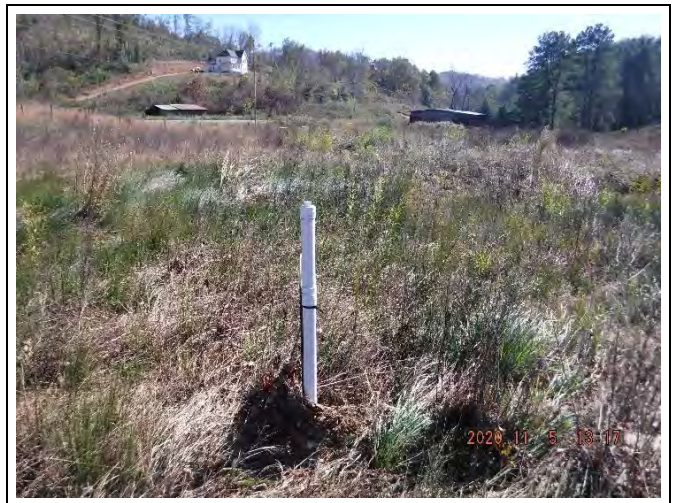
Crest Gauge 1 Reach 1. Flood debris. (November 5, 2020)
