Russell Gap Stream Mitigation Project Year 2 (2021) Monitoring Report FINAL

DMS Project ID No. 100003, DEQ Contract No. 6980

Alexander County, North Carolina, Catawba River Basin: 03050101-120010

MY2 Data Collection Period: January – October 2021

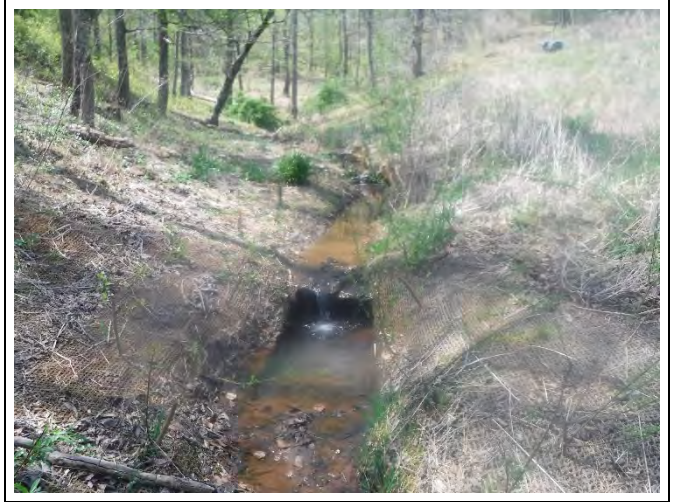
PP-2: Reach 14, view upstream toward Reach 13 at Station
11+45. (April 15, 2021)

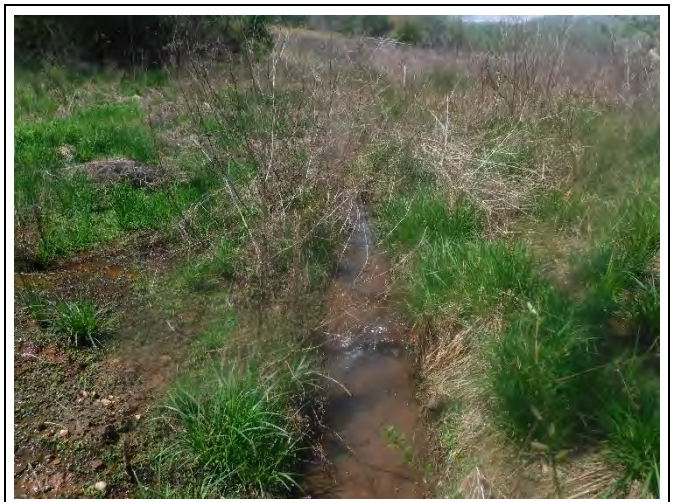
PP-6: Reach 14, end of reach Station 16+00.
(April 15, 2021)

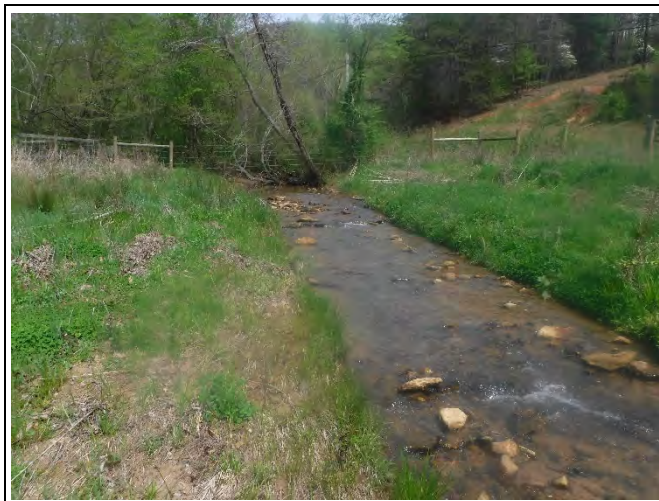
PP-7: Reach 1, view upstream, at Station 10+20.
(April 15, 2021)

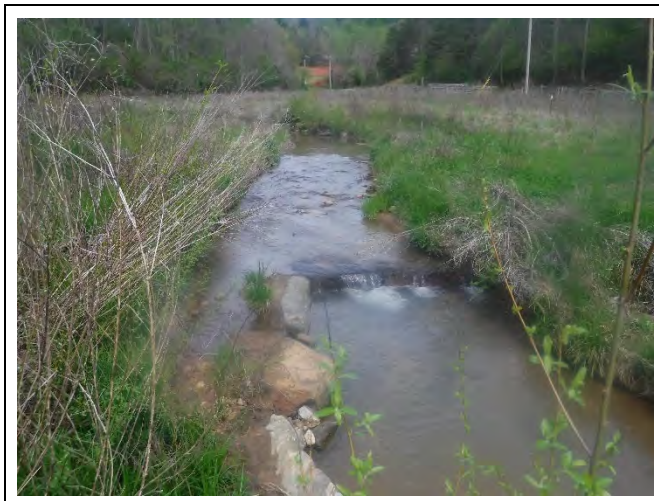
PP-9: Reach 1, view upstream at Station 15+00.
(April 15, 2021)

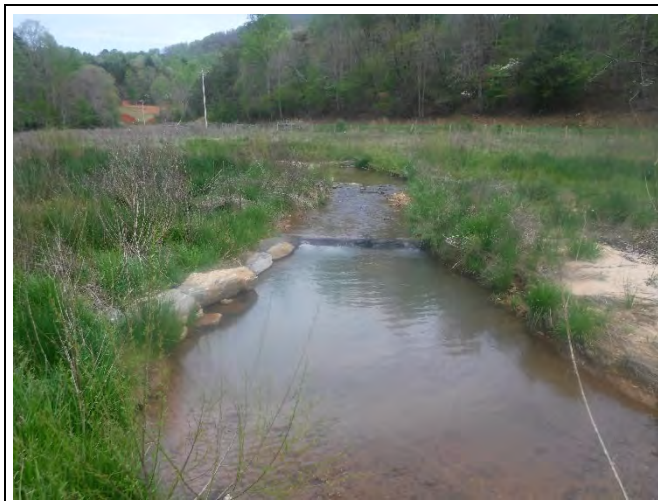
PP-10: Reach 1, view upstream at Station 17+25.
(April 15, 2021)

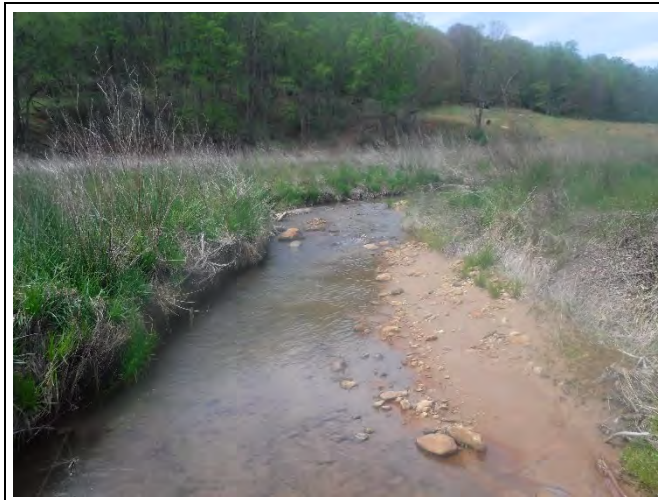
PP-11: Reach 1, view upstream at Station 20+00.
(April 15, 2021)

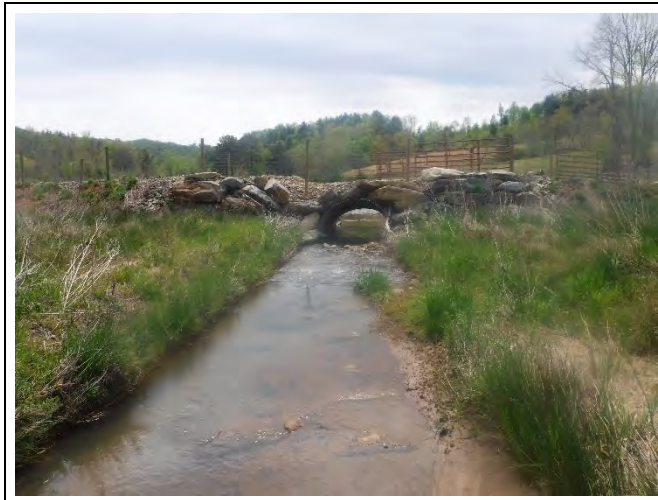
PP-12: Reach 1, view downstream at Station 20+00.
(April 15, 2021)

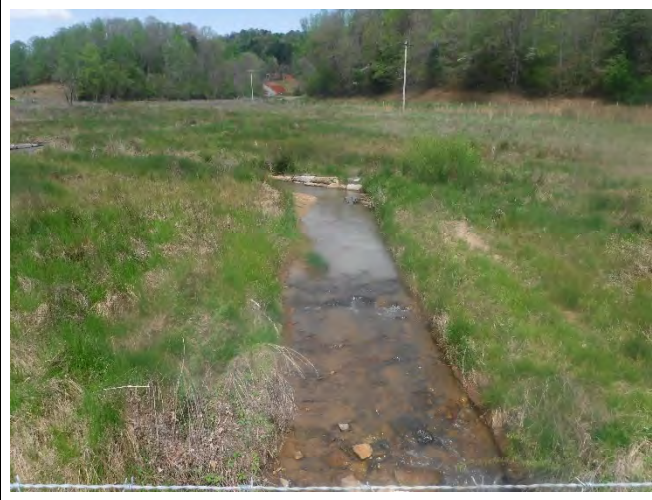
PP-13: Reach 1, view upstream at Station 20+75.
(April 15, 2021)

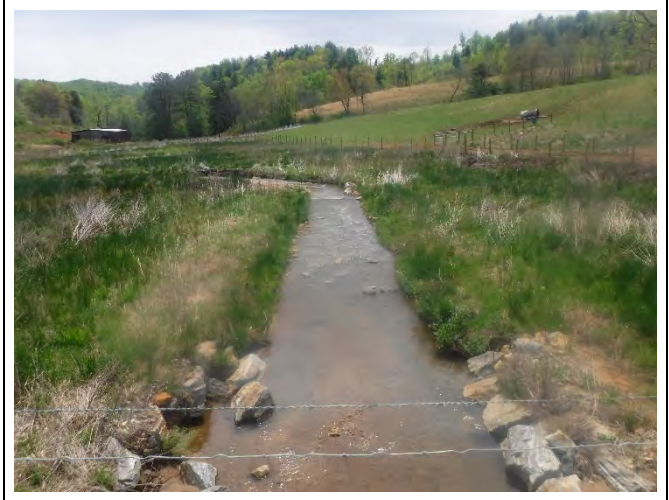
PP-14: Reach 1, view downstream at Station 20+75.
(April 15, 2021)

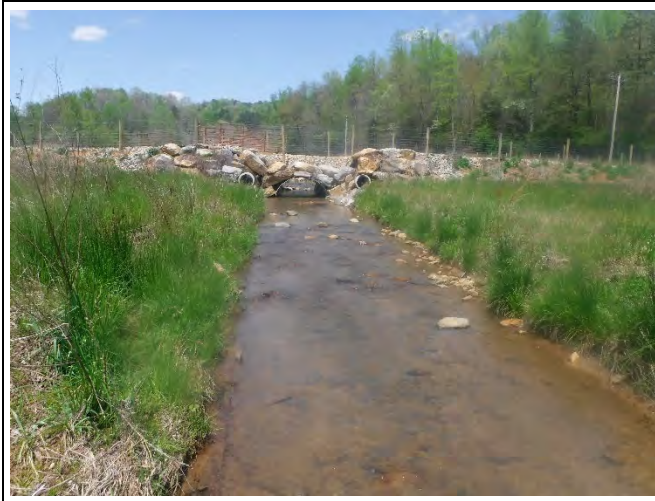
PP-15: Reach 1, view upstream at Station 21+50.
(April 15, 2021)

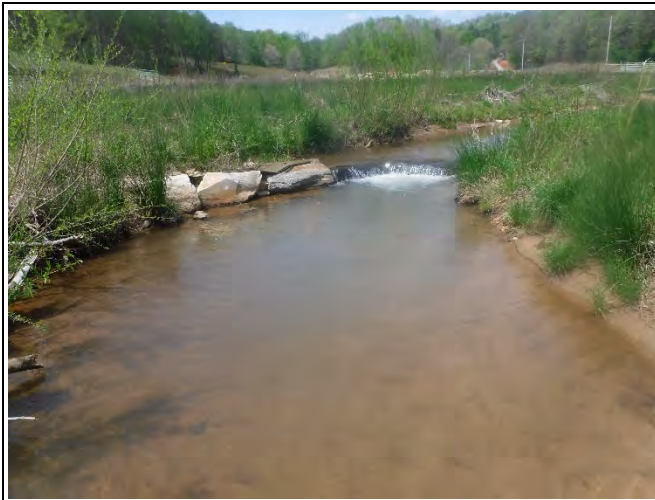
PP-17: Reach 1, view upstream at Station 24+20.
(April 15, 2021)

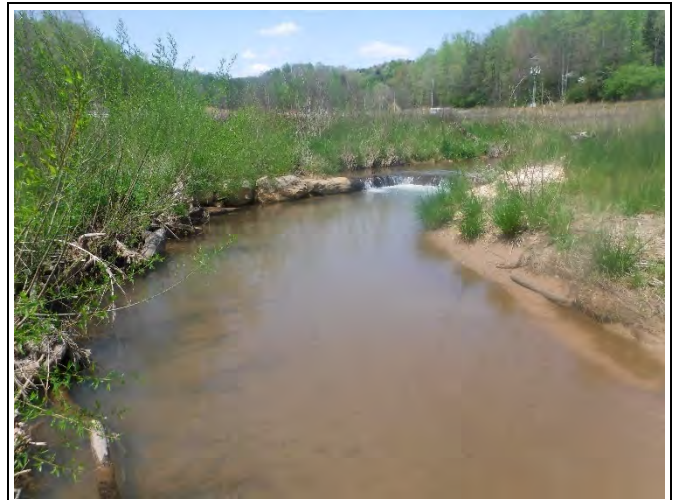
PP-18: Reach 1, view of upstream at Station 27+00.
(April 15, 2021)

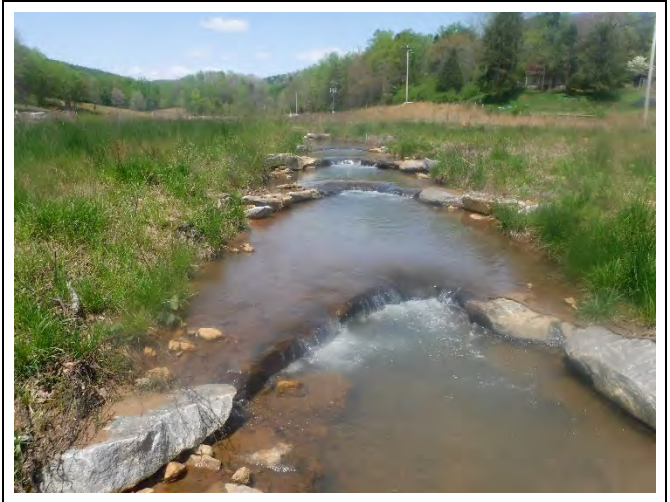
PP-20: Reach 1, view upstream at Station 29+20.
(April 15, 2021)

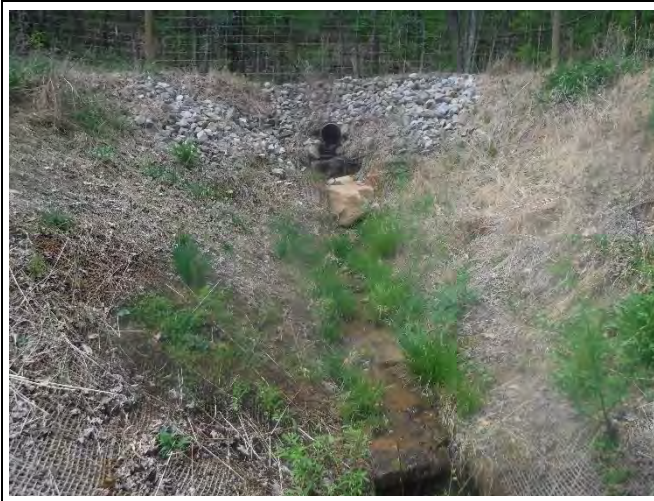
PP-21: Reach 11, view upstream at Station 10+20.
(April 15, 2021)

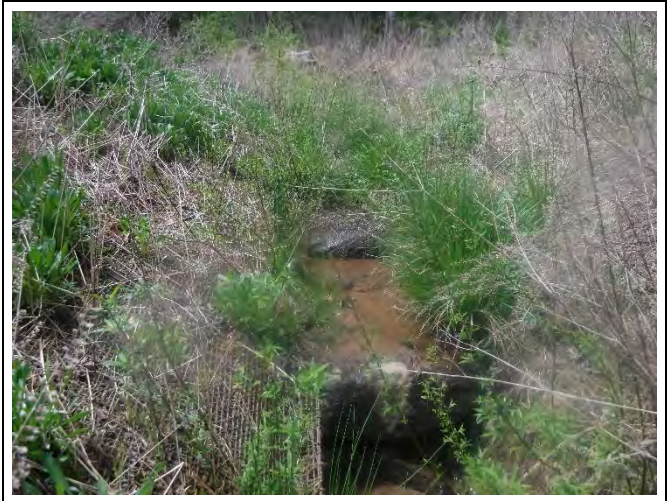
PP-22: Reach 11, view upstream at Station 11+50.
(April 15, 2021)

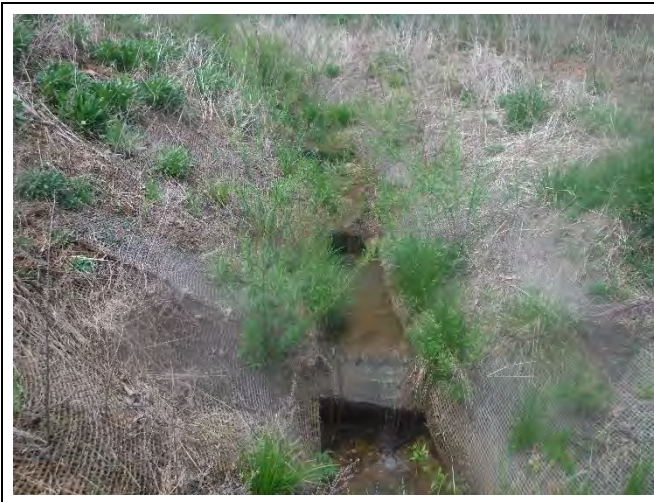
PP-23: Reach 11, view upstream at Station 12+75.
(April 15, 2021)

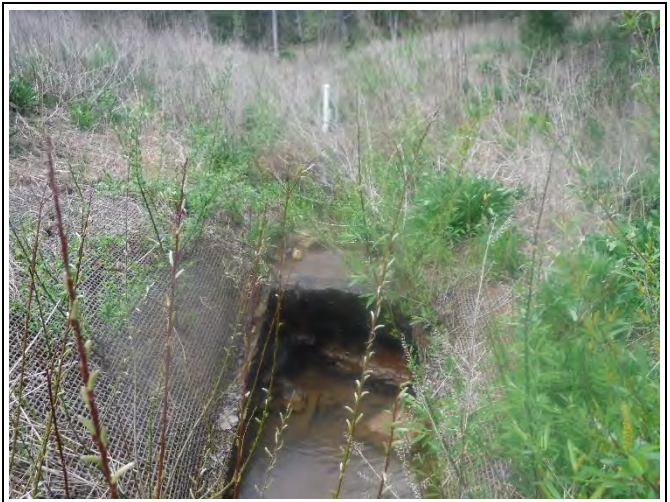
PP-24: Reach 11, view upstream at Station 14+50.
(April 15, 2021)

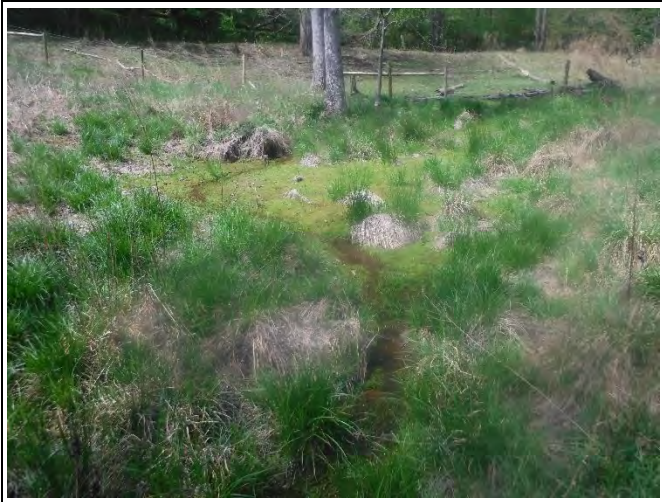
PP-25: Reach 10A, view upstream at Station 10+50.
(April 15, 2021)

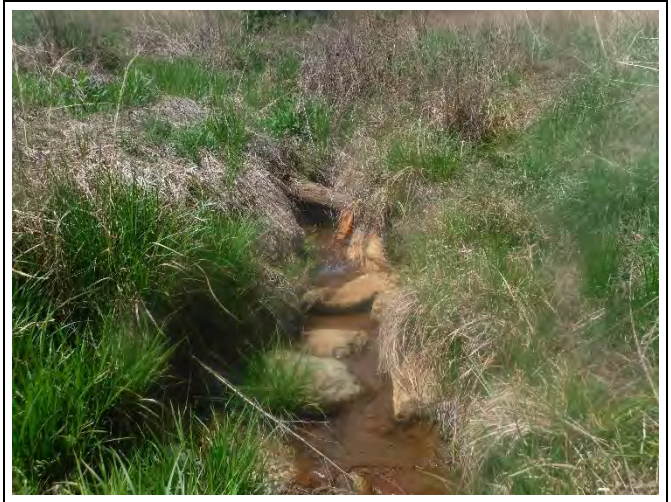
PP-26: Reach 10A, view upstream at Station 12+50.
(April 15, 2021)

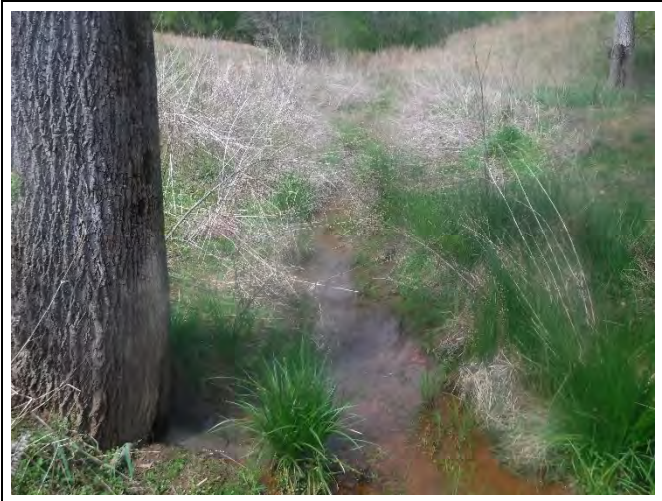
PP-27: Reach 10A, view upstream at Station 13+75.
(April 15, 2021)

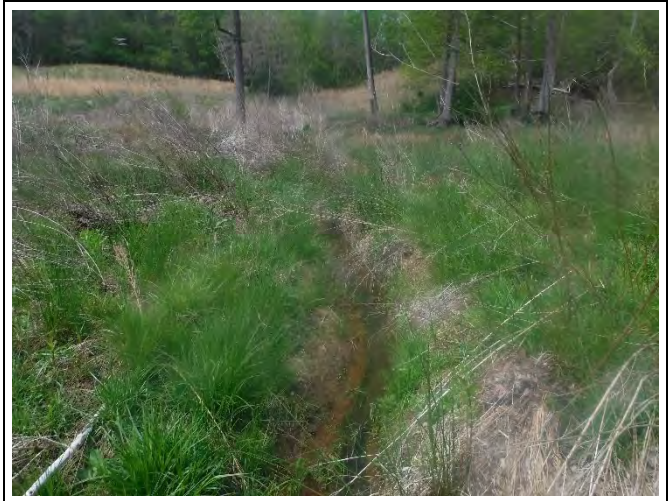
PP-28: Reach 10B, view upstream at Station 14+50.
(April 15, 2021)

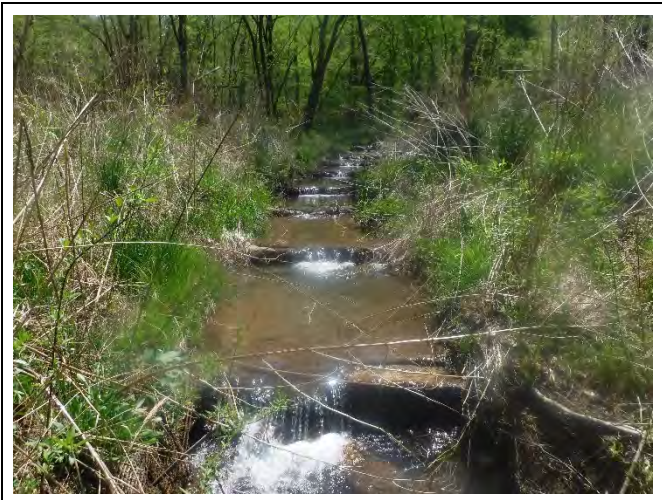
PP-29: Reach 5, view upstream at Station 11+00.
(April 15, 2021)

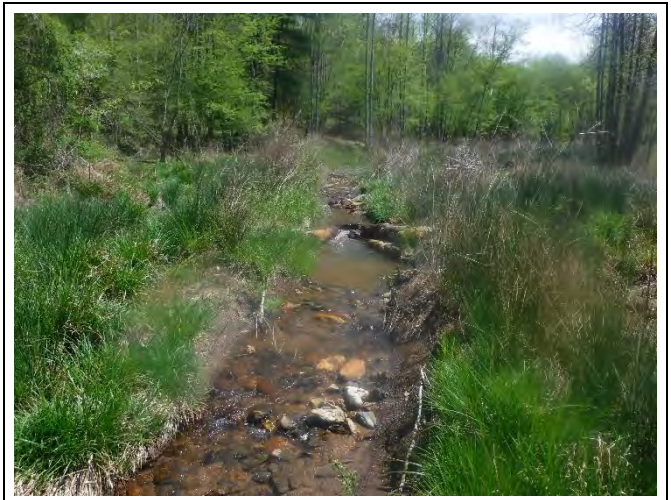
PP-30: Reach 6, view upstream at Station 14+50.
(April 15, 2021)
