Monitoring Report MY07/Closeout

**Sandy Bridge Restoration Site
DMS Contract 6400
DMS Project Number 96920**

**DWR #: 15-0414
USACE Action ID: 201500827
Rutherford County, North Carolina**

**Monitoring Data Collected: 2023
Date Submitted: December 2023**

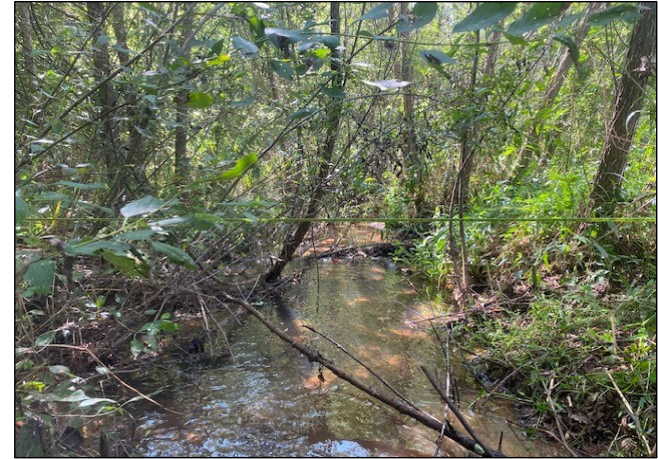
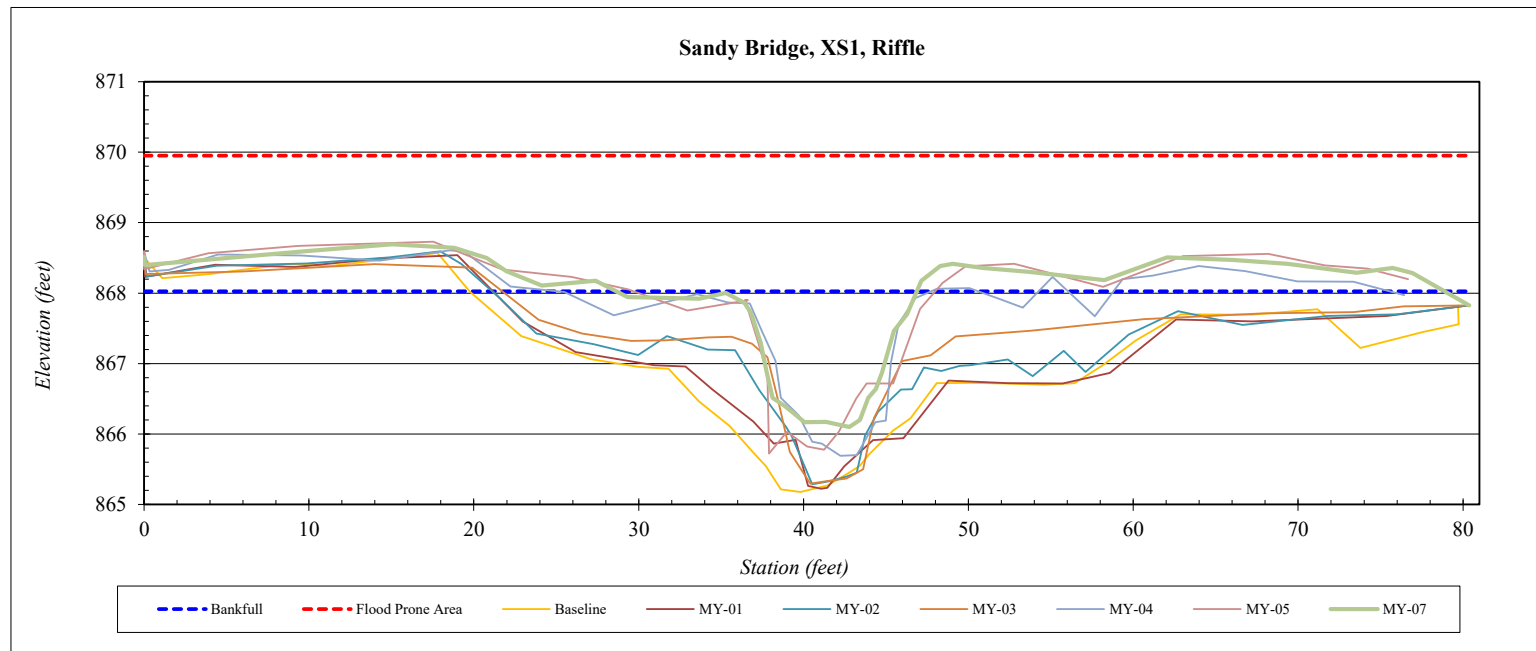
River Basin:	Broad
Site:	Sandy Bridge
XS ID	XS1
Drainage Area:	837 acres
Date:	9/7/2023
Field Crew:	Kelsey B, Caleb K, Tommy S

SUMMARY DATA	
Current Bankfull Elevation:	868.03
Bankfull Cross-Sectional Area:	13.8
Total Cross-Sectional Area:	2.9
Bankfull Width:	10.5
Flood Prone Area Elevation:	870.0
Flood Prone Width:	70.4
Max Depth at Bankfull:	1.9
Mean Depth at Bankfull:	1.3
W / D Ratio:	7.9
Entrenchment Ratio:	6.7
Bank Height Ratio:	0.8

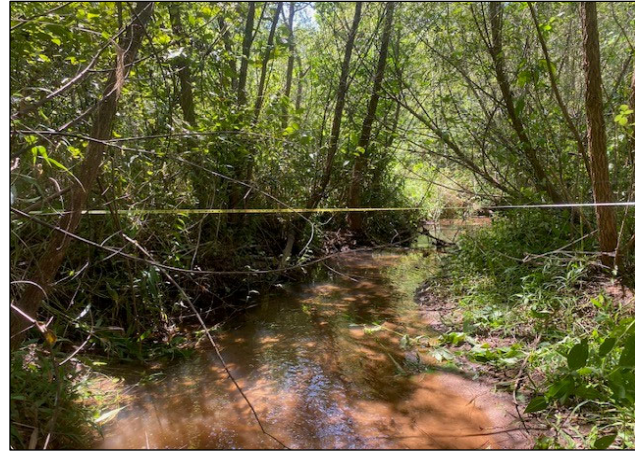
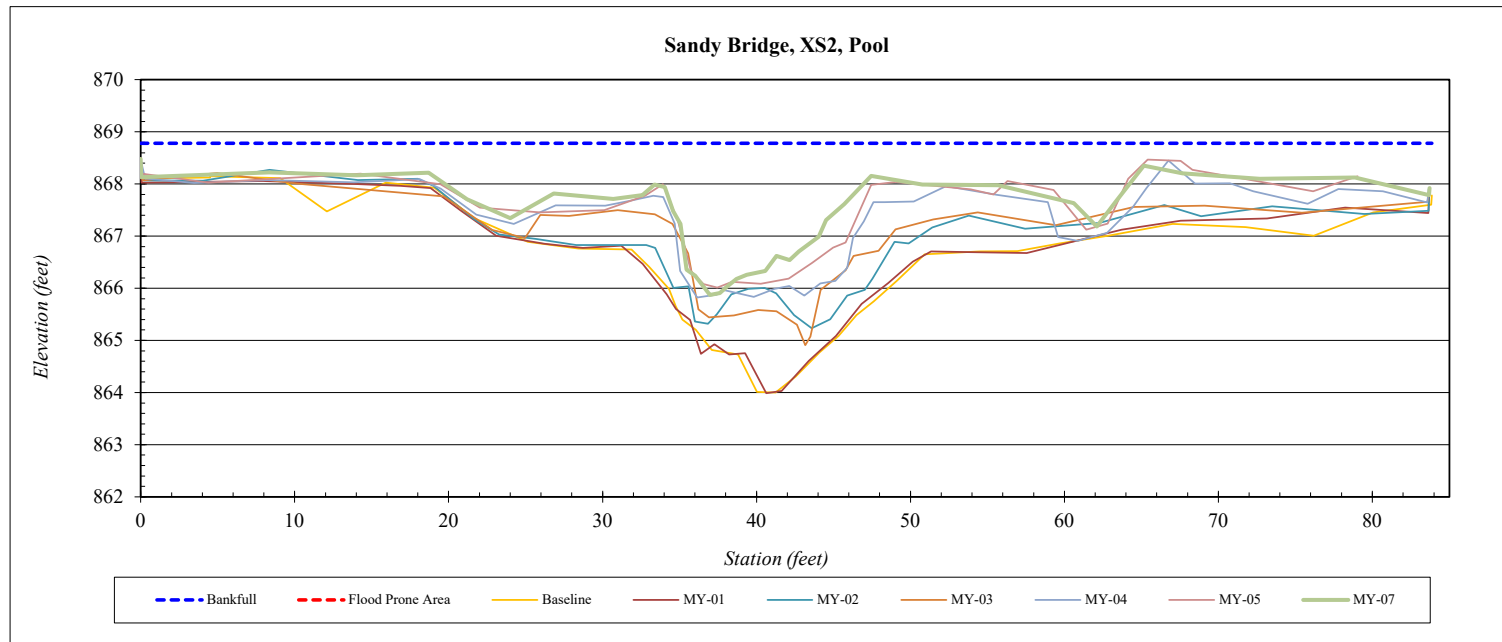
River Basin:	Broad
Site:	Sandy Bridge
XS ID	XS2
Drainage Area:	837 acres
Date:	9/7/2023
Field Crew:	Kelsey B, Caleb K, Tommy S

SUMMARY DATA	
Current Bankfull Elevation:	868.78
Bankfull Cross-Sectional Area:	26.8
Total Cross-Sectional Area:	3.0
Bankfull Width:	13.4
Flood Prone Area Elevation:	---
Flood Prone Width:	---
Max Depth at Bankfull:	2.9
Mean Depth at Bankfull:	2.0
W / D Ratio:	---
Entrenchment Ratio:	---
Bank Height Ratio:	---

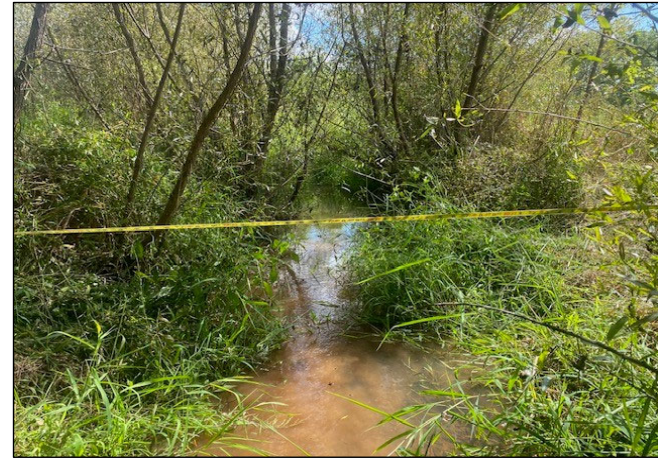
River Basin:	Broad
Site:	Sandy Bridge
XS ID	XS3
Drainage Area:	837 acres
Date:	9/7/2023
Field Crew:	Kelsey B, Caleb K, Tommy S

SUMMARY DATA	
Current Bankfull Elevation:	865.33
Bankfull Cross-Sectional Area:	13.1
Total Cross-Sectional Area:	12.5
Bankfull Width:	16.4
Flood Prone Area Elevation:	867.0
Flood Prone Width:	72.4
Max Depth at Bankfull:	1.7
Mean Depth at Bankfull:	0.8
W / D Ratio:	20.6
Entrenchment Ratio:	4.4
Bank Height Ratio:	0.9
