MONITORING YEAR 2 ANNUAL REPORT FINAL

January 2023

SANDY BRANCH MITIGATION SITE

DMS Project No. 100060
NCDEQ Contract No. 7527
USACE Action ID No. SAW-2018-01167
NCDWR Project No. 2018-0786

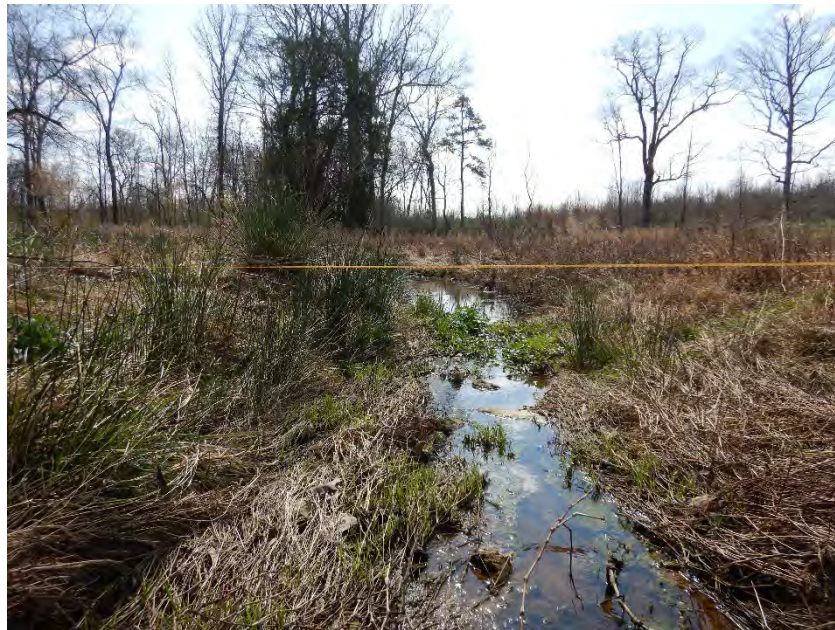
Downstream (3/7/2022)

MY0	MY1	MY2	MY3	MY5	MY7
Bankfull Elevation - Based on AB-Bankfull Area	459.29	459.34	459.47			
Bank Height Ratio - Based on AB-Bankfull Area	1.00	0.92	0.74			
Thalweg Elevation	457.99	458.14	458.18			
LTOB Elevation	459.29	459.24	459.14			
LTOB Max Depth	1.30	1.10	0.96			
LTOB Cross-Sectional Area	8.12	7.14	5.07
