Monitoring Report MY01

**Sandy Bridge Restoration Site
DMS Contract 6400
DMS Project Number 96920**

**DWR #: 15-0414
USACE Action ID: 201500827
Rutherford County, North Carolina**

**Monitoring Data Collected: October 2017
Date Submitted: January 2018**

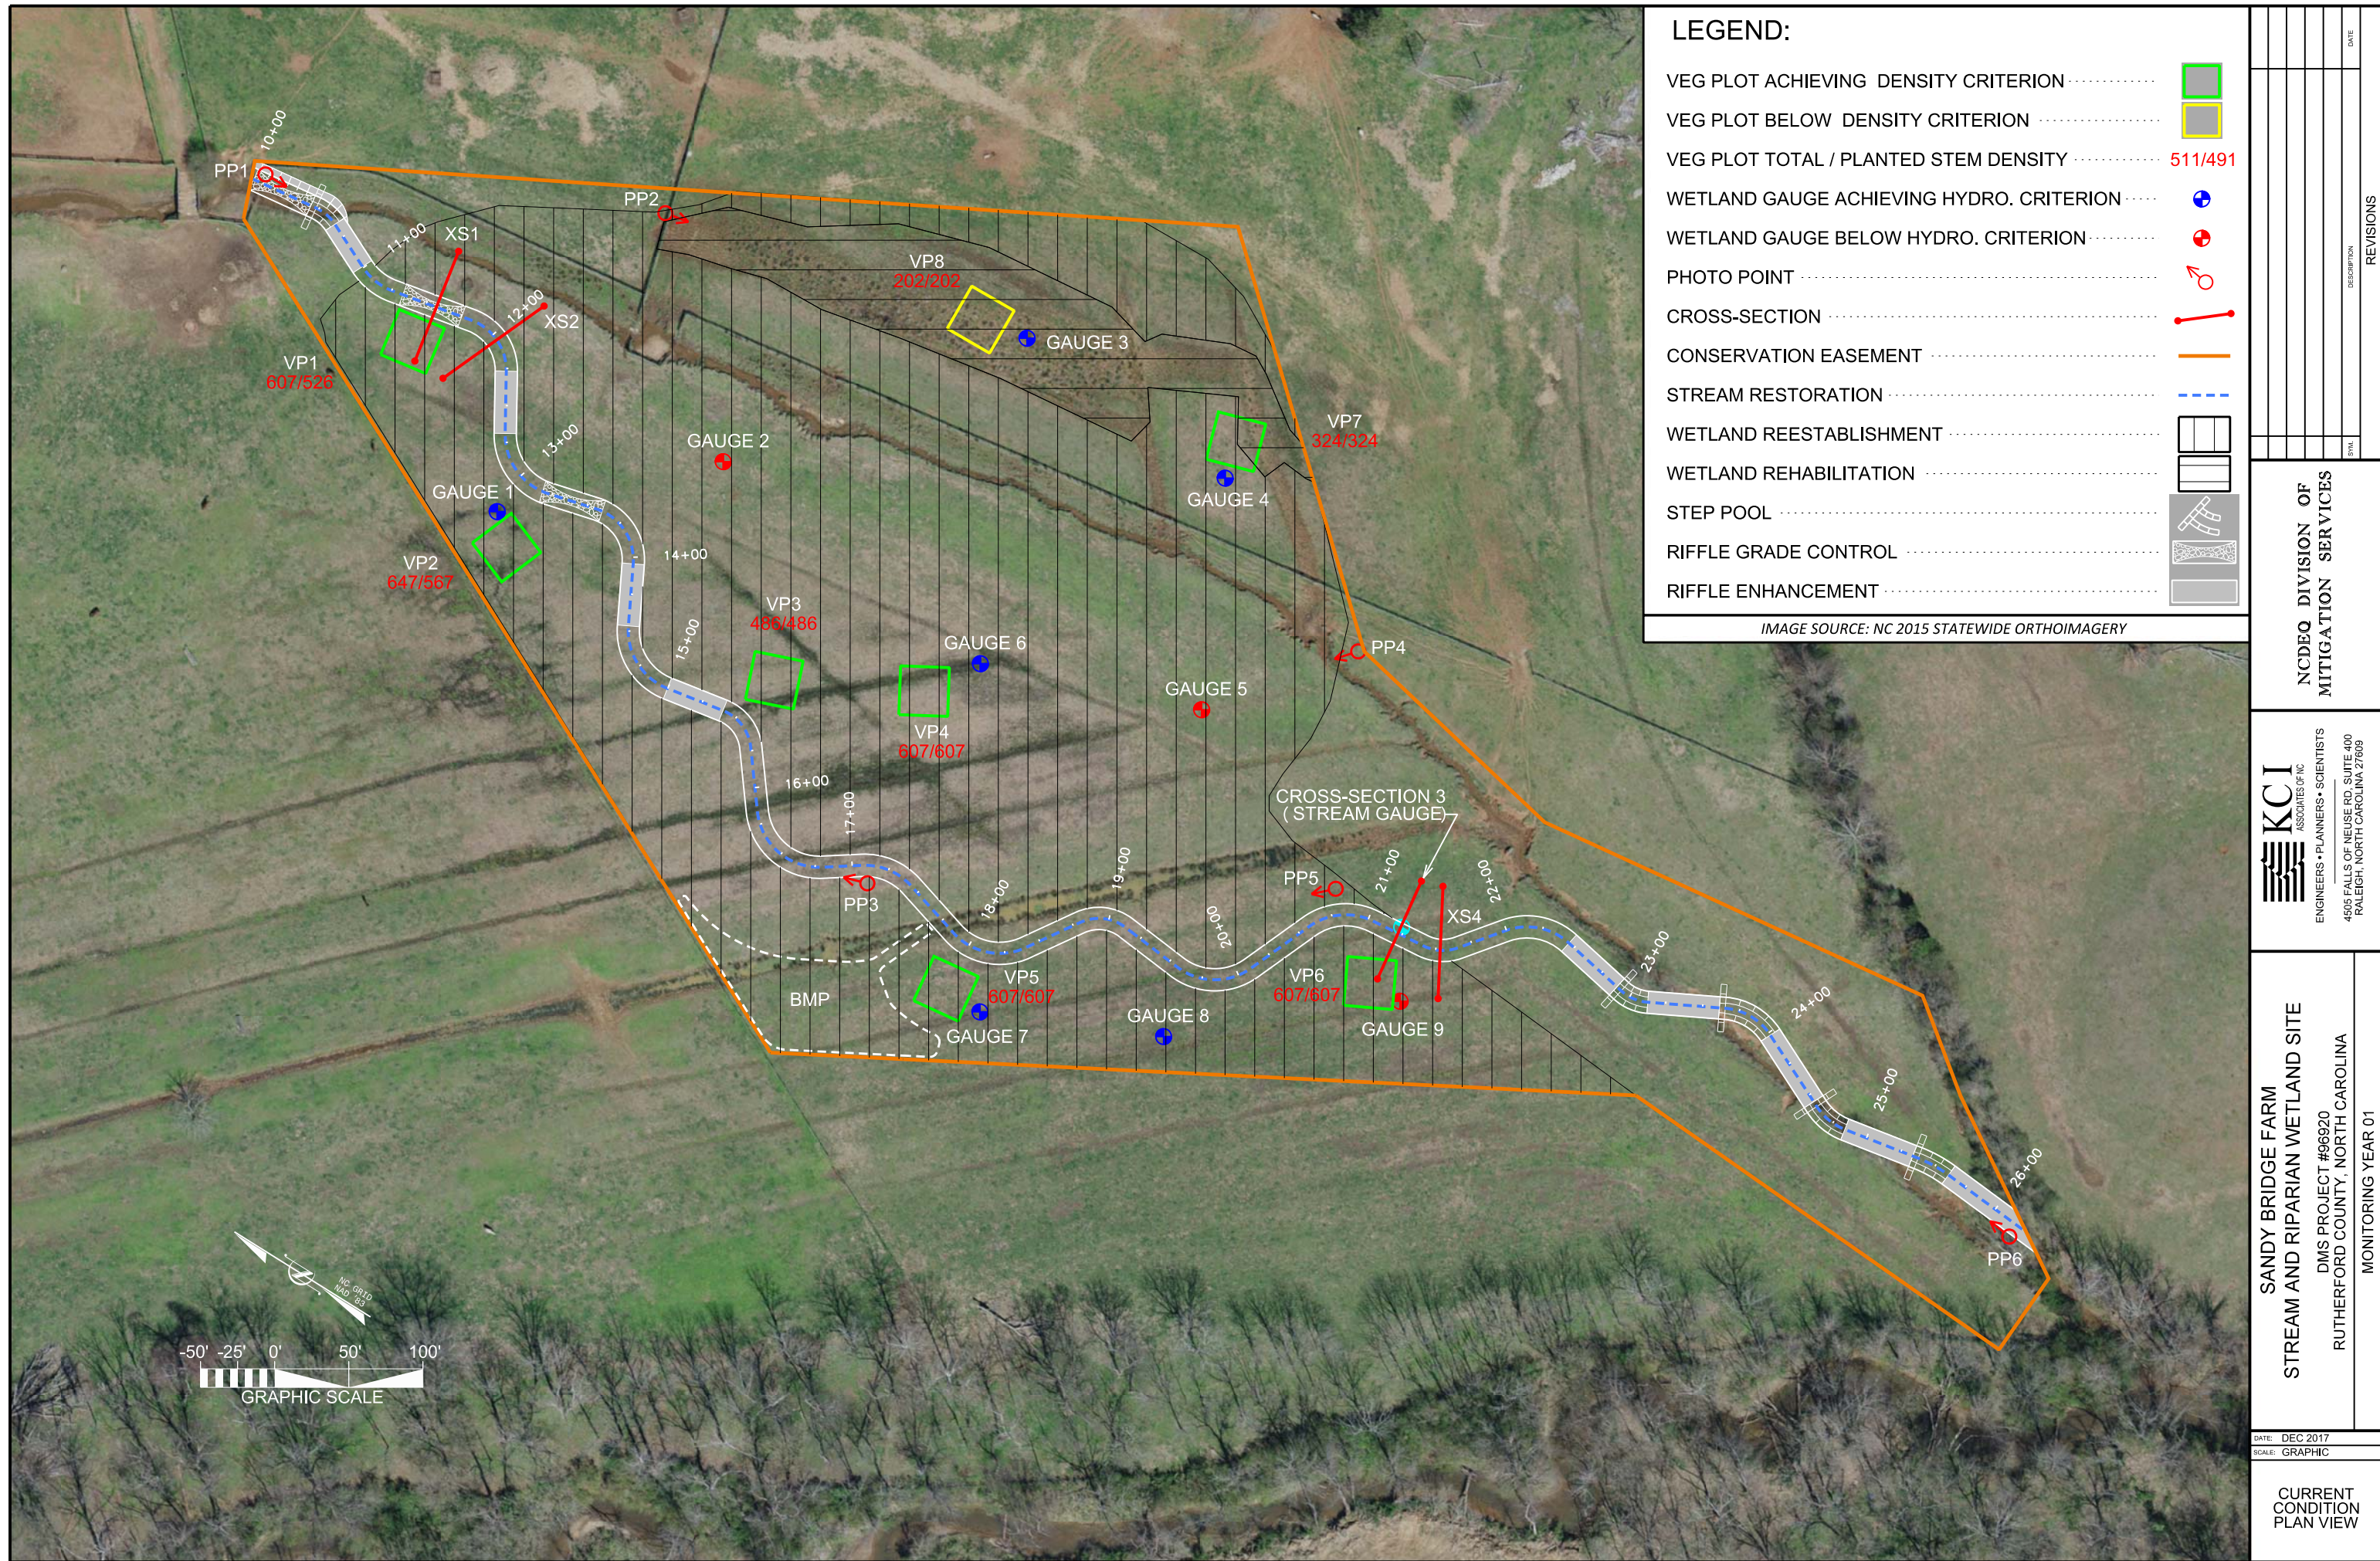
DATE: DEC 2017
SCALE: GRAPHIC
**CURRENT
CONDITION
PLAN VIEW**

2. CCPV figure indicates “EDMS” project. Should this be “DMS”?

KCI Response: This typo has been corrected.

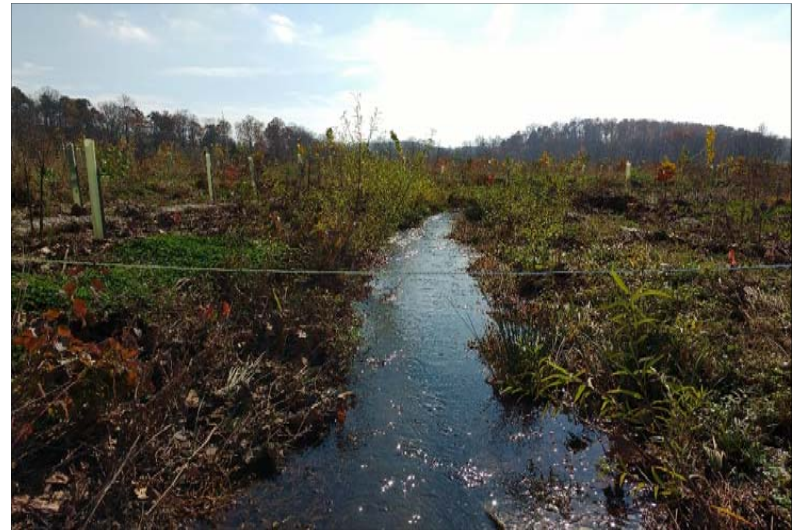
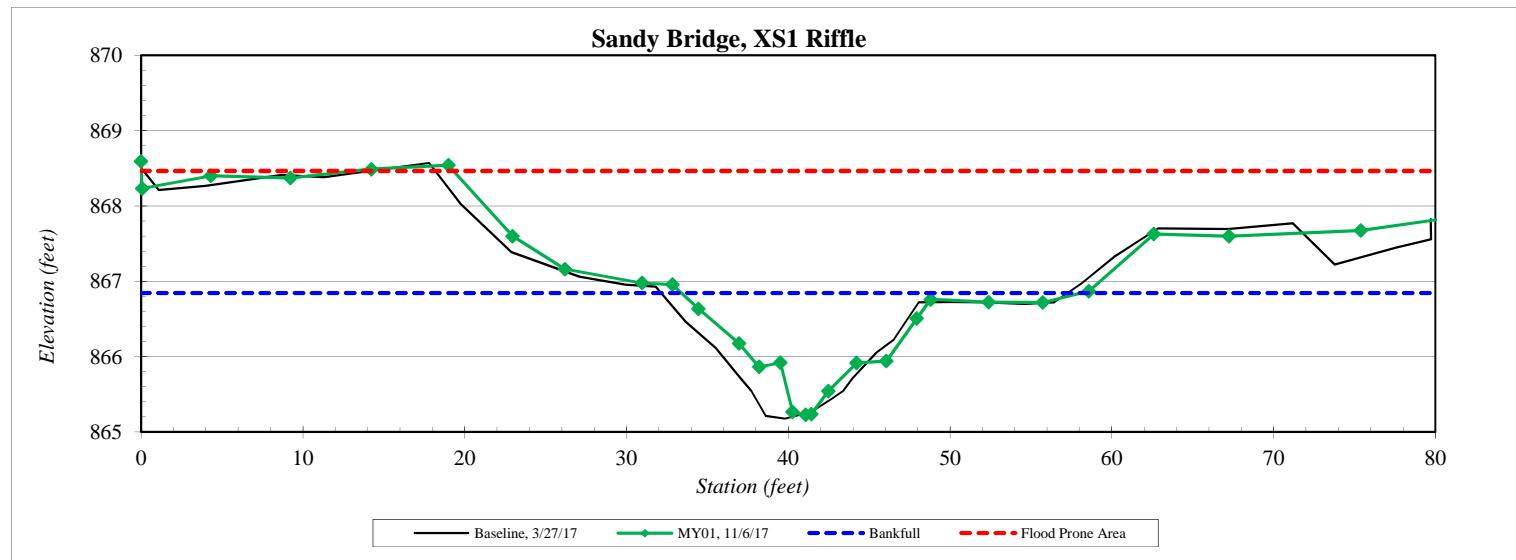
River Basin:	Broad
Project Name	Sandy Bridge
XS ID	XS1
Drainage Area:	837 acres
Date:	11/6/2017
Field Crew:	T. Seelinger, J. Sullivan

SUMMARY DATA	
Bankfull Elevation:	866.8
Bankfull Cross-Sectional Area:	13.8
Total Cross-Sectional Area:	10.9
Bankfull Width:	24.7
Flood Prone Area Elevation:	868.5
Flood Prone Width:	>60
Max Depth at Bankfull:	1.6
Mean Depth at Bankfull:	0.6
W / D Ratio:	44.2
Entrenchment Ratio:	2.4
Bank Height Ratio:	0.9

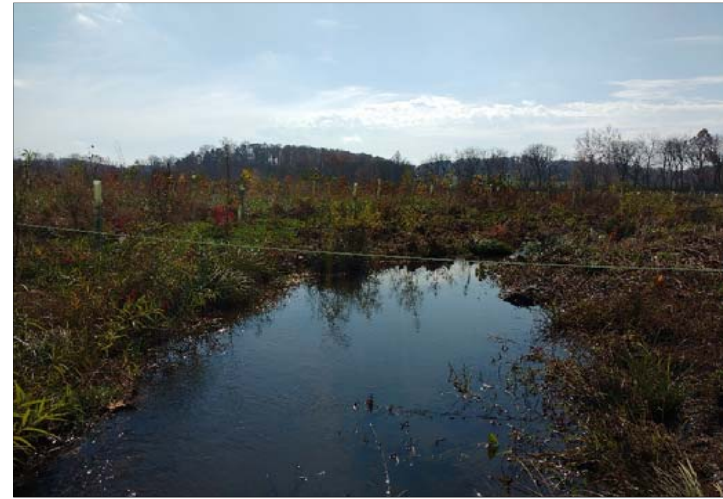
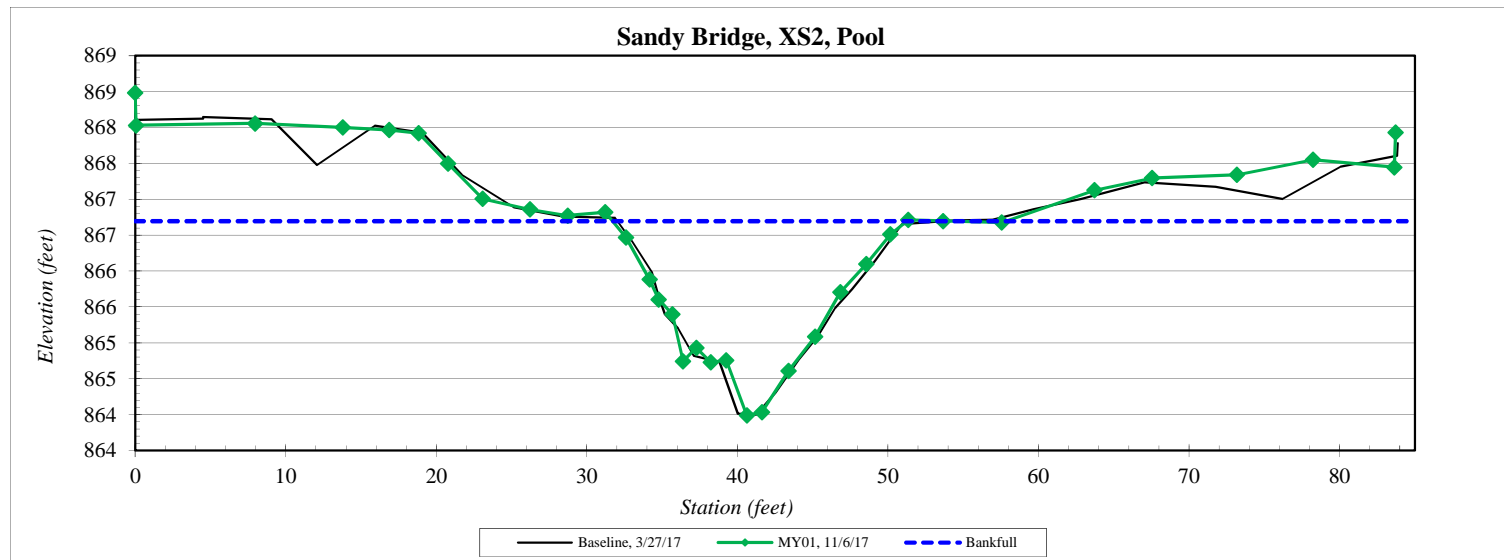
River Basin:	Broad
Project Name	Sandy Bridge
XS ID	XS2
Drainage Area:	837 acres
Date:	11/6/2017
Field Crew:	T. Seelinger, J. Sullivan

SUMMARY DATA	
Bankfull Elevation:	866.7
Bankfull Cross-Sectional Area:	26.8
Total Cross-Sectional Area:	26.1
Bankfull Width:	23.4
Flood Prone Area Elevation:	-
Flood Prone Width:	-
Max Depth at Bankfull:	2.7
Mean Depth at Bankfull:	1.1
W / D Ratio:	20.4
Entrenchment Ratio:	-
Bank Height Ratio:	-

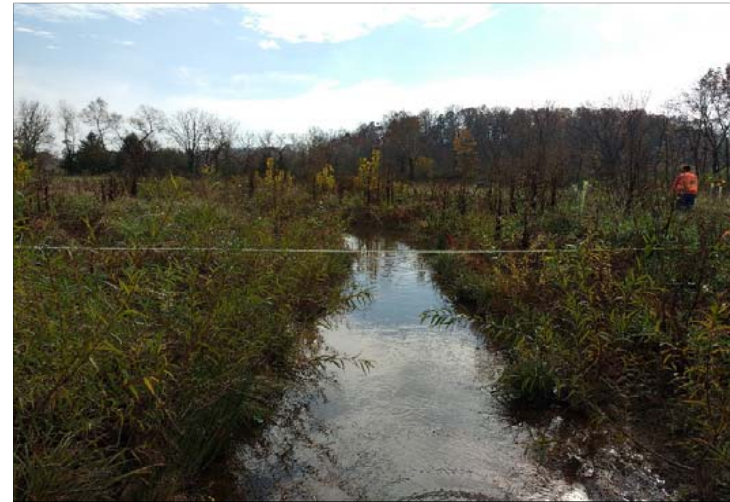
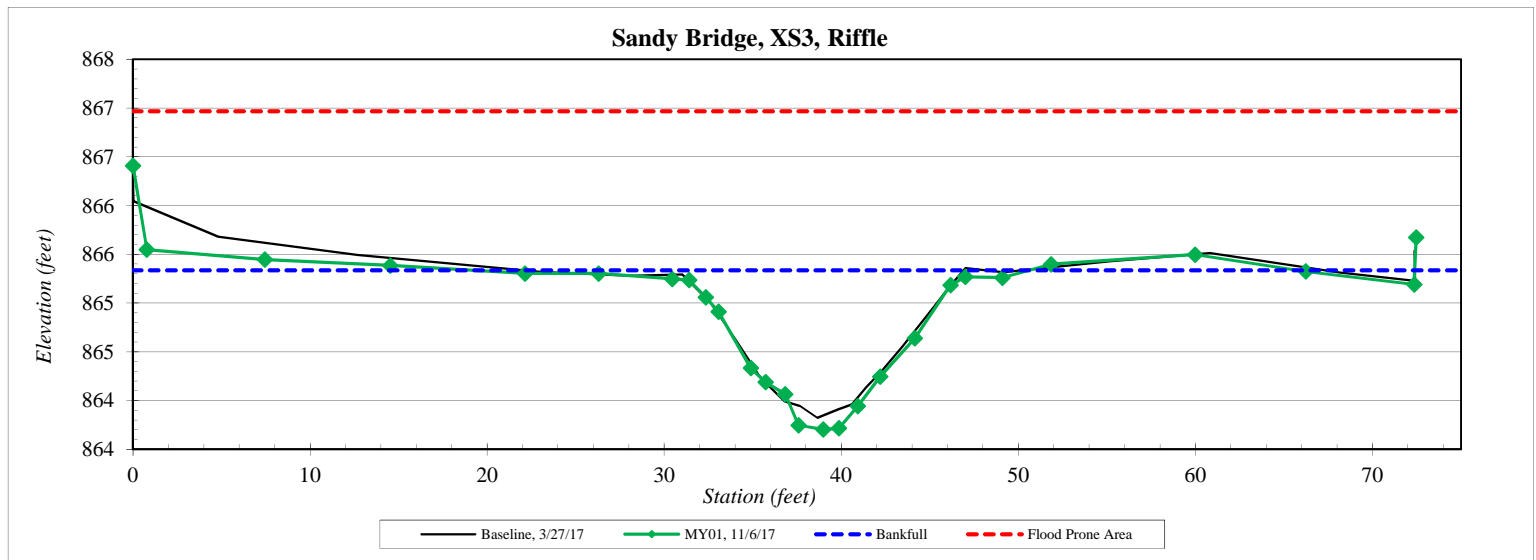
River Basin:	Broad
Project Name	Sandy Bridge
XS ID	XS3
Drainage Area:	837 acres
Date:	11/6/2017
Field Crew:	T. Seelinger, J. Sullivan

SUMMARY DATA	
Bankfull Elevation:	865.3
Bankfull Cross-Sectional Area:	13.1
Total Cross-Sectional Area:	12.4
Bankfull Width:	17.3
Flood Prone Area Elevation:	867.0
Flood Prone Width:	>72
Max Depth at Bankfull:	1.6
Mean Depth at Bankfull:	0.8
W / D Ratio:	22.8
Entrenchment Ratio:	4.2
Bank Height Ratio:	1.0

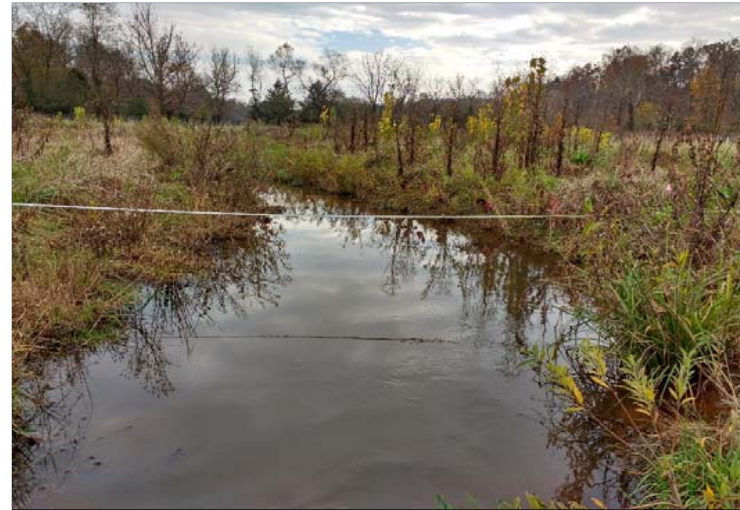
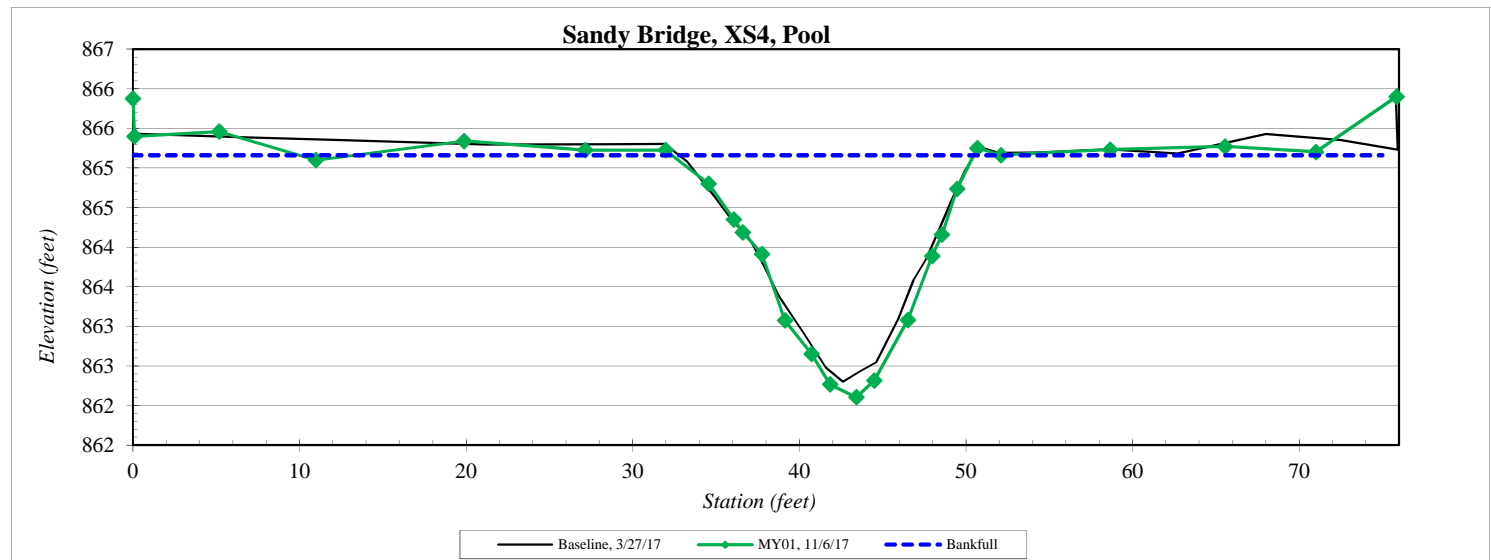
River Basin:	Broad
Project Name	Sandy Bridge
XS ID	XS4
Drainage Area:	837 acres
Date:	11/6/2017
Field Crew:	T. Seelinger, J. Sullivan

SUMMARY DATA	
Bankfull Elevation:	865.2
Bankfull Cross-Sectional Area:	28.8
Total Cross-Sectional Area:	30.7
Bankfull Width:	18.1
Flood Prone Area Elevation:	-
Flood Prone Width:	-
Max Depth at Bankfull:	3.1
Mean Depth at Bankfull:	1.6
W / D Ratio:	11.4
Entrenchment Ratio:	-
Bank Height Ratio:	-

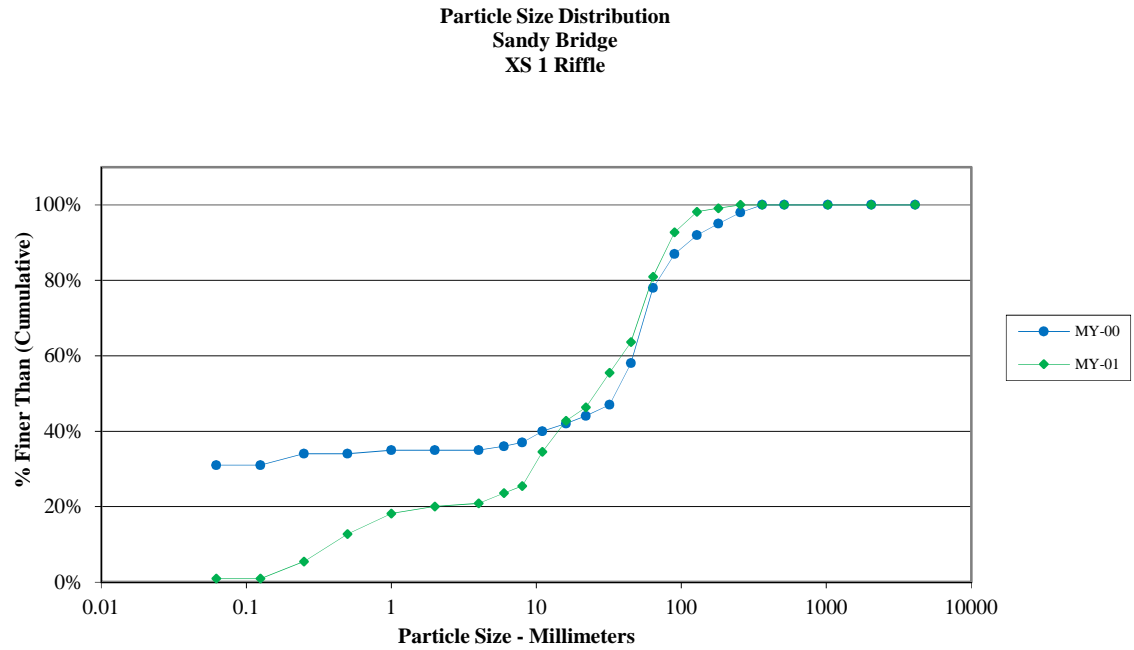
Size (mm)	
D16	0.76
D35	11
D50	26
D65	46
D84	70
D95	100

Type	
silt/clay	1%
sand	19%
gravel	61%
cobble	19%
boulder	0%
bedrock	0%
hardpan	0%
wood/det	0%
artificial	0%

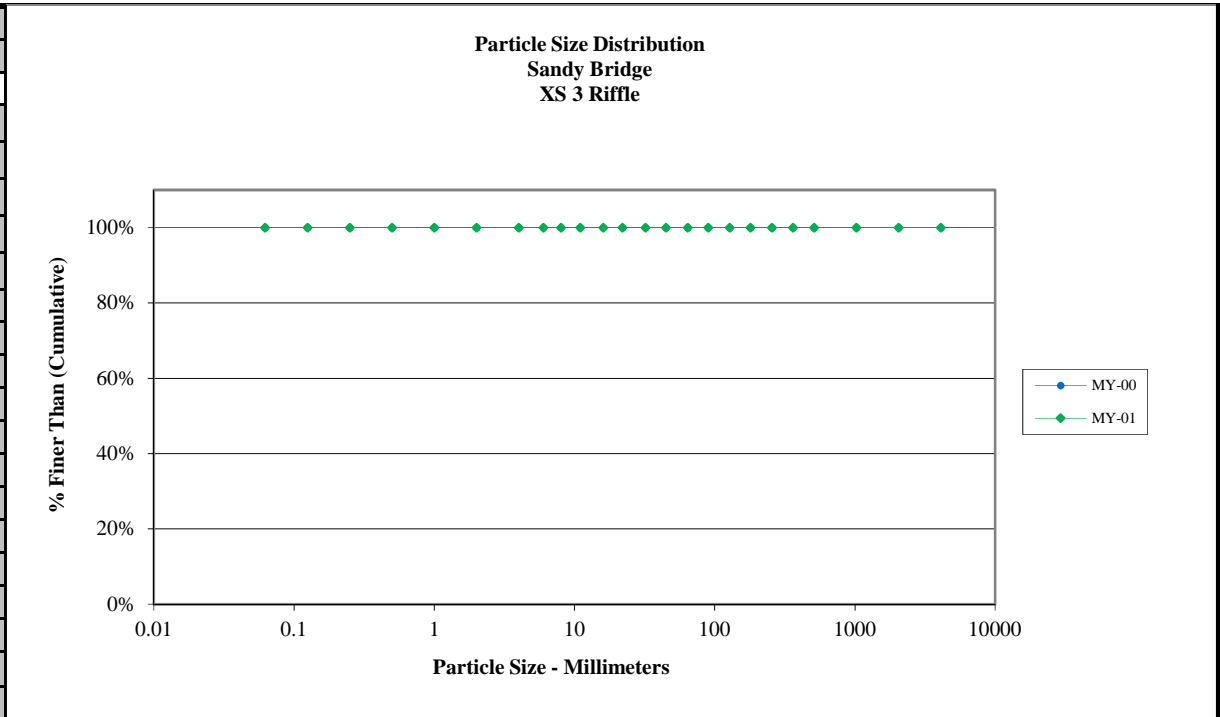
Size (mm)	
D16	0.062
D35	0.062
D50	0.062
D65	0.062
D84	0.062
D95	0.062

Type	
silt/clay	100%
sand	0%
gravel	0%
cobble	0%
boulder	0%
bedrock	0%
hardpan	0%
wood/det	0%
artificial	0%

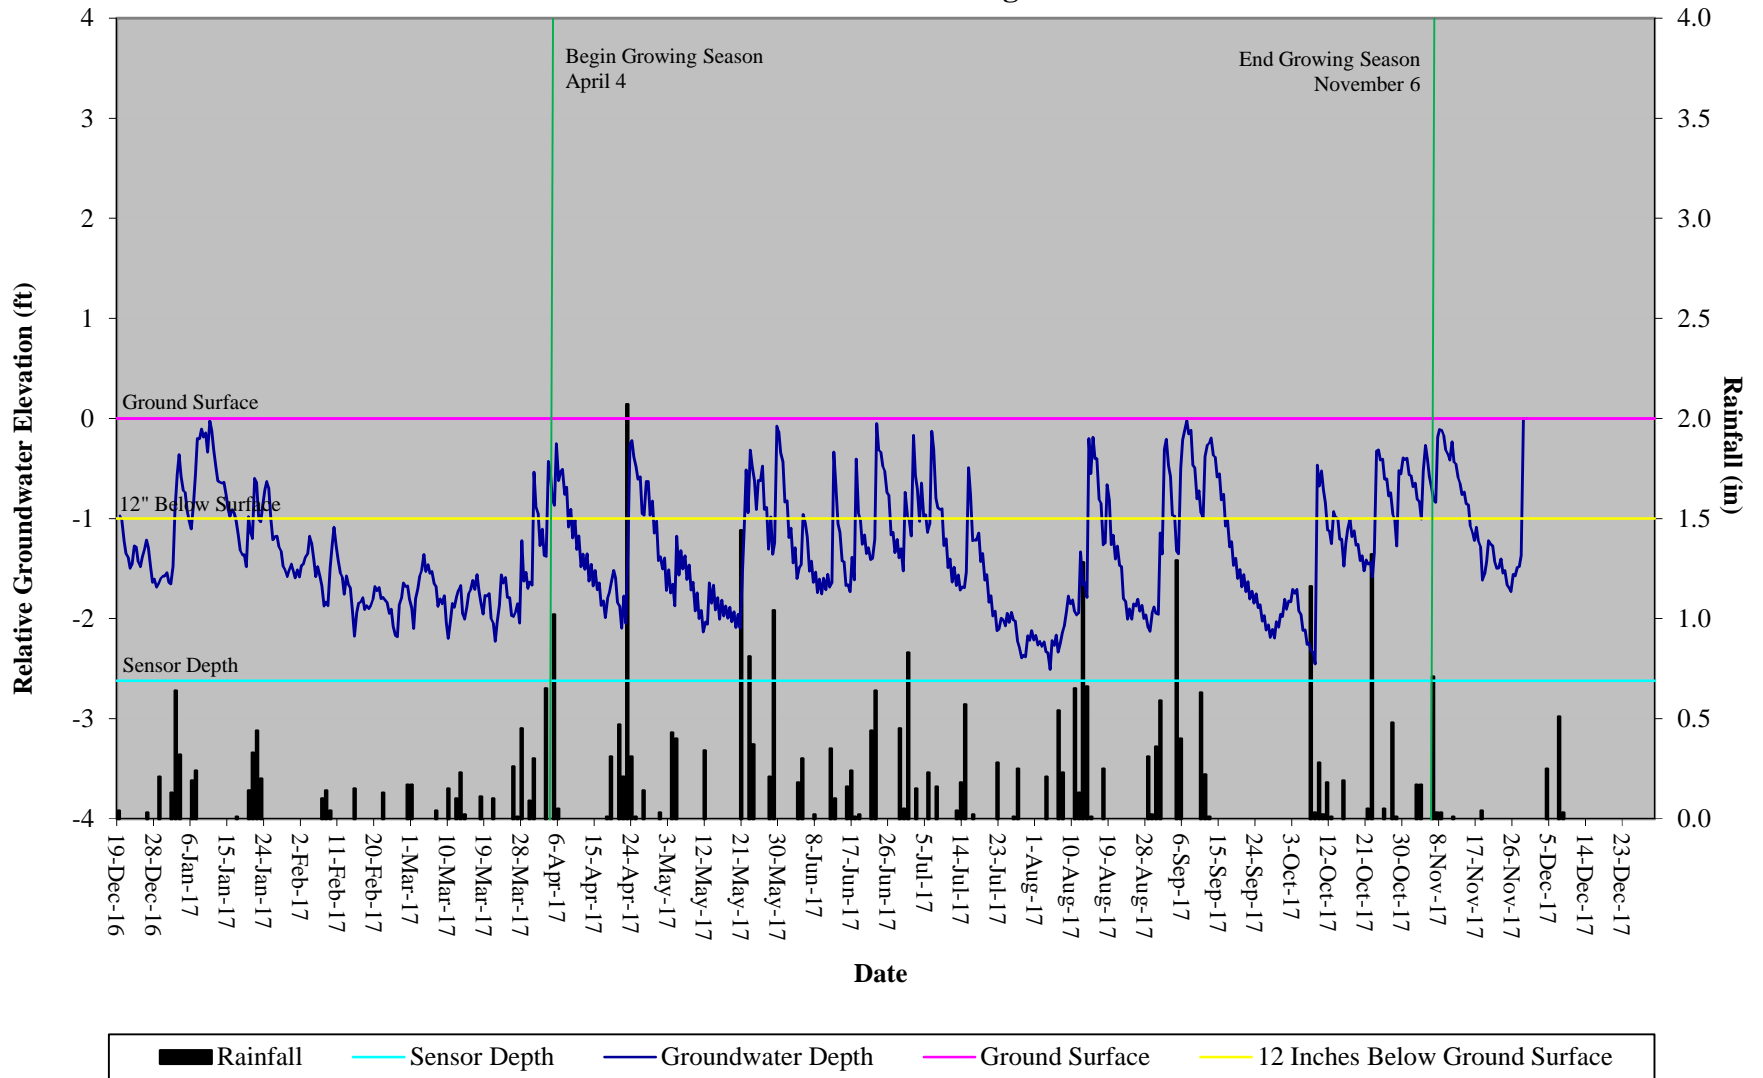
Sandy Bridge Farm Restoration Site Hydrograph Wetland Gauge 2

Greater than 10% Continuous Saturation/Max Consecutive Days During Growing Season (Percentage)						
Gauge #	MY-01 2017	MY-02 2018	MY-03 2019	MY-04 2020	MY-05 2021	MY-06 2022	MY-07 2023
Gauge 1	Yes/30 (13.8%)						
Gauge 2	No/11 (5.1%)						
Gauge 3	Yes/110 (50.7%)						
Gauge 4	Yes/47 (21.7%)						
Gauge 5	No/11 (5.1%)						
Gauge 6	Yes/30 (13.8%)						
Gauge 7	Yes/22 (10.1%)						
Gauge 8	Yes/29 (13.4%)						
Gauge 9	No/15 (6.9%)
