# Monitoring Report MY02

**Sandy Bridge Restoration Site  
DMS Contract 6400  
DMS Project Number 96920**

**DWR #: 15-0414  
USACE Action ID: 201500827  
Rutherford County, North Carolina**

**Monitoring Data Collected: September 2018  
Date Submitted: December 2018**

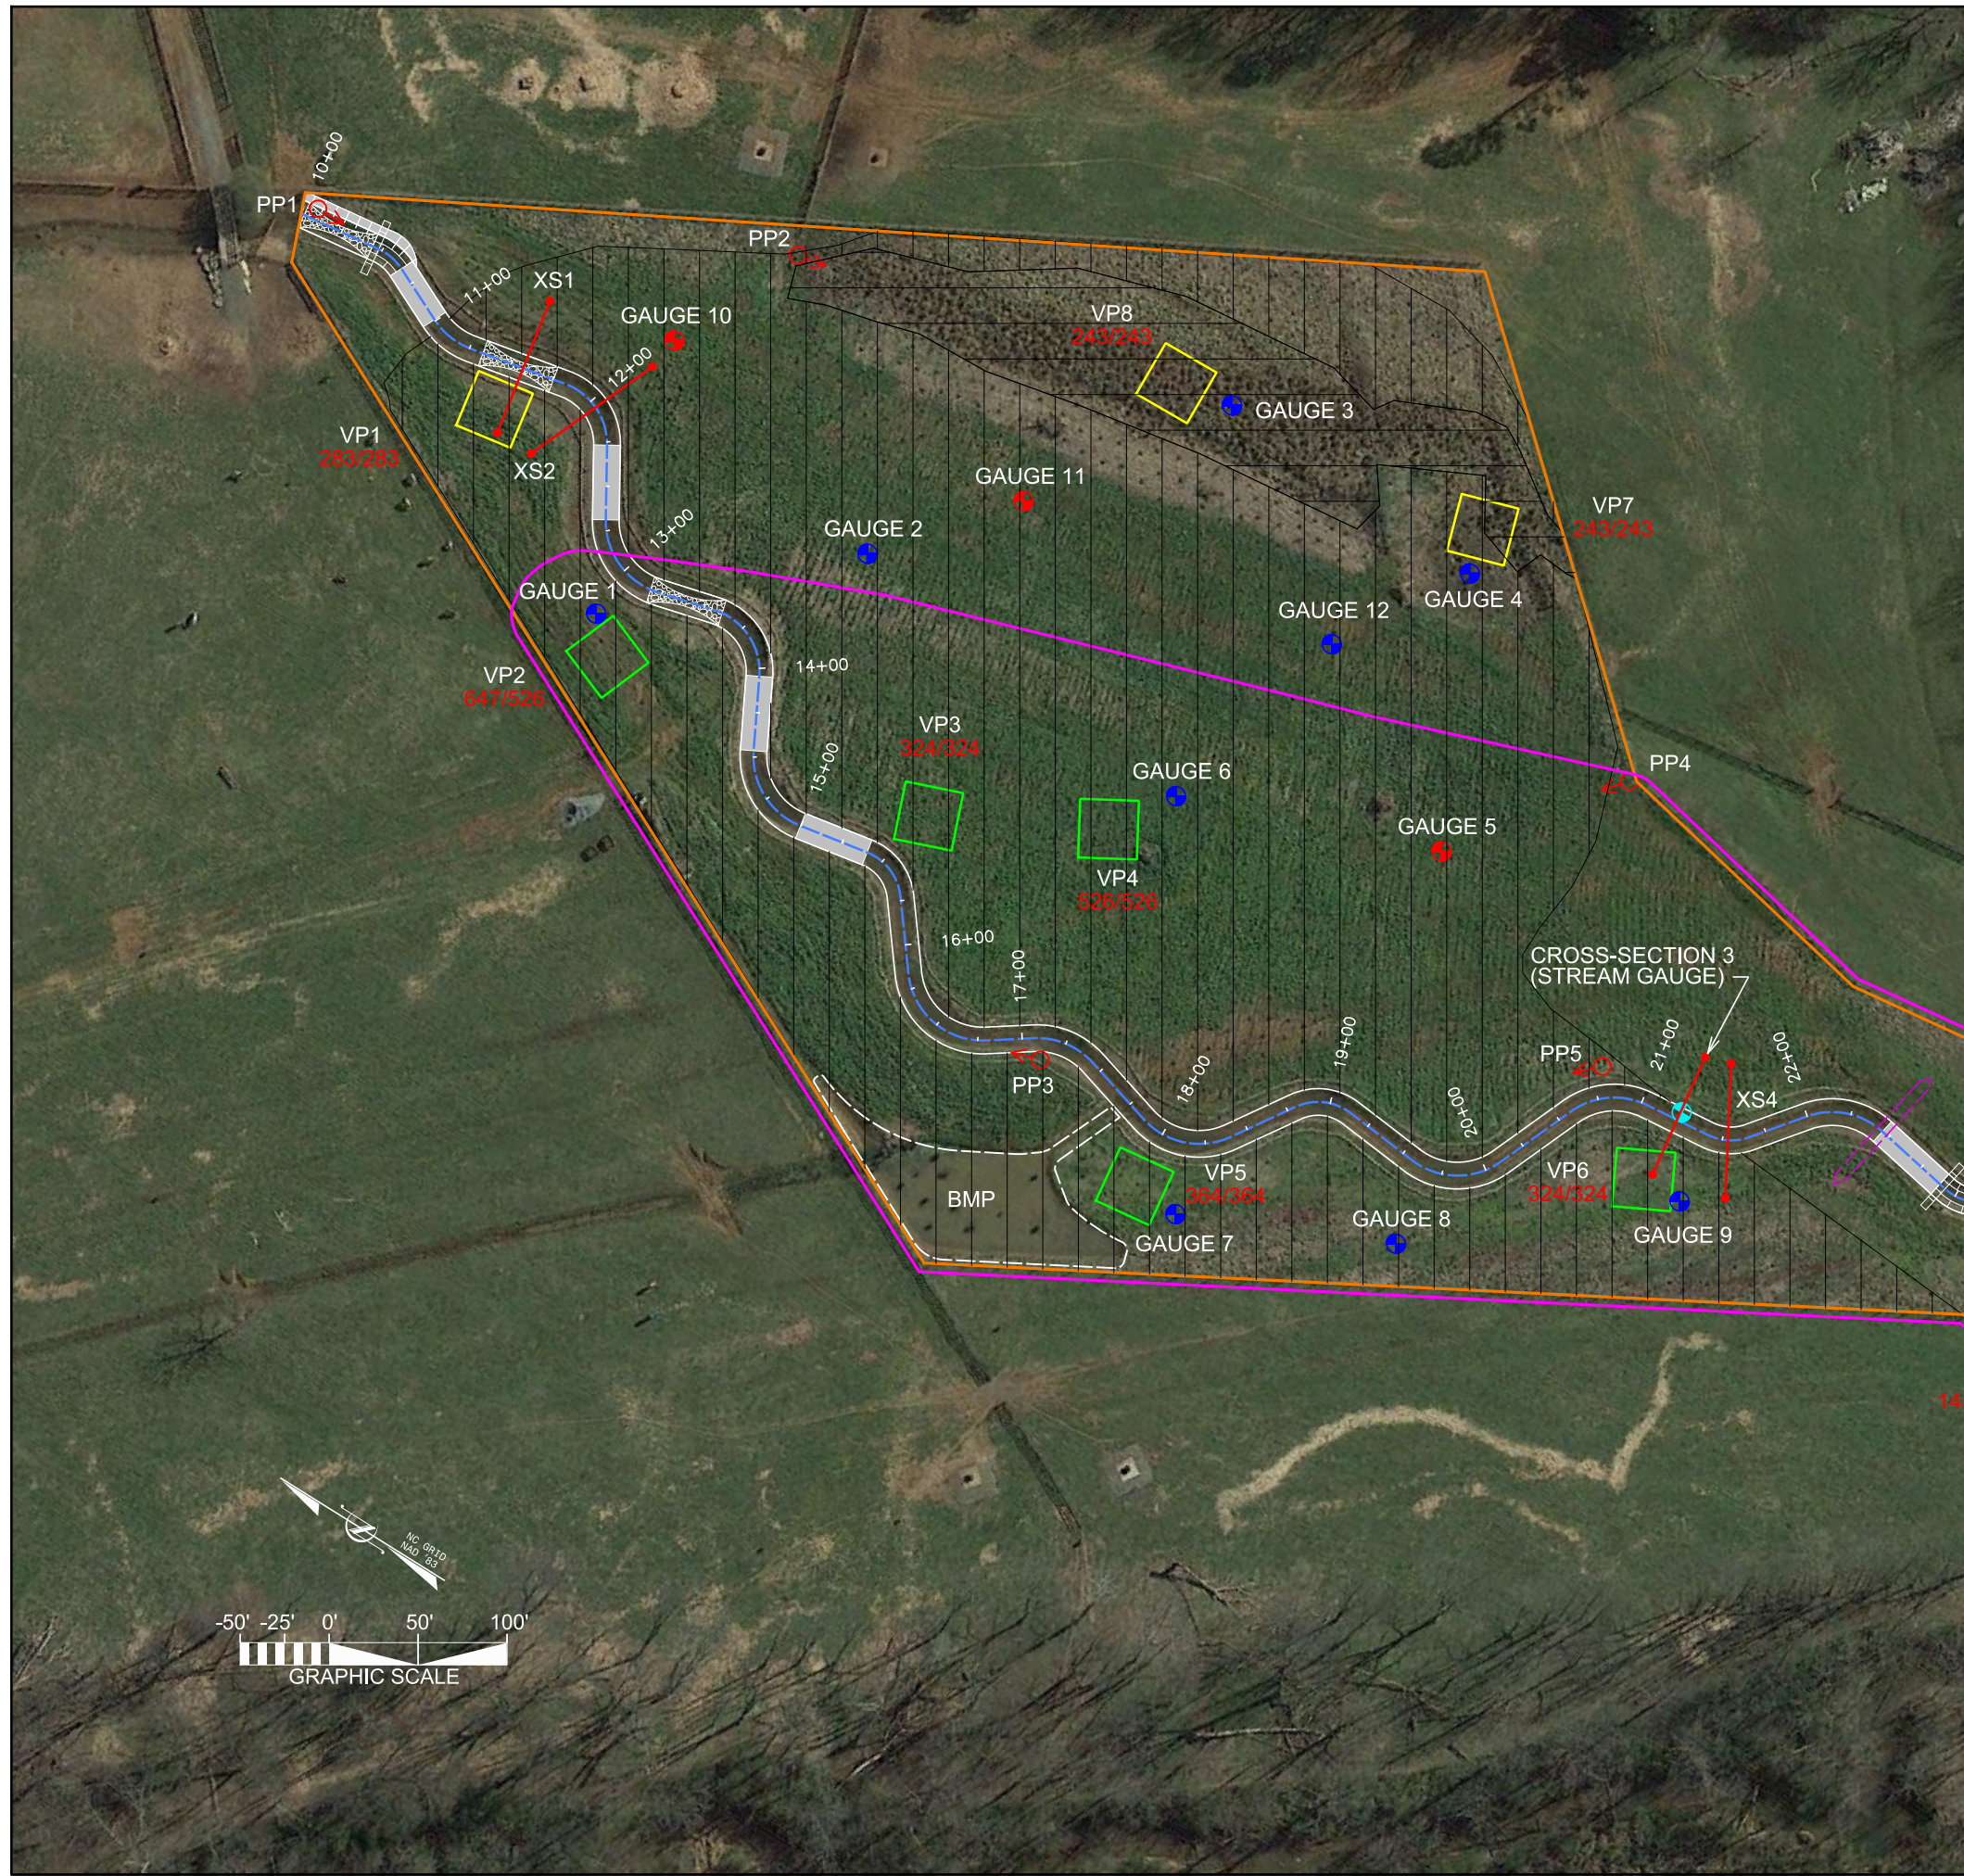
<b>5. Easement Encroachment Areas</b>	Areas or points (if too small to render as polygons at map scale).	none	Pattern and Color	0	0.00	0.0%
<b>6. Beaver Impacted Area</b>	Area where beavers have chewed down many trees, or where flooding occurred	none	Pattern and Color	1	6.30	66.3%

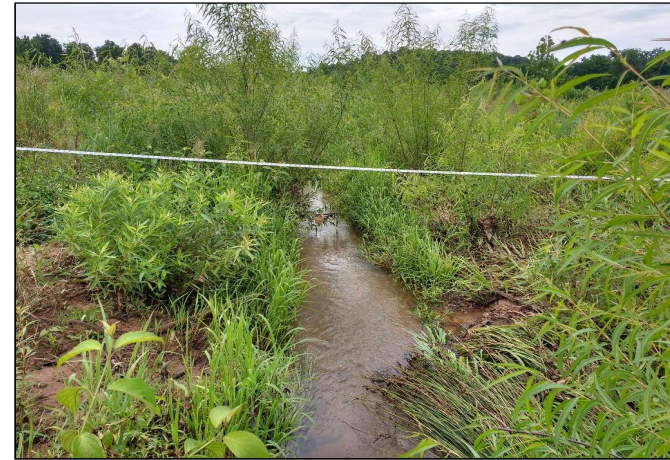
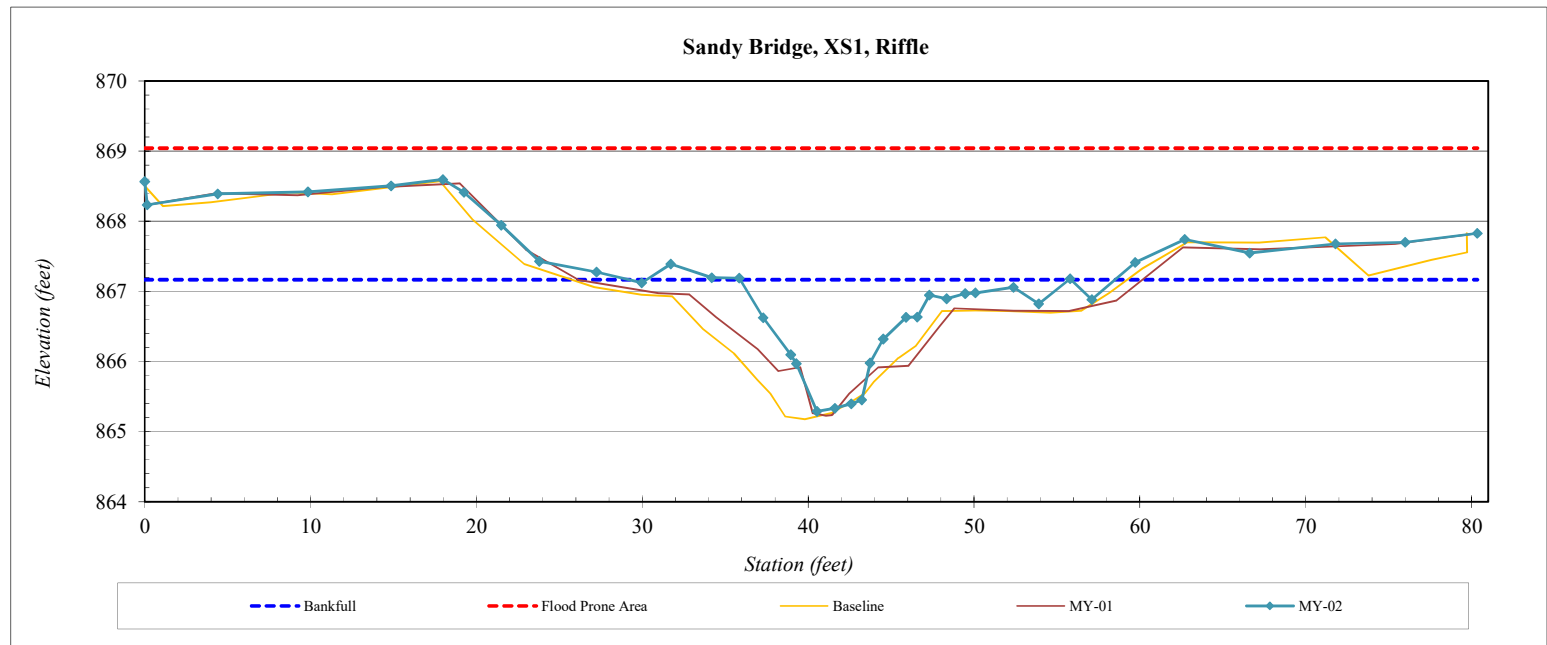
<b>River Basin:</b>	Broad
<b>Site:</b>	Sandy Bridge
<b>XS ID</b>	XS1
<b>Drainage Area:</b>	837 acres
<b>Date:</b>	6/28/2018
<b>Field Crew:</b>	T. Seelinger, D. Rosso

SUMMARY DATA	
<b>Current Bankfull Elevation:</b>	867.17
<b>Bankfull Cross-Sectional Area:</b>	14.0
<b>Total Cross-Sectional Area:</b>	7.2
<b>Bankfull Width:</b>	23.5
<b>Flood Prone Area Elevation:</b>	869.0
<b>Flood Prone Width:</b>	80.3
<b>Max Depth at Bankfull:</b>	1.9
<b>Mean Depth at Bankfull:</b>	0.6
<b>W / D Ratio:</b>	39.4
<b>Entrenchment Ratio:</b>	3.4
<b>Bank Height Ratio:</b>	0.9

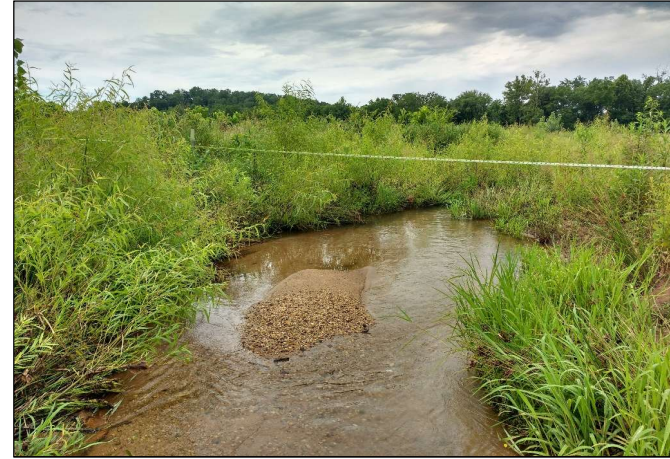
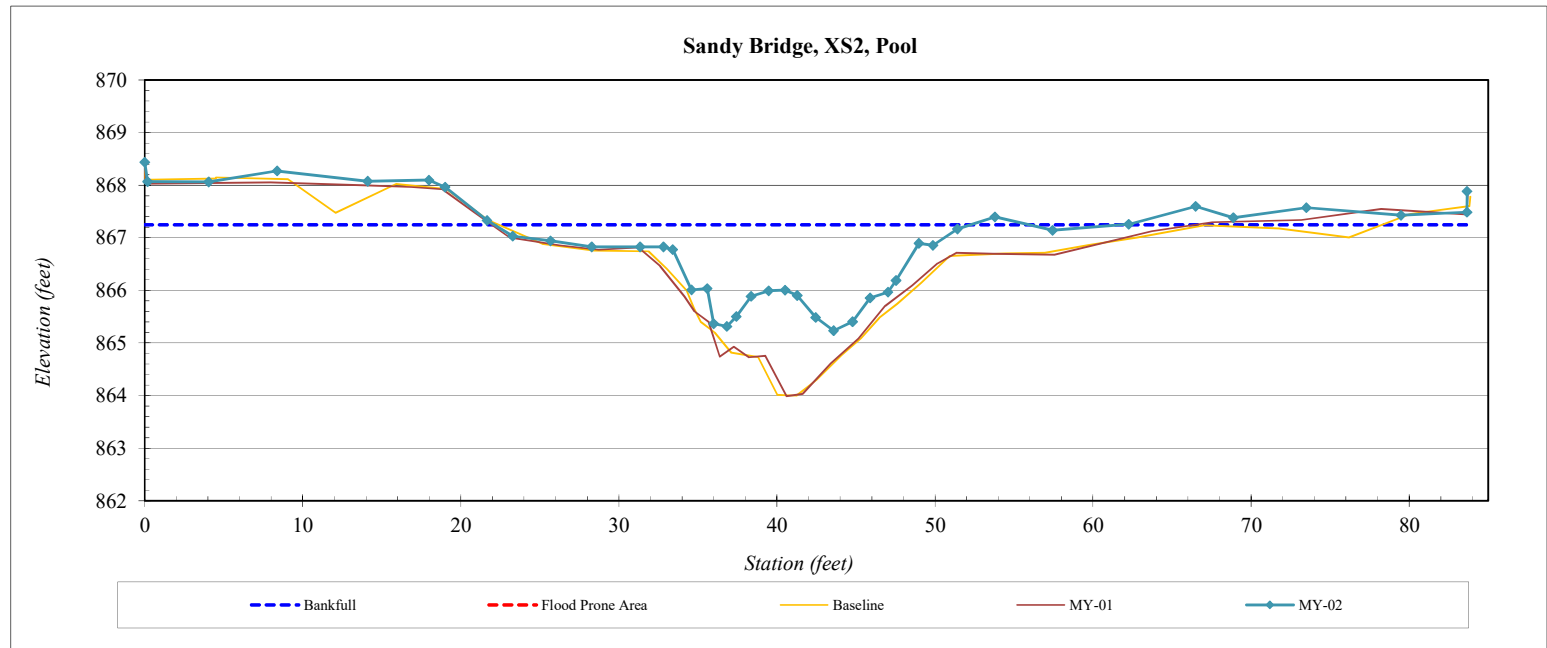
<b>River Basin:</b>	Broad
<b>Site:</b>	Sandy Bridge
<b>XS ID</b>	XS2
<b>Drainage Area:</b>	837 acres
<b>Date:</b>	6/28/2018
<b>Field Crew:</b>	T. Seelinger, D. Rosso

SUMMARY DATA	
<b>Current Bankfull Elevation:</b>	867.25
<b>Bankfull Cross-Sectional Area:</b>	26.8
<b>Total Cross-Sectional Area:</b>	12.9
<b>Bankfull Width:</b>	36.0
<b>Flood Prone Area Elevation:</b>	-
<b>Flood Prone Width:</b>	-
<b>Max Depth at Bankfull:</b>	2.0
<b>Mean Depth at Bankfull:</b>	0.7
<b>W / D Ratio:</b>	48.4
<b>Entrenchment Ratio:</b>	-
<b>Bank Height Ratio:</b>	-

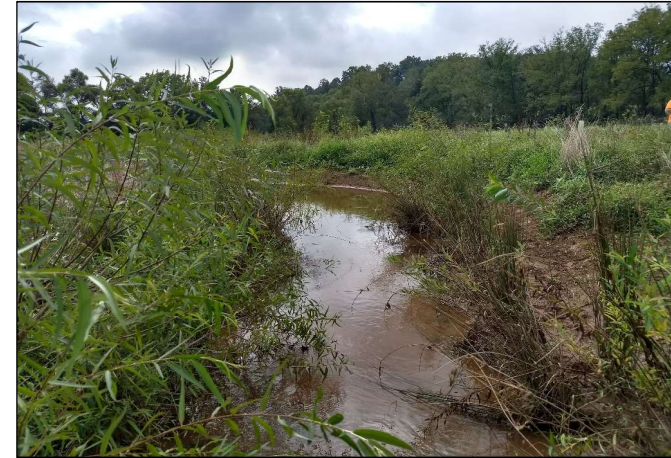
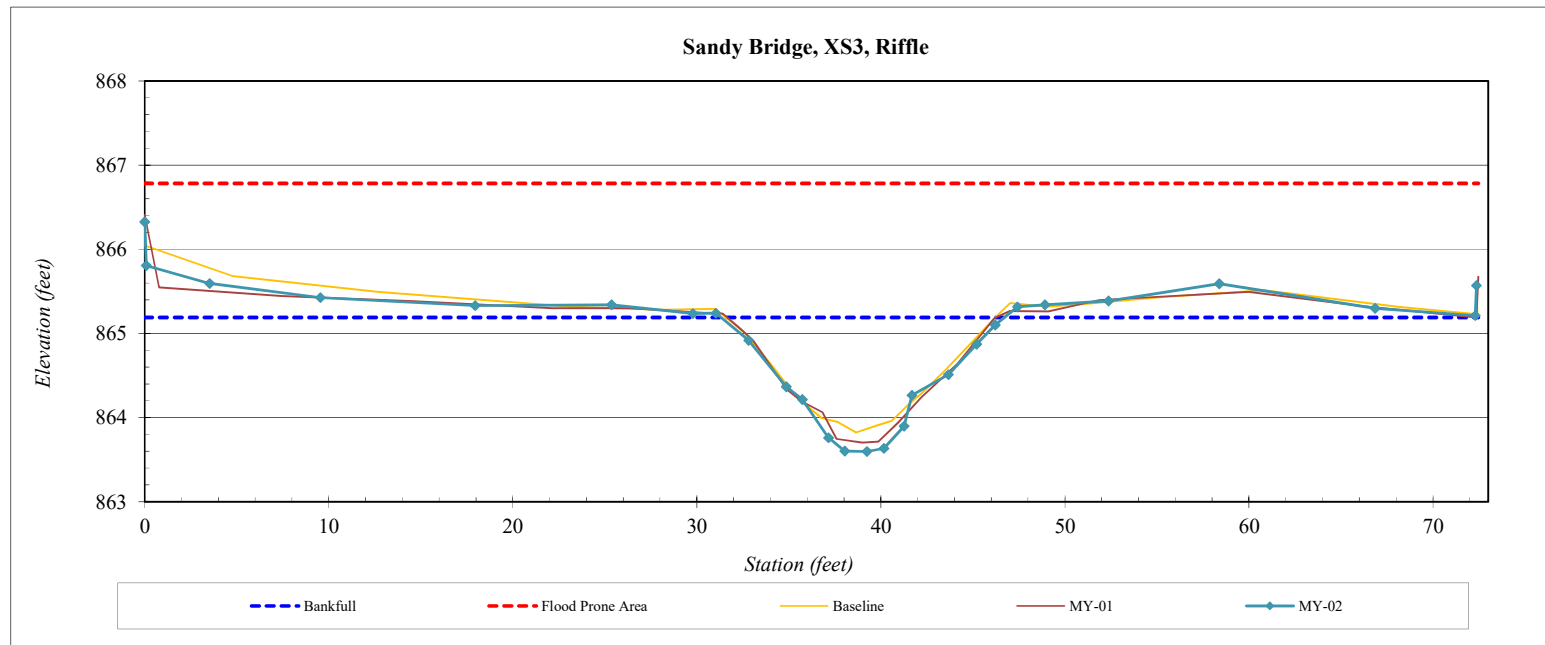
<b>River Basin:</b>	Broad
<b>Site:</b>	Sandy Bridge
<b>XS ID</b>	XS3
<b>Drainage Area:</b>	837 acres
<b>Date:</b>	9/11/2018
<b>Field Crew:</b>	T. Seelinger, K. O'Briant

SUMMARY DATA	
<b>Current Bankfull Elevation:</b>	865.19
<b>Bankfull Cross-Sectional Area:</b>	13.1
<b>Total Cross-Sectional Area:</b>	15.1
<b>Bankfull Width:</b>	15.4
<b>Flood Prone Area Elevation:</b>	866.8
<b>Flood Prone Width:</b>	72.4
<b>Max Depth at Bankfull:</b>	1.6
<b>Mean Depth at Bankfull:</b>	0.9
<b>W / D Ratio:</b>	18.0
<b>Entrenchment Ratio:</b>	4.7
<b>Bank Height Ratio:</b>	1.0
