Monitoring Report MY04

**Sandy Bridge Restoration Site
DMS Contract 6400
DMS Project Number 96920**

**DWR #: 15-0414
USACE Action ID: 201500827
Rutherford County, North Carolina**

**Monitoring Data Collected: 2020
Date Submitted: December 2020**

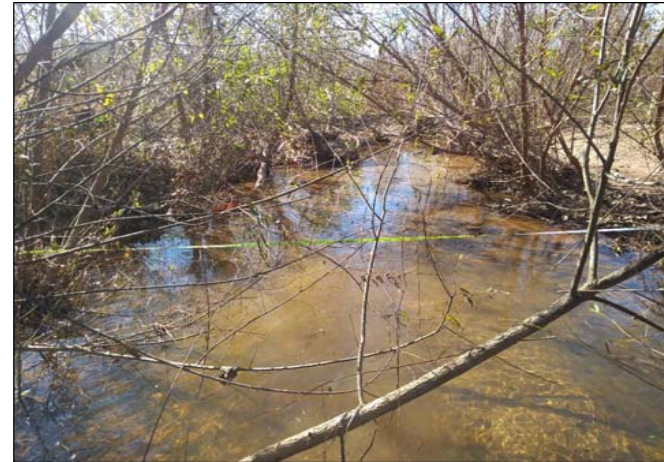
River Basin:	Broad
Site:	Sandy Bridge
XS ID	XS2
Drainage Area:	837 acres
Date:	11/4/2020
Field Crew:	T. Seelinger, A. Gutierrez

1. Aggradation (attributed to beaver) is noted in the text as a site issue however the visual assessment table indicates 100% of the project performing as intended for the aggradation metric. Both pool cross sections (XS2 and XS4) are showing the pools with significant filling in. Please field-verify and quantify/update the visual assessment tables every year as appropriate.

KCI Response: The Visual Assessment Table and the CCPV have been updated to reflect the aggradation that is present on-site as a result of the beaver impoundments.
