**Sandy Creek Stream Enhancement
& Wetland Restoration/Creation
Durham County
North Carolina**

1st Year Monitoring Report

December 1, 2004

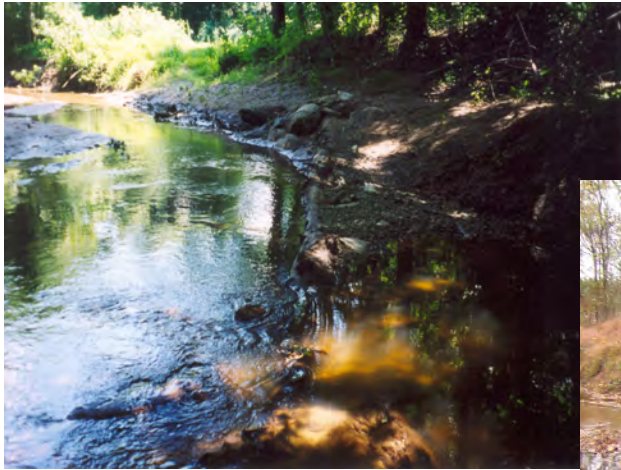
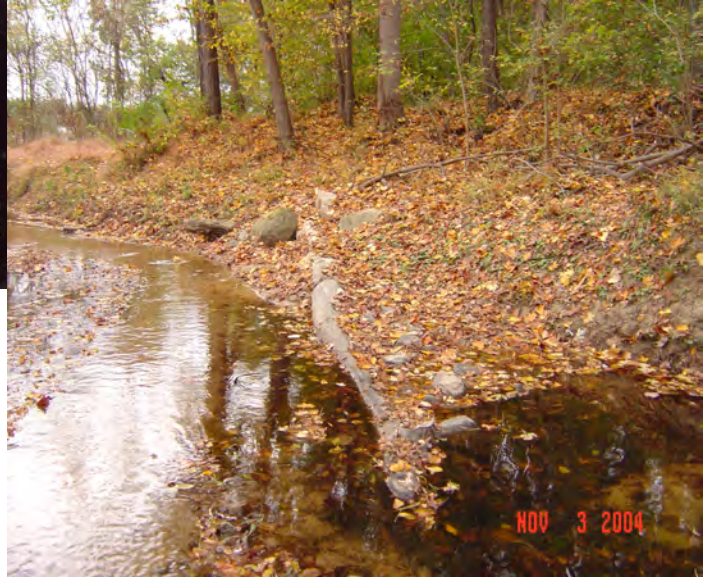
Log Vane #1, Station 2+04

Overall the Sandy Creek stream enhancement is doing excellent. The entire thirteen (13) log vanes are in excellent condition and are functioning properly stabilizing the banks and creating bed form features. There is no evidence of any problems with the log vane structures along the entire length. The stream cross-section dimensions have remained stable as measured at the permanent cross section.

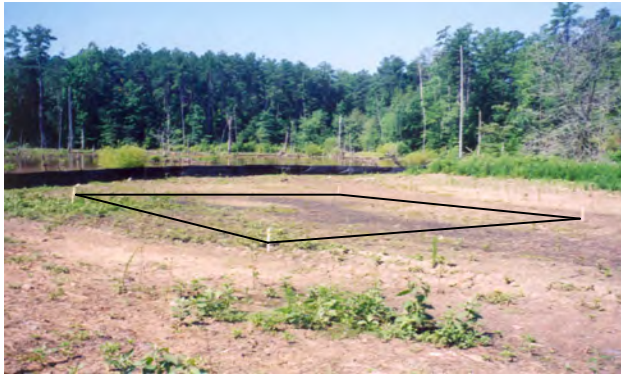
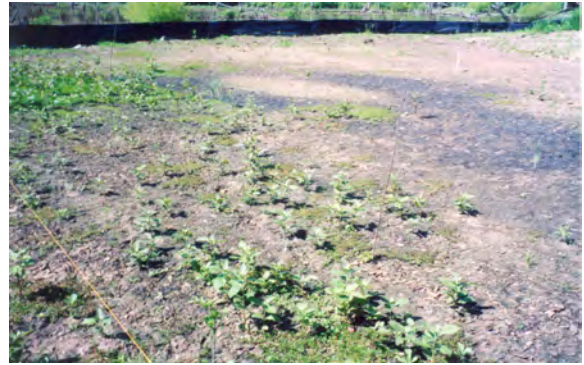
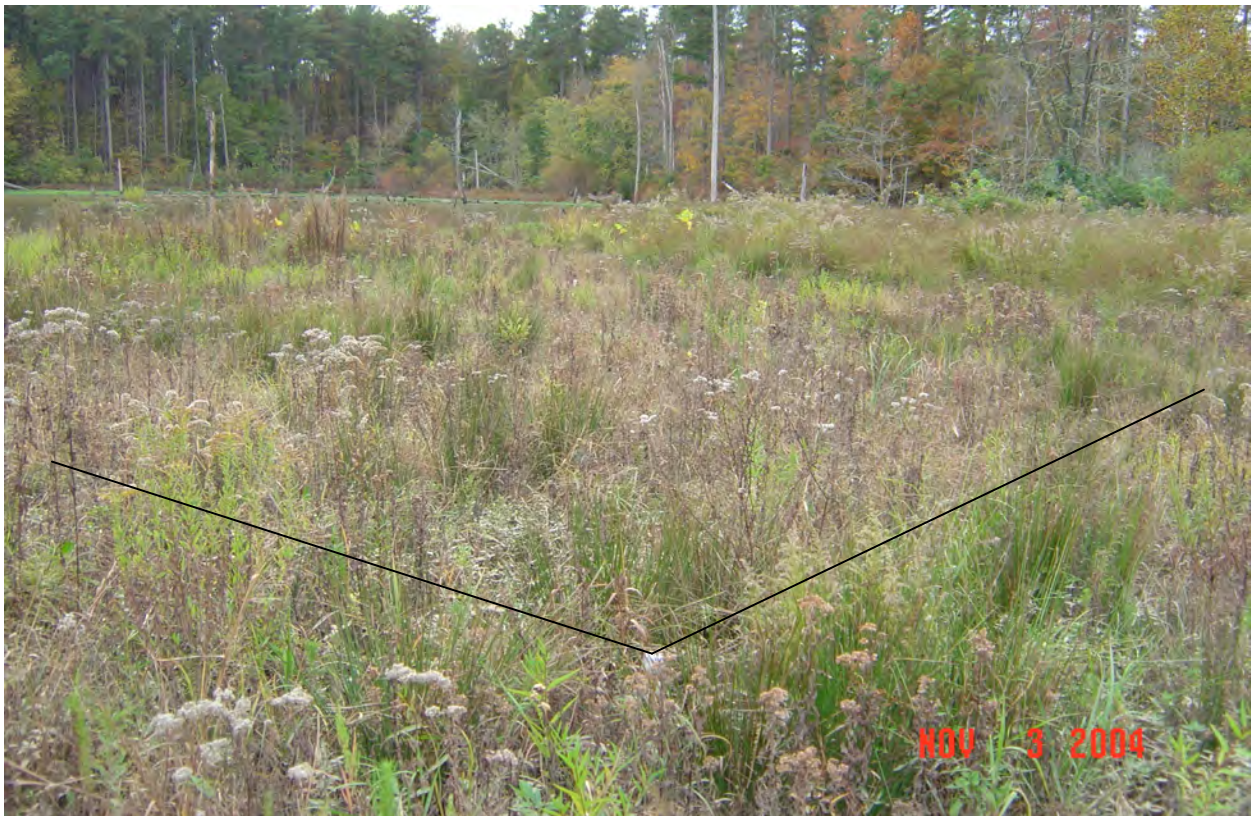
Vegetation Plot 1 – Sandy Creek Wetland Site

Development of planted and volunteer herbaceous species is excellent, with percent cover averaging 81.3%. In plots 1,2, and 3, the herbaceous component is comprised of planted grasses, perennial dicotyledons, sedges (*Carex*, *Scirpus*, and *Cyperinus*), rushes (*Juncus*), spikerushes (*Eleocharis*), and cattails (*Typha latifolia*). It is evident that the facultative herbaceous component is doing well in wetter regions of the site, but in some dryer regions (such as on the island, Plot 5) invasive species, namely lespedeza (*Lespedeza cuneata*) and frost aster (*Aster pilosus*), have developed dense cover to the detriment of more desirable species.

Above pictures taken after construction July 12, 2003. Picture below was taken November 3, 2004 after one growing season.

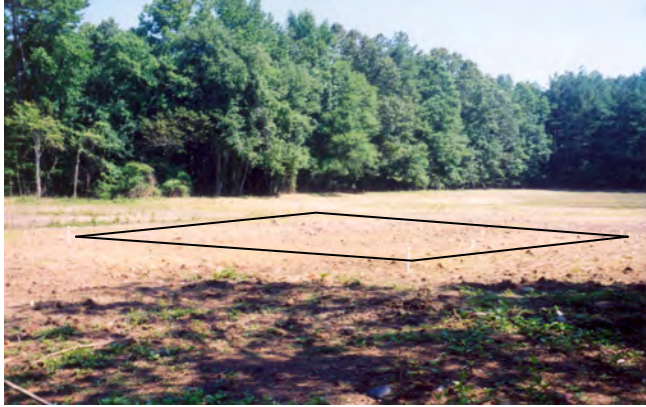
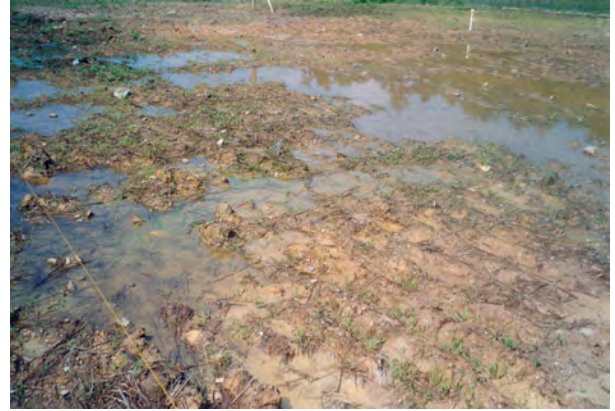
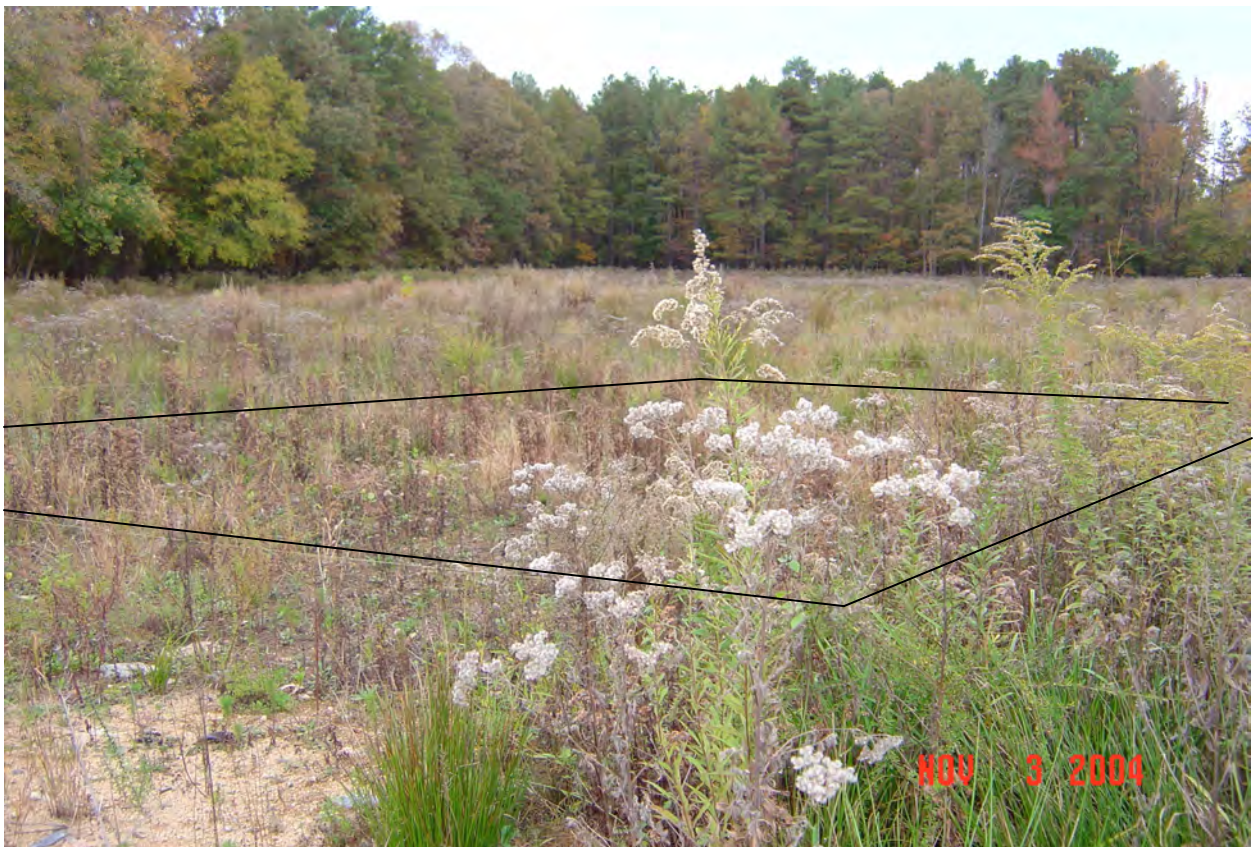
Vegetation Plot 2 – Sandy Creek Wetland Site

The above pictures were included in the original as-built report for the project. The pictures were taken on July 12, 2003. The photograph at the bottom of the picture was taken on November 3, 2004 after one growing season.

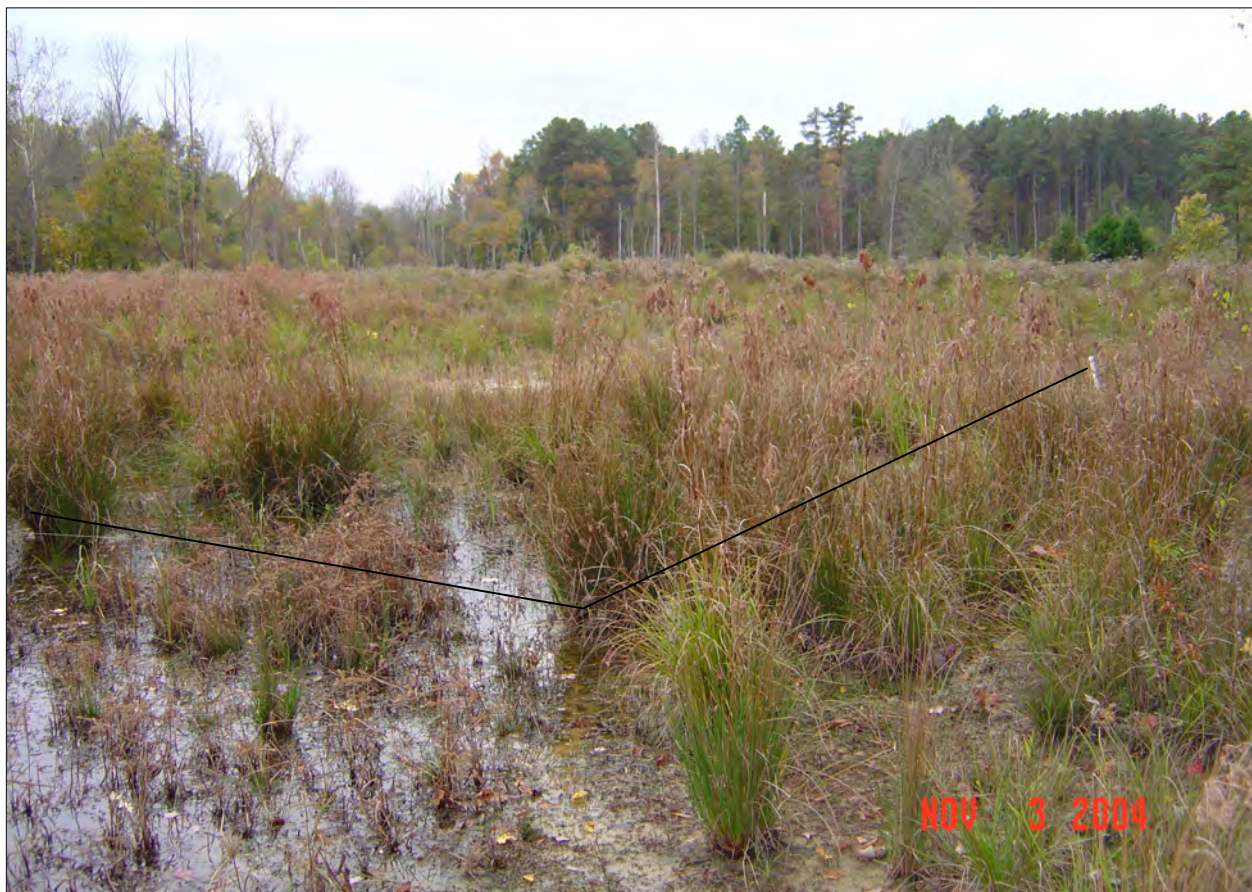
Picture 4

The pictures above were taken July 12, 2003 after construction. The picture below was taken on November 3, 2004 after one year of growing season.

Vegetation Plot 4 – Sandy Creek Wetland Site

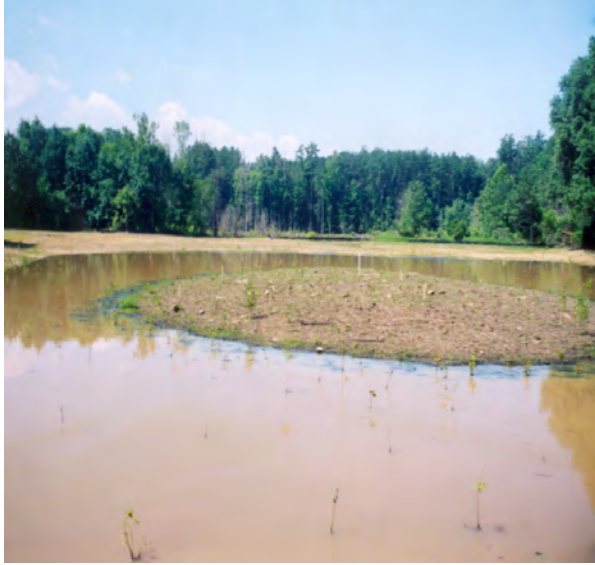
Picture 5

Vegetation Plot 5 – Sandy Creek Wetland Site

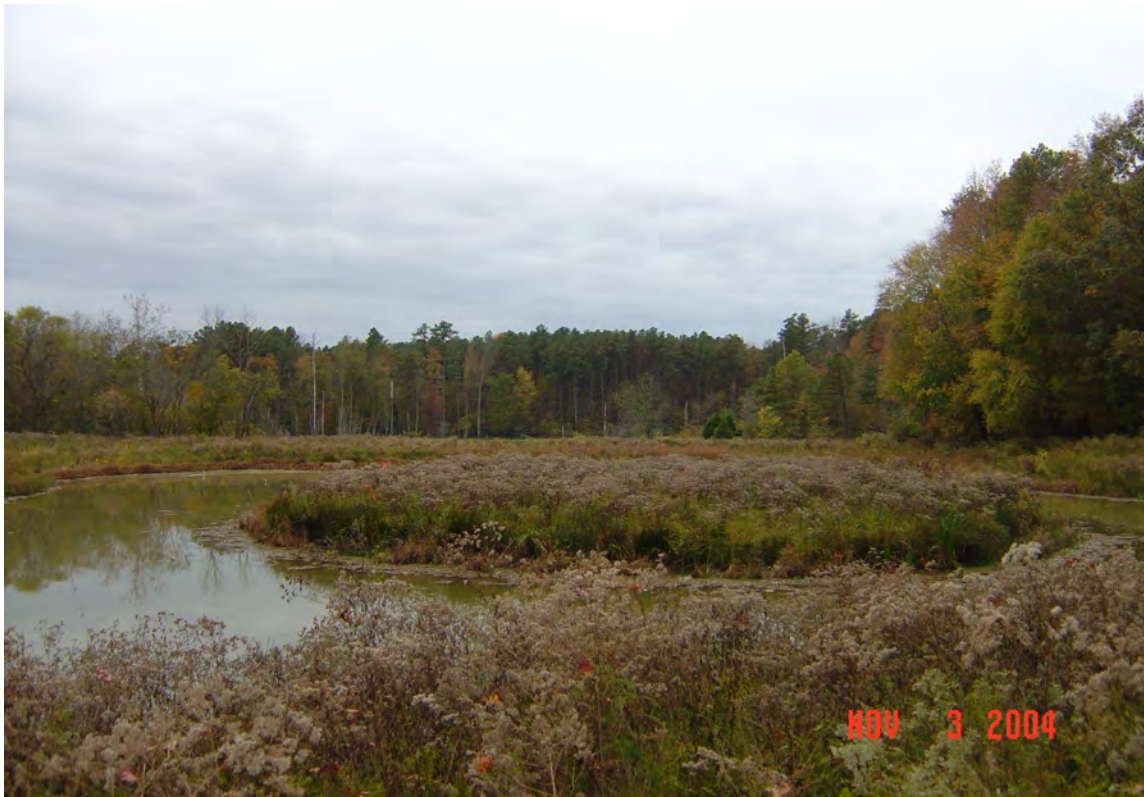
The above pictures were taken on July 12, 2003. The picture below, taken November 3, 2004, shows one season of growth on the newly constructed site.
