**SANDY CREEK STREAM ENHANCEMENT  
AND WETLAND RESTORATION SITE  
2005 Annual Monitoring Report (Year 2)**

**Durham County  
EEP Project No. 322  
Design Firm: Becky L. Ward Consulting**

**February, 2006**

**Prepared by: ECOSCIENCE CORPORATION  
1101 Haynes Street, Suite 101  
Raleigh, NC 27604**

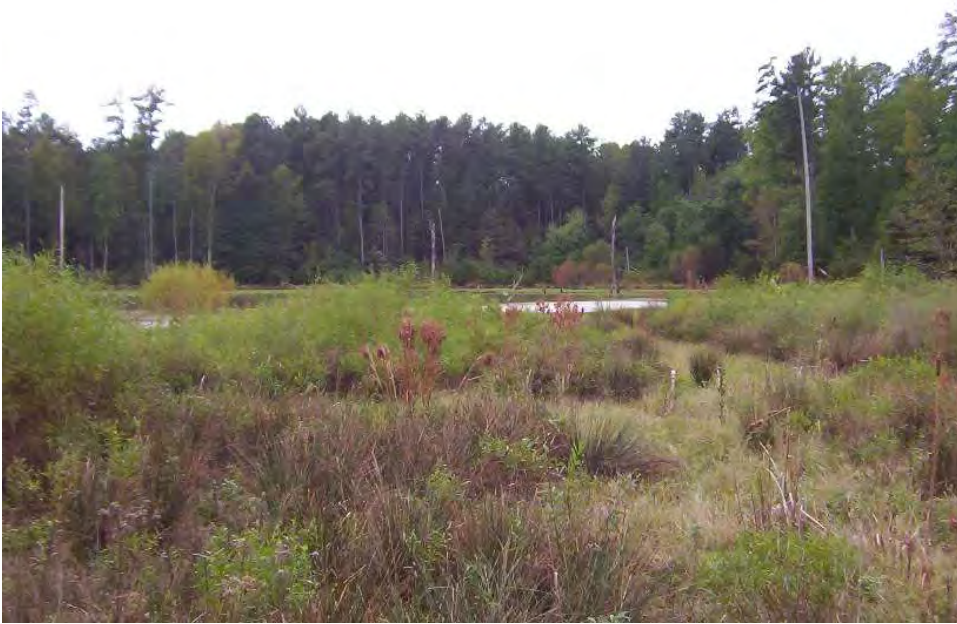
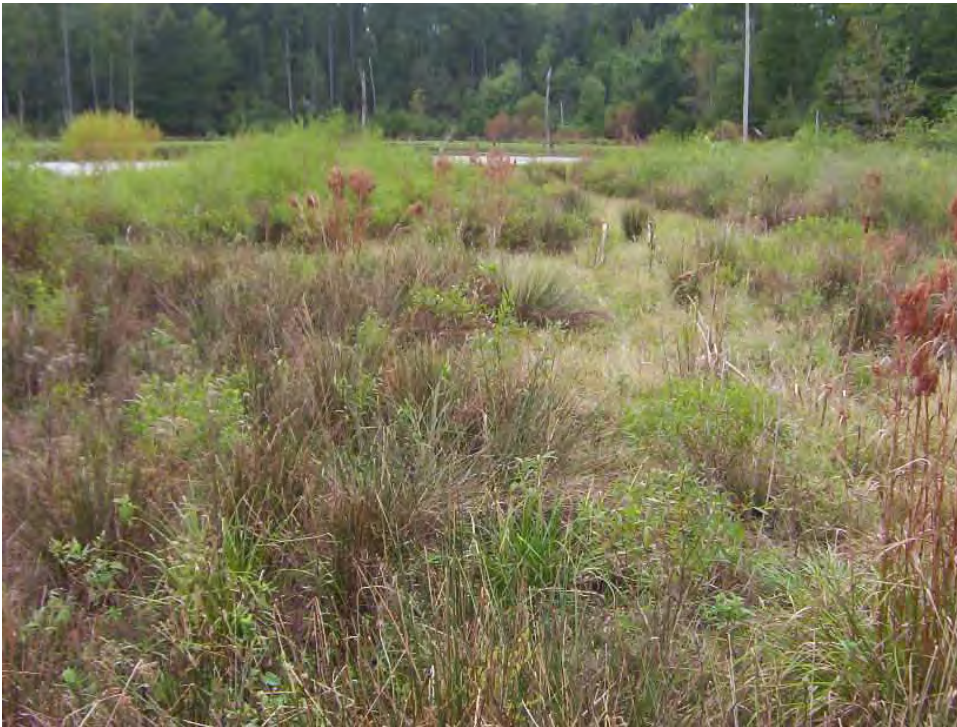
## Vegetation Plot 1 – Sandy Creek Wetland Restoration

The above pictures were taken on October 14, 2005, after two seasons of growth on site.

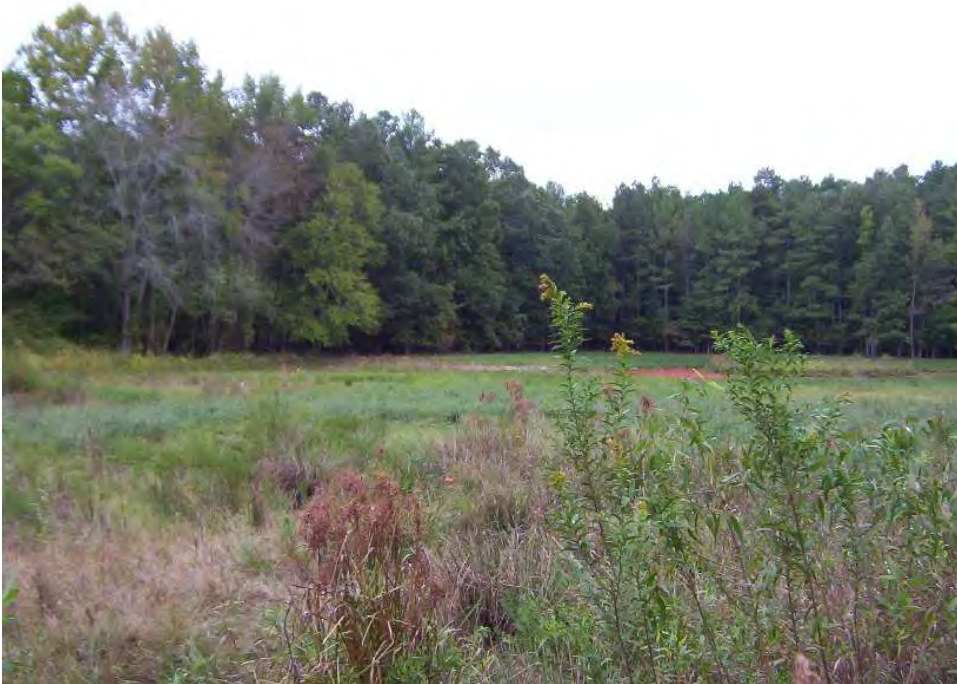
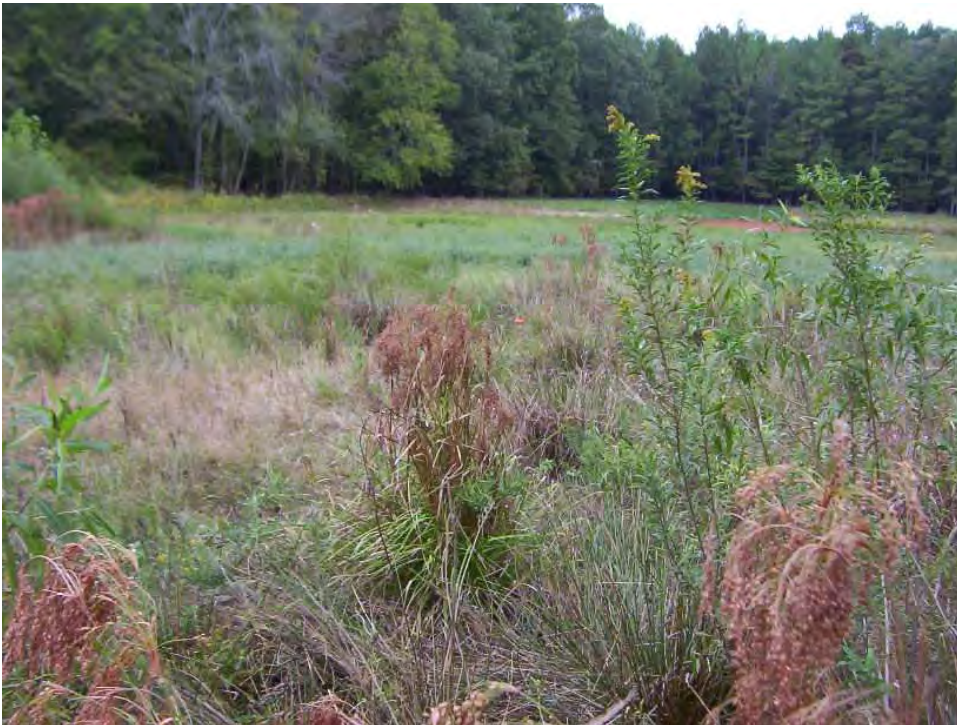
## Vegetation Plot 2 – Sandy Creek Wetland Restoration

The above pictures were taken on October 14, 2005, after two seasons of growth on site.

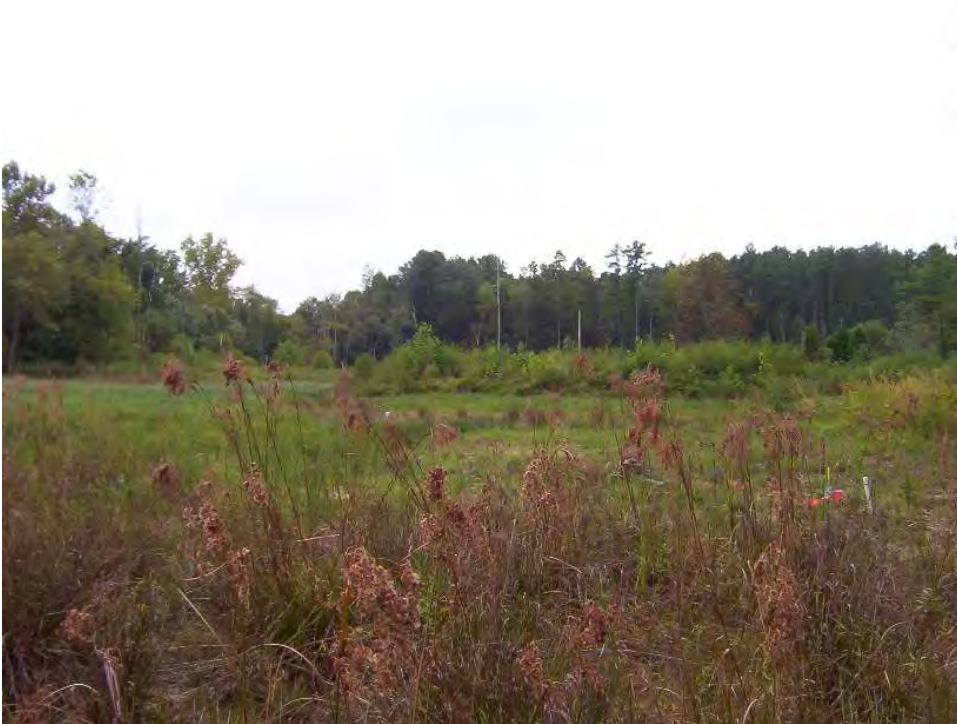
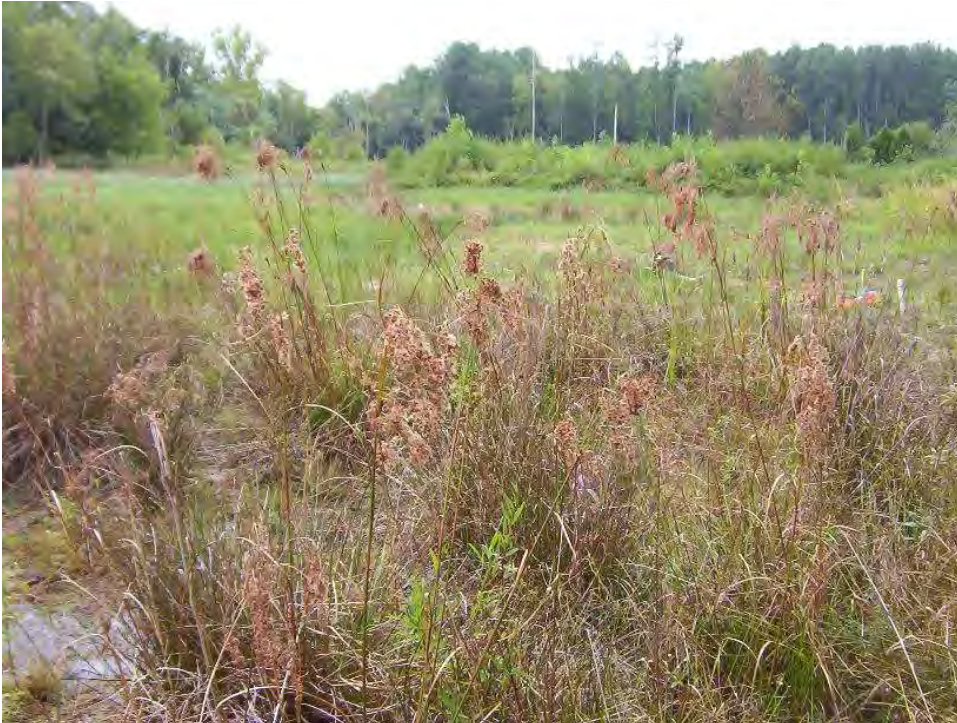
## Vegetation Plot 3 – Sandy Creek Wetland Restoration

The above pictures were taken on October 14, 2005, after two seasons of growth on site.

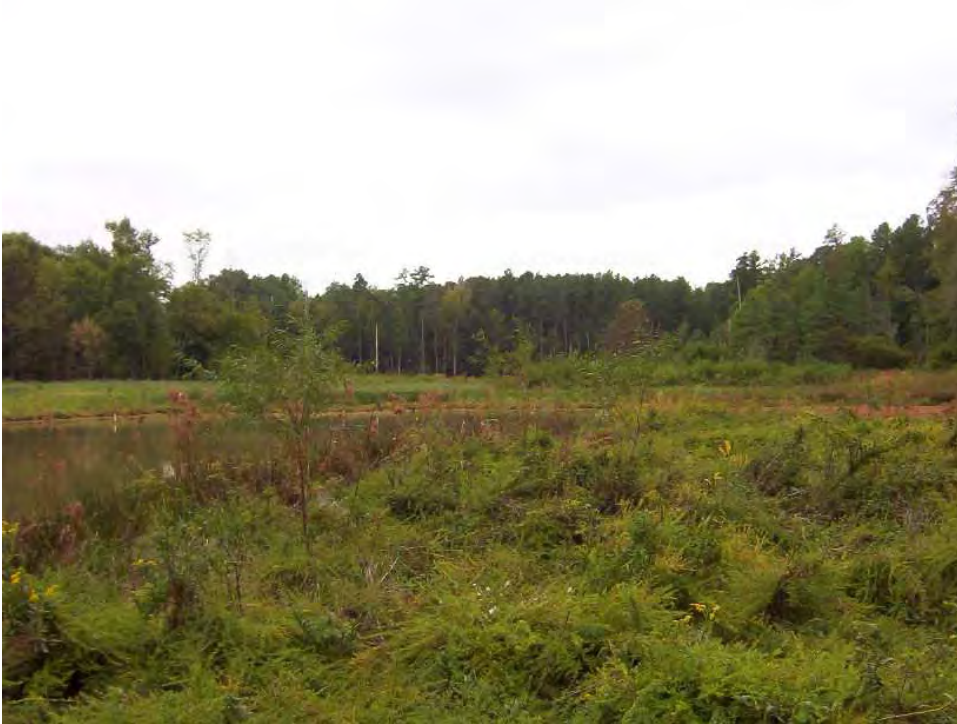
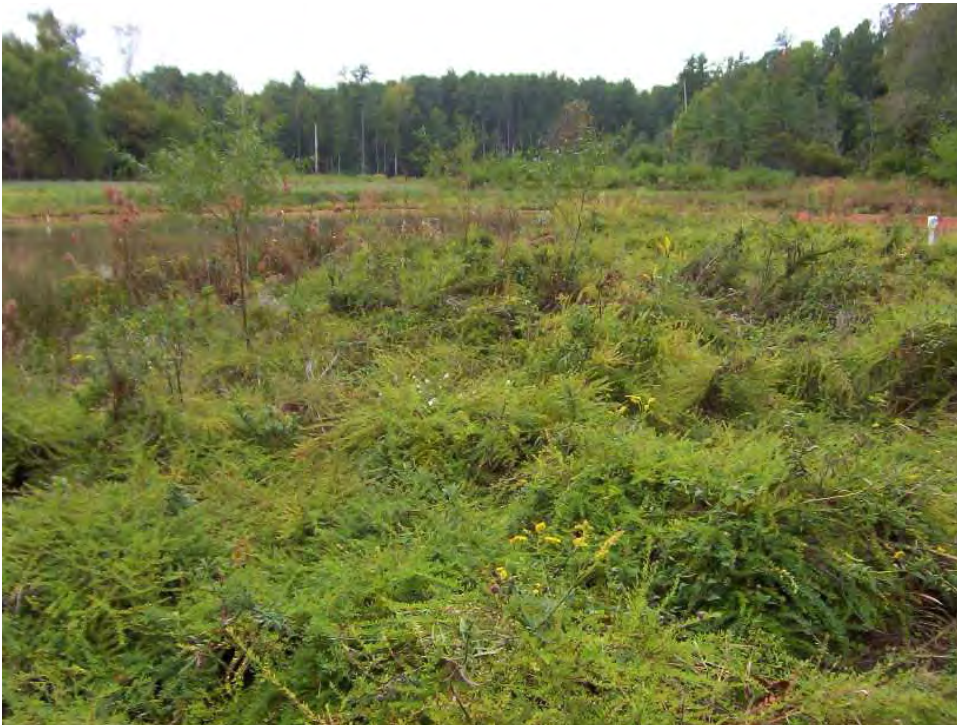
## Vegetation Plot 5 – Sandy Creek Wetland Restoration

The above pictures were taken on October 14, 2005, after two seasons of growth on site.

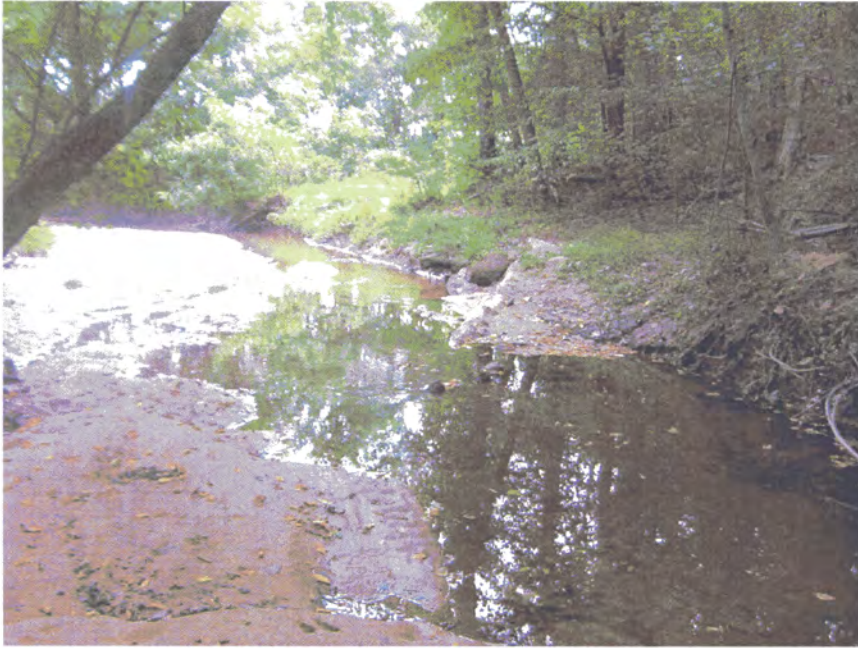
Log Vane #1, Station 2 + 04

The log vanes in Sandy Creek were observed and evaluated for stability and effectiveness. The vanes appear stable with no visible signs of breaching. Vegetation has established on the depositional areas behind the vane arms at many locations. The banks adjacent to all the vanes were stable and showed no evidence of erosion. However, the enhancement of bed form from the installation of these vanes is not currently evident. Based on cursory observations, the high sediment load in the stream has not allowed pools to form behind any of the structures. The thalweg appears to meander from each storm event with no discernable bed features throughout the reach. The permanent cross-section survey and pebble counts show no significant change over the past year.

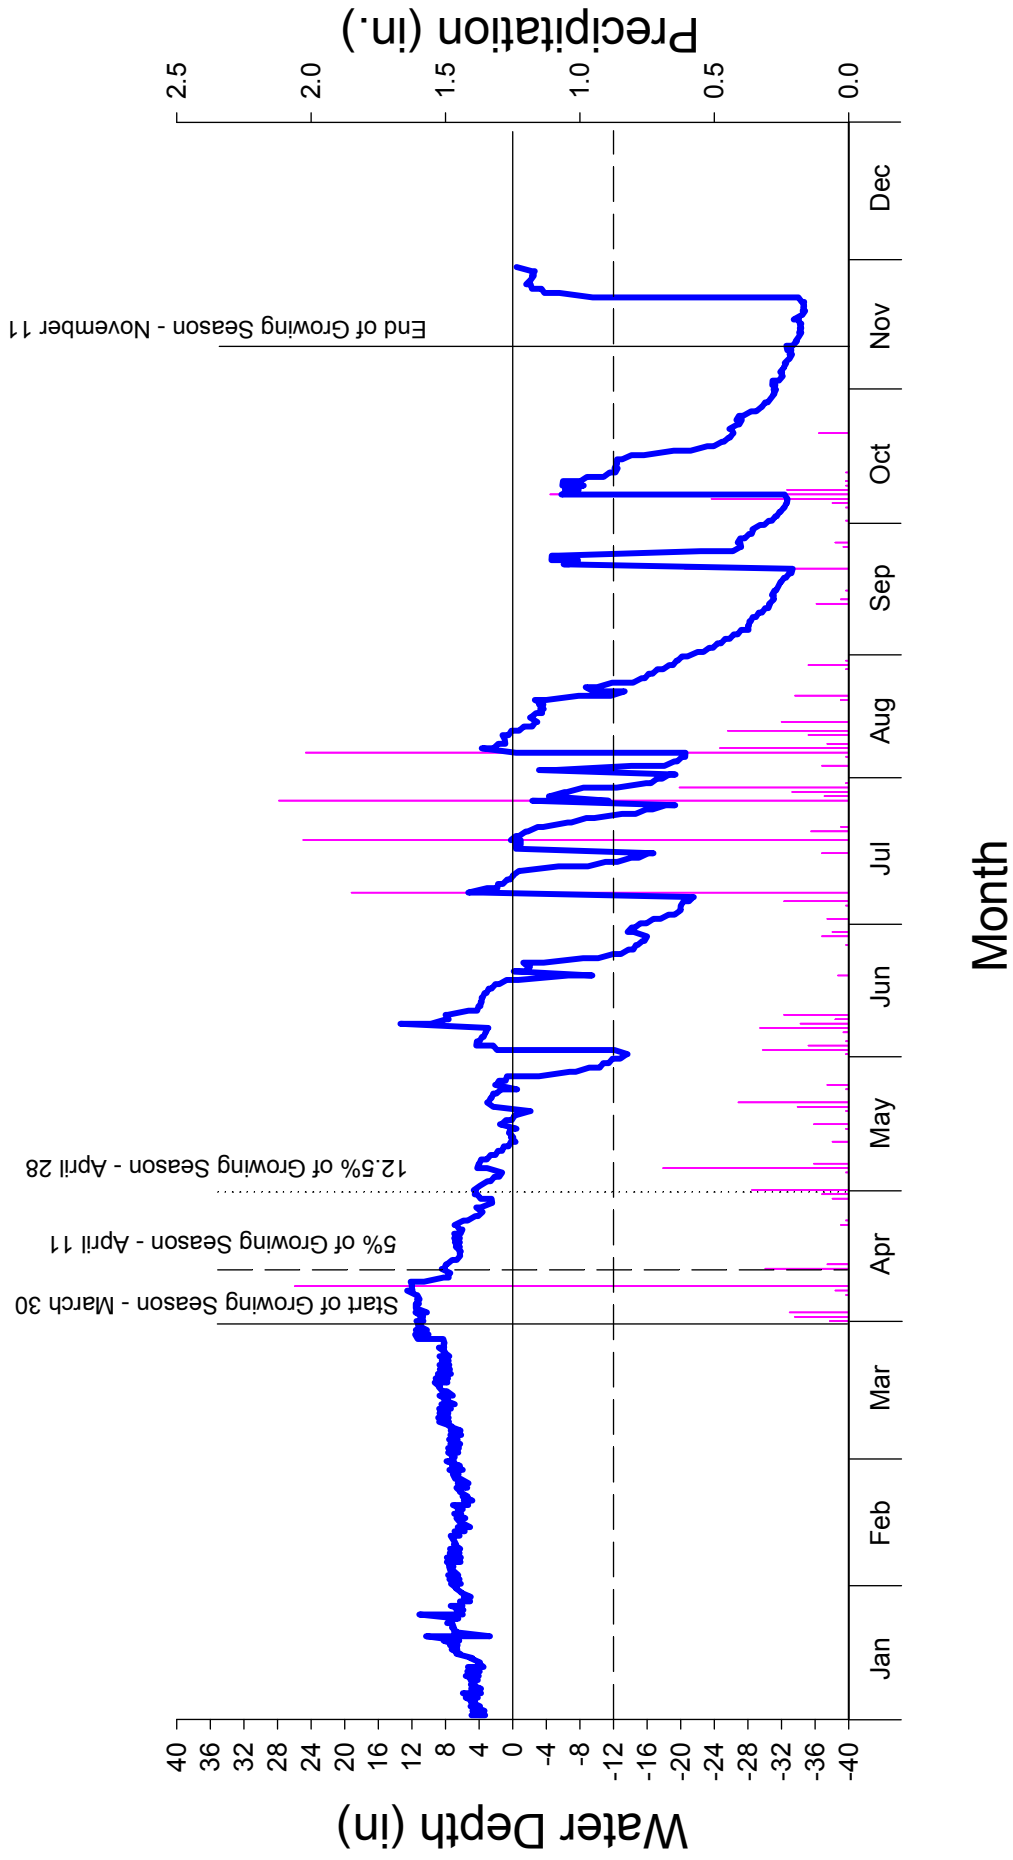
# Sandy Creek 2005 Monitoring Gauge A - N3CF7A65

The 2005 hydrologic monitoring results indicate overall continued hydrologic success within the Site. Two of the three on-site groundwater monitoring gauges exhibited saturation within 12 inches of the ground surface for at least 12.5 percent (consecutive days) of the growing season (March 30 – November 11 or 227 days). The third gauge narrowly missed the success criteria with saturation occurring for 12 percent of the growing season. This particular gauge met the wetland hydrology success criteria
