**CHARLES WILLIAMS STREAM, WETLAND, AND BUFFER SITE**  
**DMS Project No. 80**

**MONITORING YEAR 3 (2015)**  
**Construction Completed February 2013**  
**Planting Completed February 2014**

**Randolph County, NC**  
**State Construction Project No. 07-07125-01A**

**FINAL REPORT November 2015**

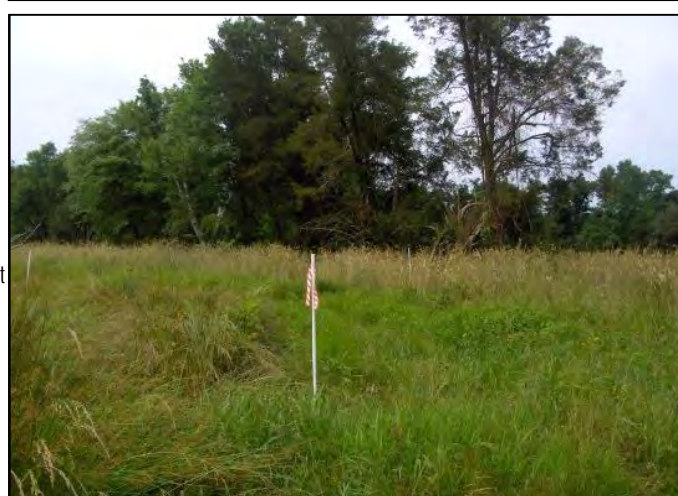
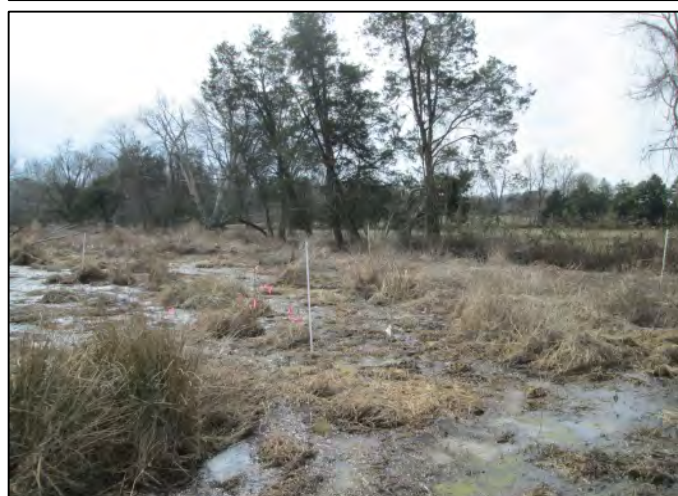
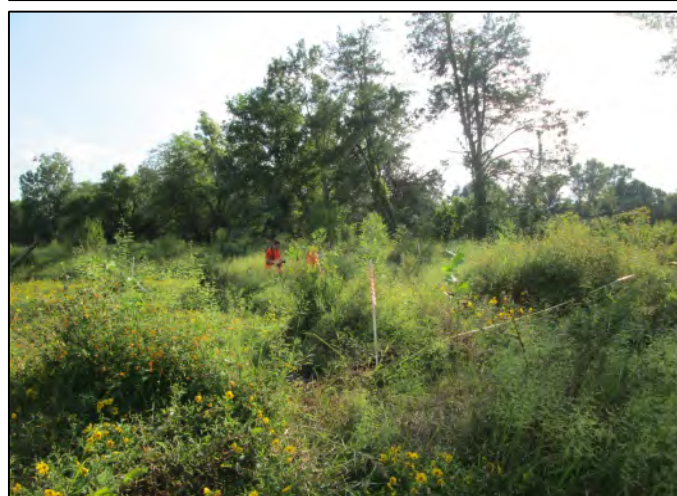
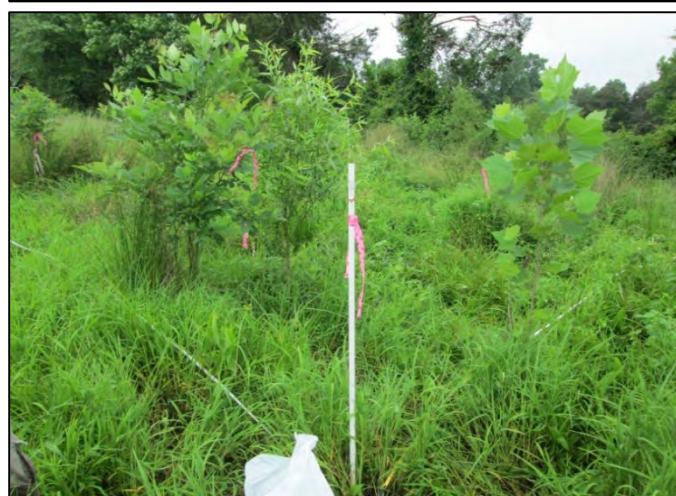
Vegetation Plot 6  
Facing Southwest

Due to the random placement of vegetation plots, only one of the eight plots associated with stream/wetland credit is currently placed within the wetland enhancement area (Vegetation Plot #6). The remaining seven plots are situated in non-wetland areas; however, based on current site conditions, three plots (Vegetation Plots #3, #7, and #8) may likely be in wetland areas by the time MY4 assessments are performed. The wetland status of the current plots will be reassessed during MY4 activities.

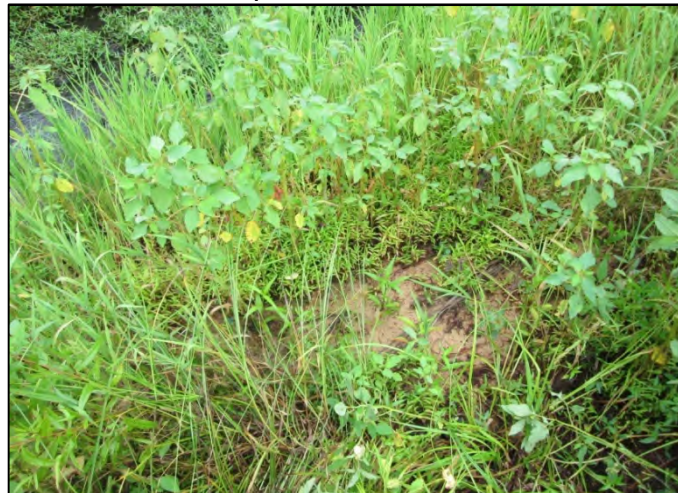
A bankfull event was actively observed on April 17<sup>th</sup>, 2015 during a rainfall event. Additional evidence of this and other subsequent bankfull events was documented on June 30, 2015. Evidence consisted of wrack material and sediment staining above the bankfull indicators along the channel and alluvial deposits outside the channel. The crest gauge was checked in June 2015, but could not be successfully read due to a large aggregation of ants within the gauge. Annual photograph comparisons of the stream channel are depicted in Appendix B and hydrologic data associated with this year's monitoring assessment are provided in Appendix E.

2. Alluvial Deposits Documented 30 June 2015

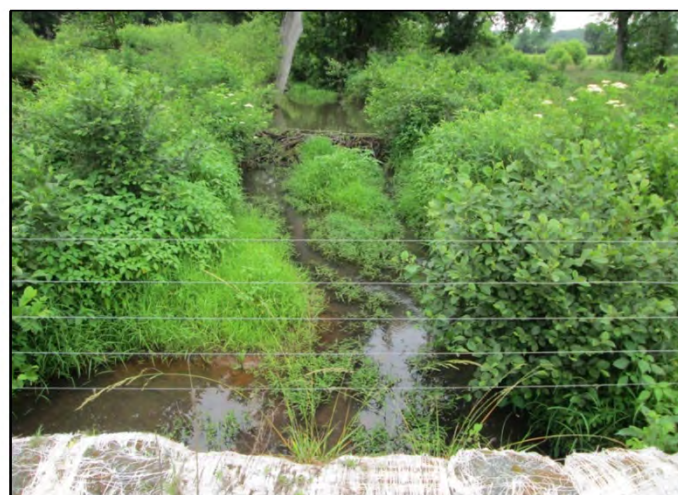
During MY2 monitoring, a recently constructed beaver dam was observed within the channel at approximately station 14+34.75. In May of 2015 during MY3 monitoring, another recently constructed beaver dam was observed immediately upstream of the culverted road crossing at approximately station 19+51.50. During June of 2015, these dams were removed by hand and beaver trapping was

1. Beaver Dam, 3 June 2015

conducted by APHIS. As of June 30, 2015, no additional beaver activity was observed within the easement area. Please refer to Appendix B for representative photographs.

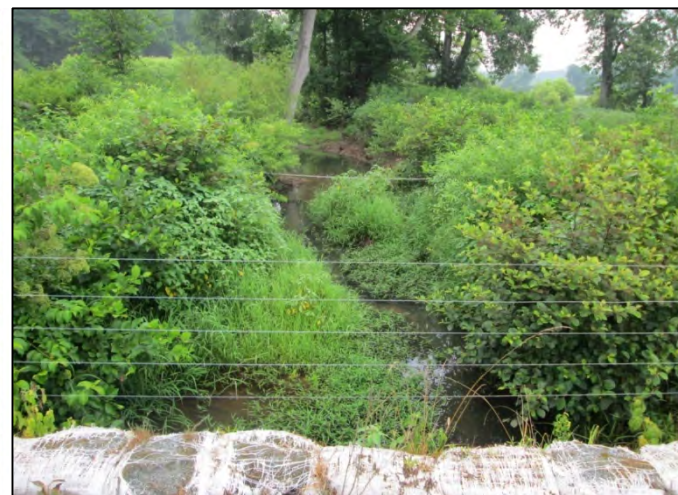
2. Breached Beaver Dam, 23 June 2015

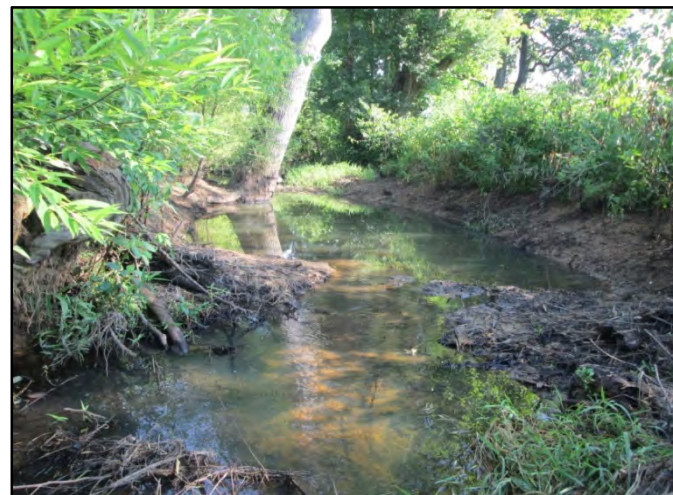
3. Breached Beaver Dam, 30 June 2015
