CHARLES WILLIAMS STREAM, WETLAND, AND BUFFER SITE
DMS Project No. 80

MONITORING YEAR 4 (2016)
Construction Completed February 2013
Planting Completed February 2014

Randolph County, NC
State Construction Project No. 07-07125-01A

November 2016

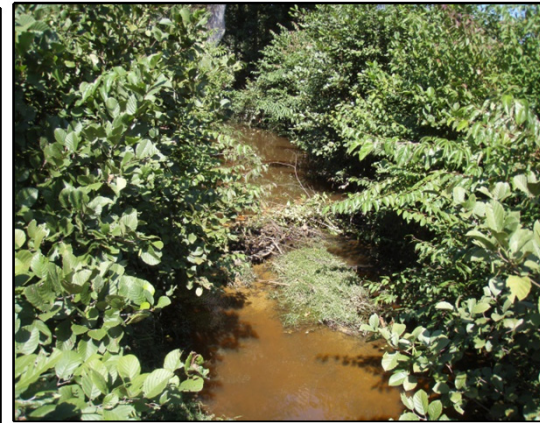
3. Beaver Dam Reconstructed as of 4 Oct. 2016

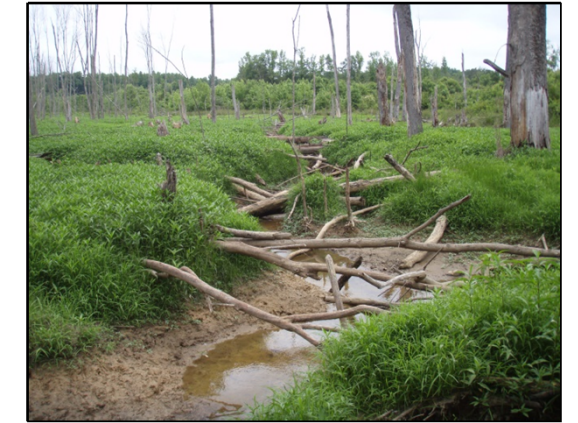
5. Breached Beaver Impoundment Upstream of Project, 2 June 2016

Large beaver dam at upstream end of project was breached in late MY 3 or early MY 4, resulting in sediment deposition in pools downstream. No information whether cause was intentional/human or accidental/natural.
