**CHARLES WILLIAMS STREAM, WETLAND, AND BUFFER SITE  
DMS Project No. 80**

**MONITORING YEAR 5 (2017)  
Construction Completed February 2013  
Planting Completed February 2014**

**Randolph County, NC  
State Construction Project No. 07-07125-01A**

**December 2017**

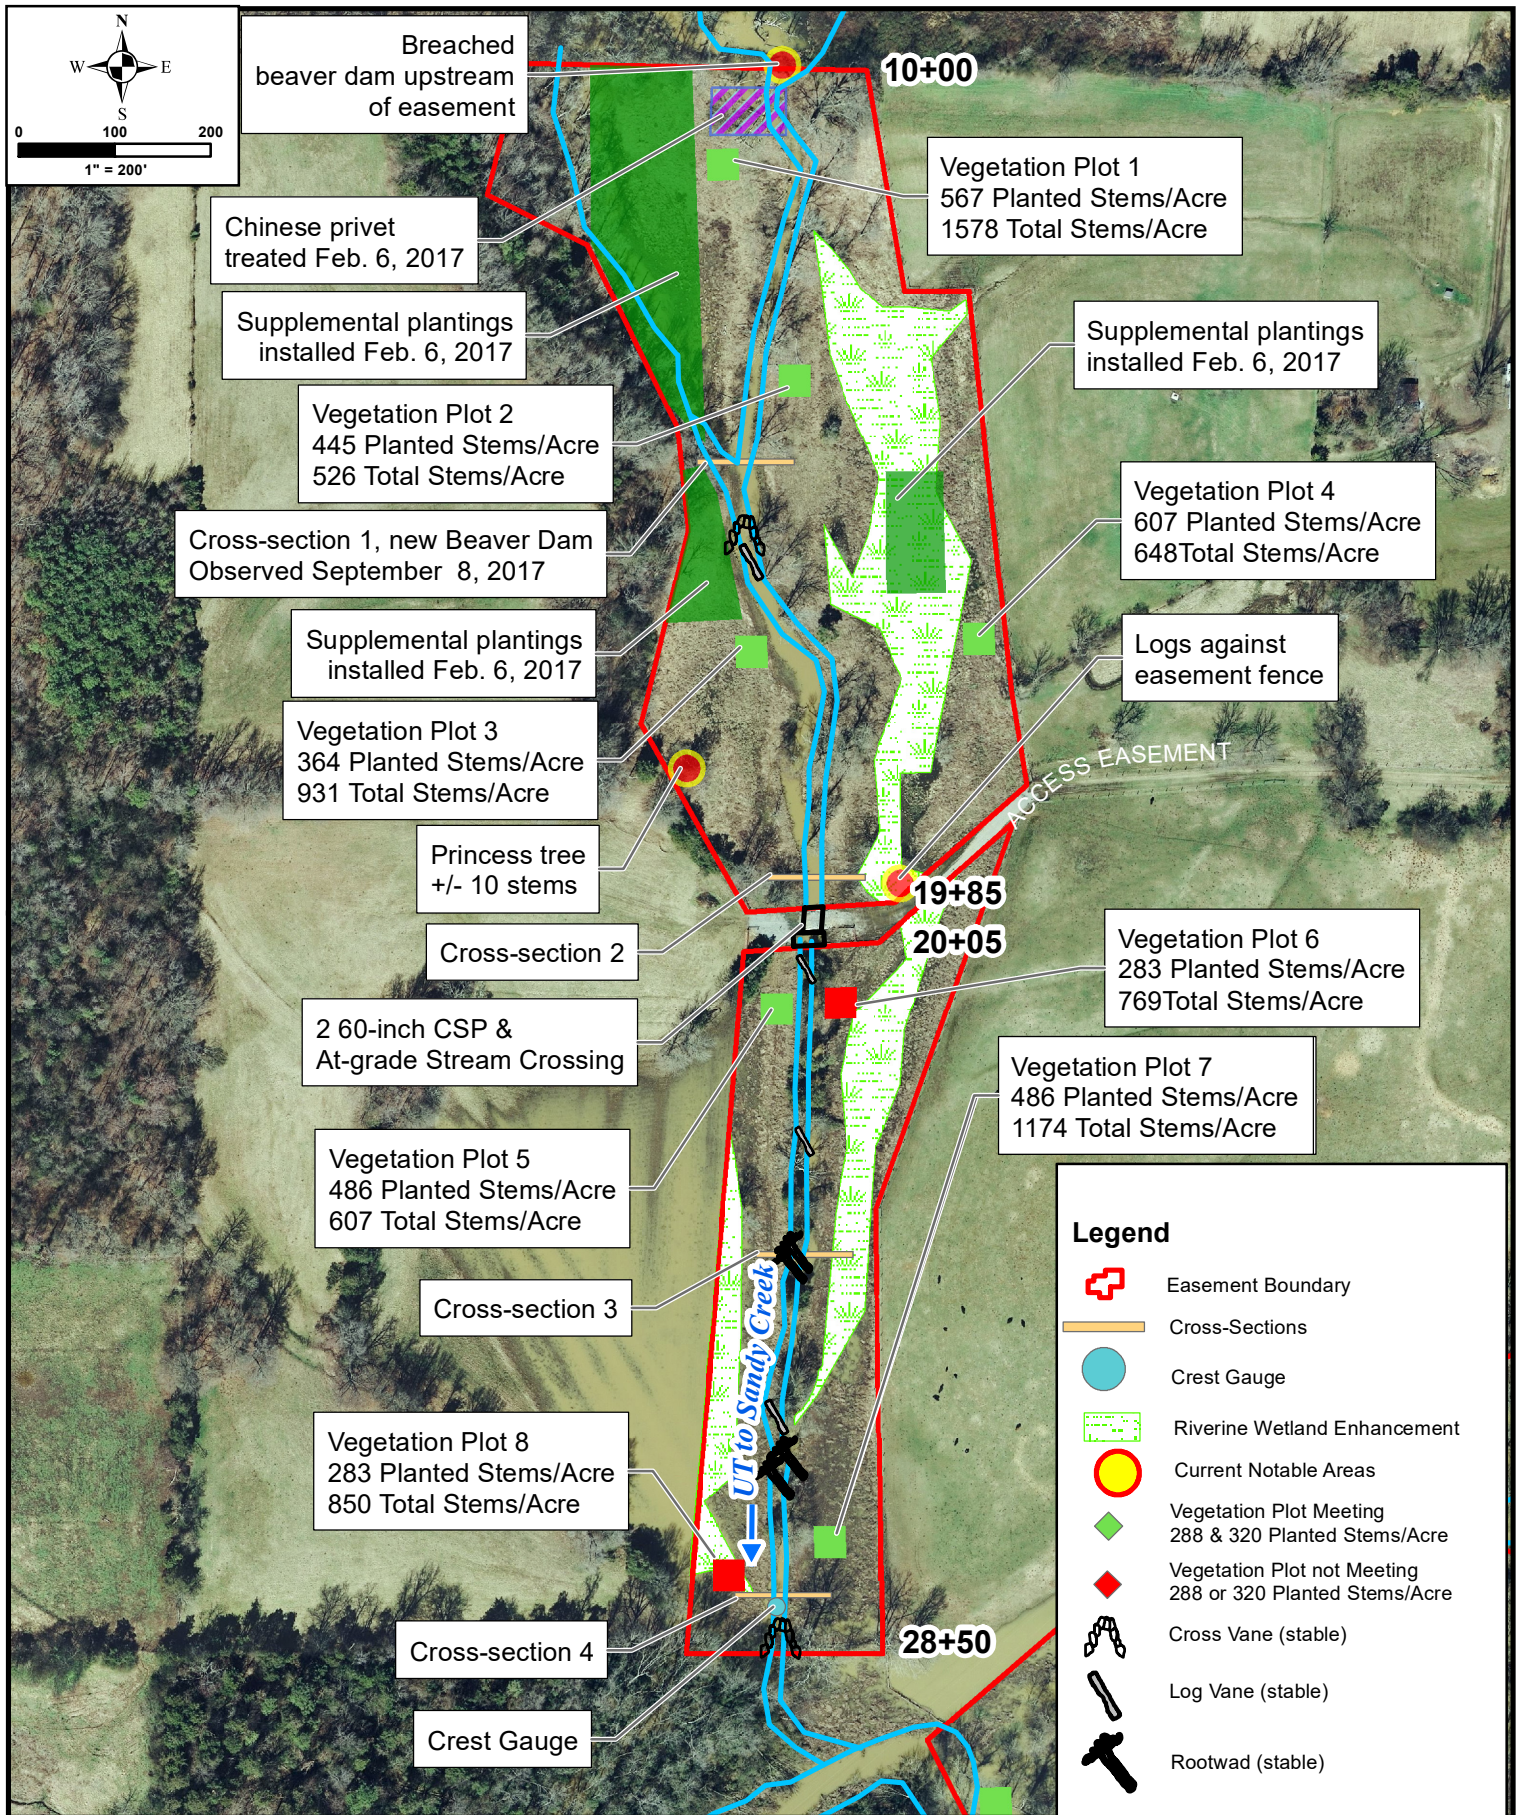
**FIGURE 3a**

**CURRENT CONDITIONS PLAN VIEW**  
**Charles Williams Site -**  
**DMS Project No. 80**

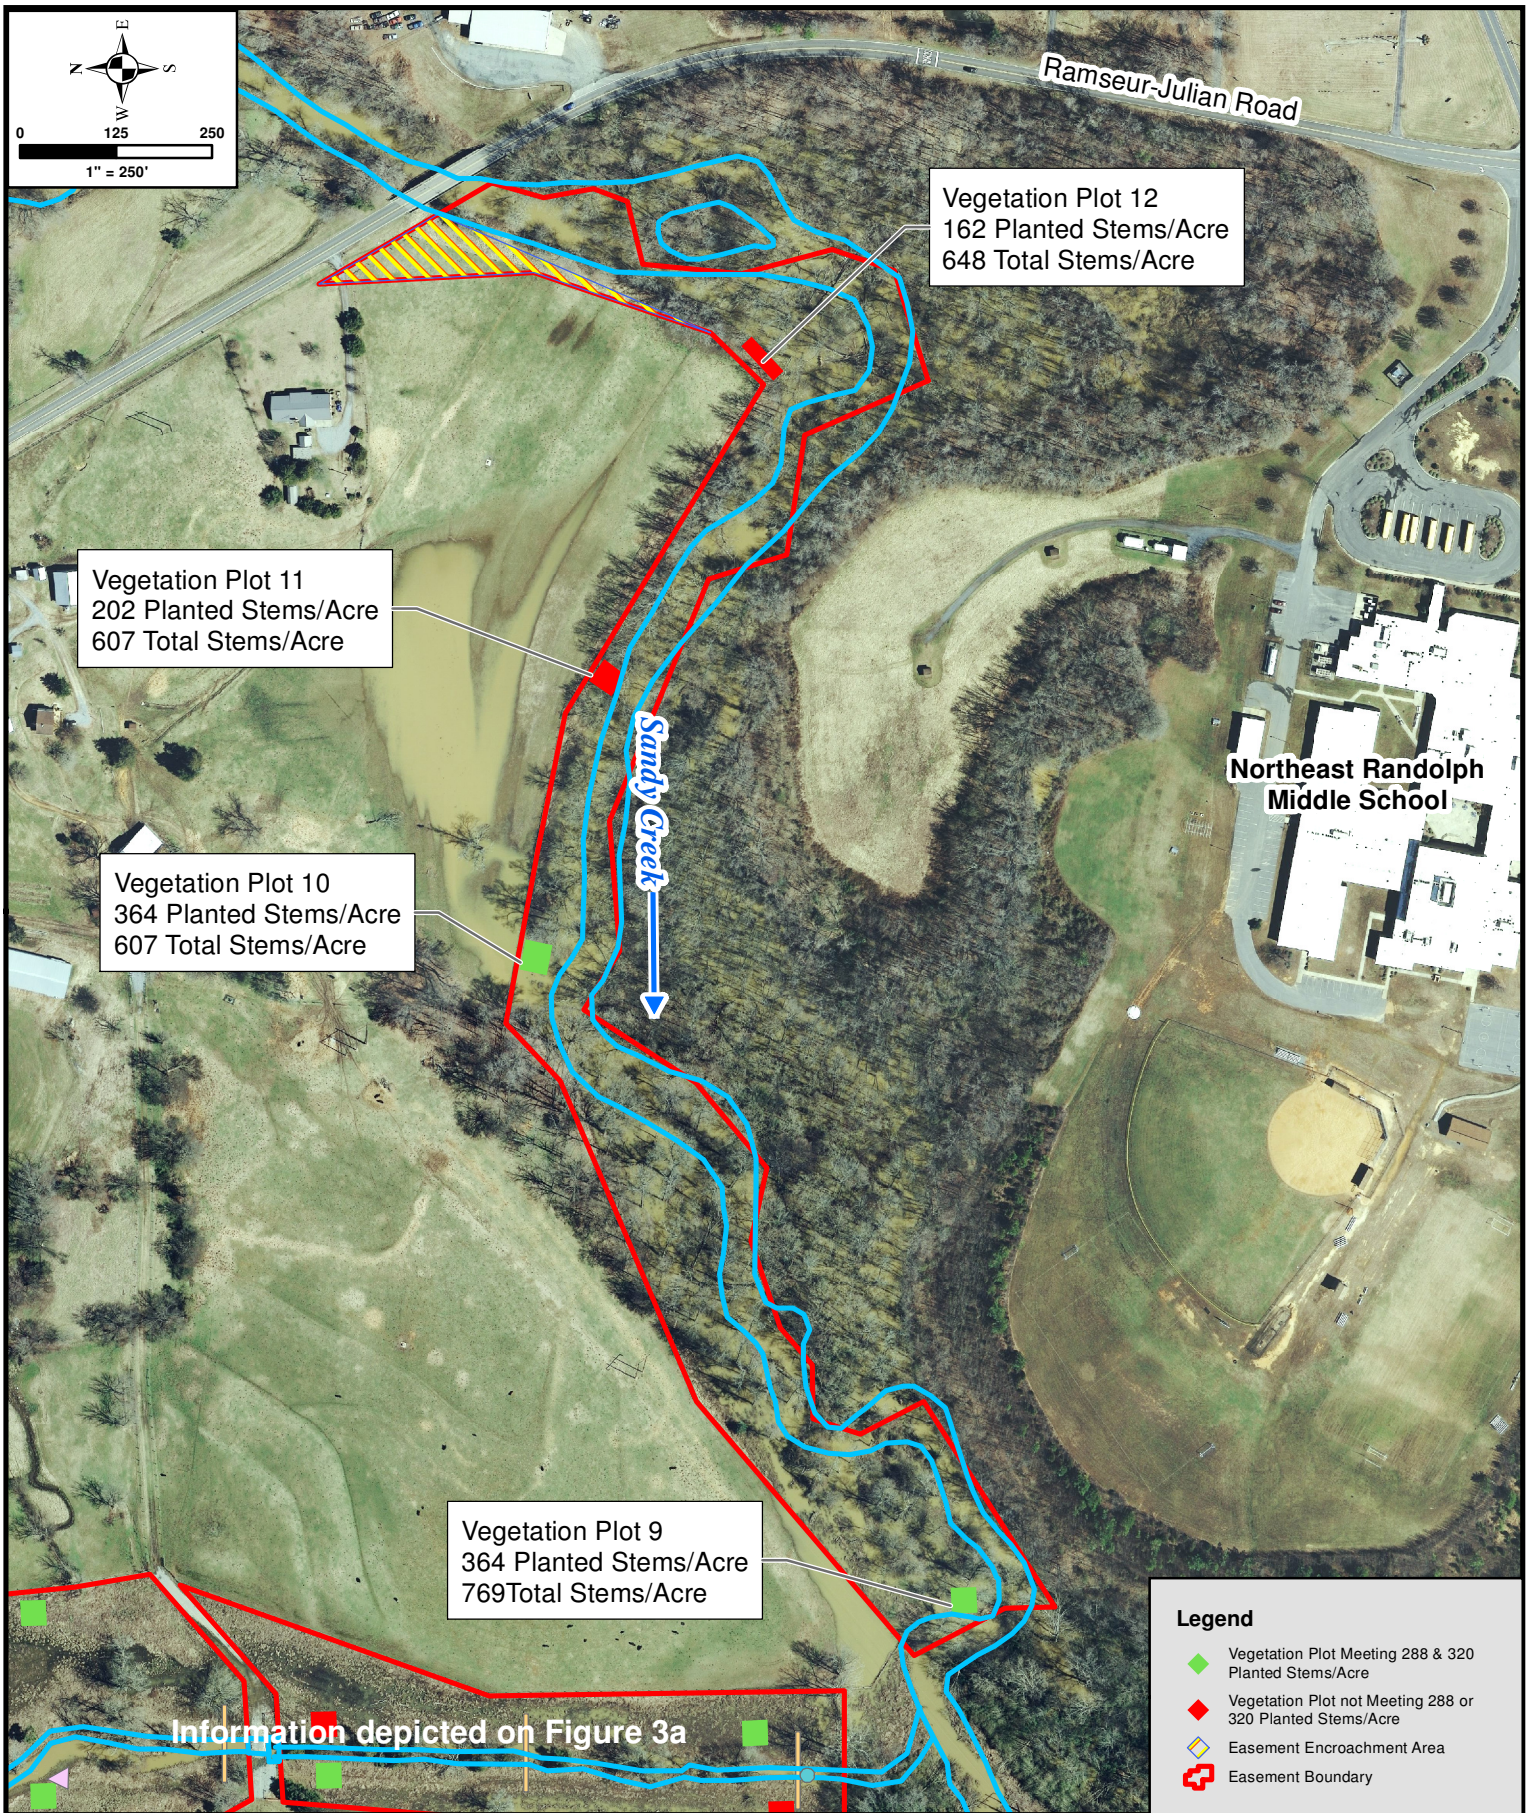
**FIGURE 3b**

**CURRENT CONDITIONS PLAN VIEW**  
**Charles Williams Site -**  
**DMS Project No. 80**

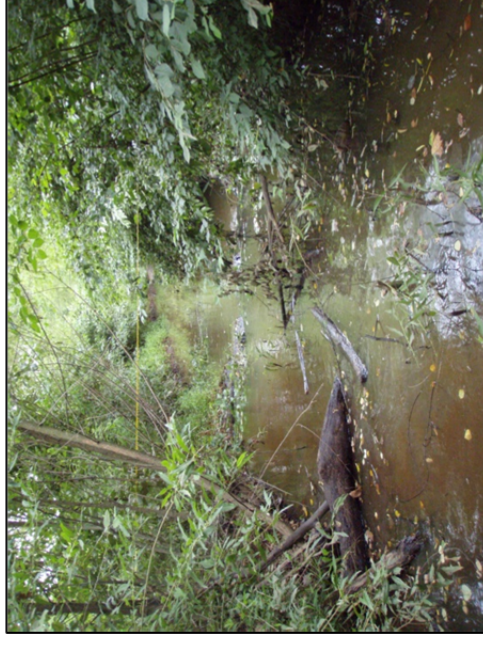
UT to Sandy Creek, Cross Section 1, Rifle, Station: 14+41

SUMMARY DATA	
Bankfull Elevation:	553.1
Bankfull Cross Sectional Area:	37.9
Bankfull Width:	32.2
Flood Prone Area Elevation:	555.6
Flood Prone Width:	200+
Max. Depth at Bankfull:	2.3
Mean Depth at Bankfull:	1.3
Width/Depth Ratio:	24.8
Entrenchment Ratio:	>6
Bank Height Ratio:	1.0

Stream Type: C5 Photograph facing downstream @ XS 1

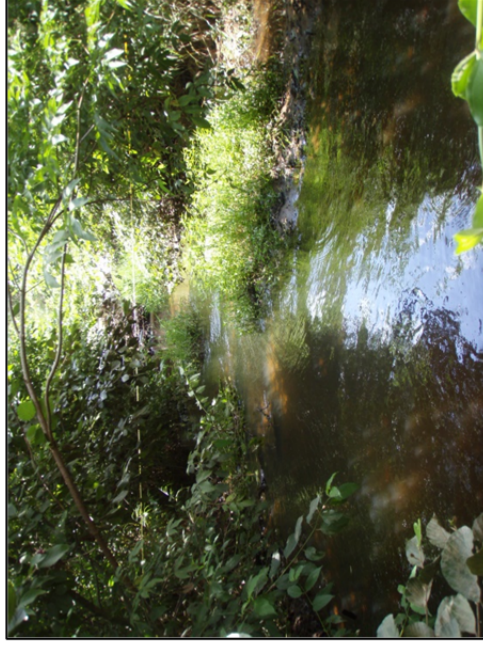
UT to Sandy Creek, Cross Section 2, Run, Station: 19+36

SUMMARY DATA	
Bankfull Elevation:	552.9
Bankfull Cross Sectional Area:	33.9
Bankfull Width:	23.7
Flood Prone Area Elevation:	555.2
Flood Prone Width:	200+
Max. Depth at Bankfull:	2.2
Mean Depth at Bankfull:	1.6
Width/Depth Ratio:	14.8
Entrenchment Ratio:	>8
Bank Height Ratio:	1.0

Stream Type: C5 Photograph facing downstream @ XS 2

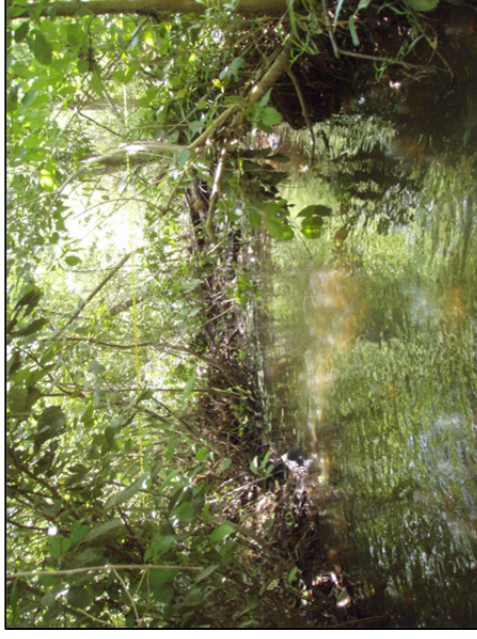
UT to Sandy Creek, Cross Section 3, Gilde, Station: 23+49

SUMMARY DATA	
Bankfull Elevation:	551.9
Bankfull Cross Sectional Area:	32.5
Bankfull Width:	23.0
Flood Prone Area Elevation:	554.9
Flood Prone Width:	200+
Max. Depth at Bankfull:	2.7
Mean Depth at Bankfull:	1.5
Width/Depth Ratio:	15
Entrenchment Ratio:	>8
Bank Height Ratio:	1.1

Stream Type: C5 Photograph facing downstream @ XS 3

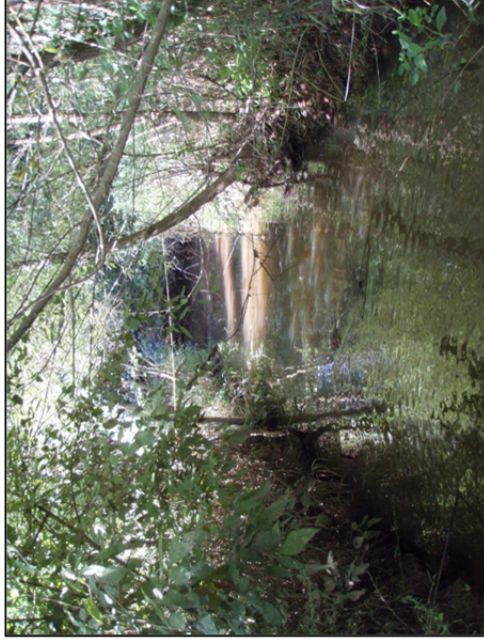
UT to Sandy Creek, Cross Section 4, Riffle, Station: 27+14

SUMMARY DATA	
Bankfull Elevation:	551.7
Bankfull Cross Sectional Area:	39.7
Bankfull Width:	25.1
Flood Prone Area Elevation:	554.8
Flood Prone Width:	200+
Max. Depth at Bankfull:	3.2
Mean Depth at Bankfull:	1.7
Width/Depth Ratio:	14.7
Entrenchment Ratio:	>8.0
Bank Height Ratio:	1.0

Stream Type: C5 Photograph facing downstream @ XS 4
