# **MONITORING YEAR 1 ANNUAL REPORT**

## **SASSARIXA SWAMP MITIGATION SITE**

Johnston County, NC  
Neuse River Basin  
HUC 03020201

DMS Project No. 100040  
DMS Contract No. 7425  
DMS RFP No. 16-007279  
USACE Action ID No. 2018-00432  
DWR Project No. 2018-0198

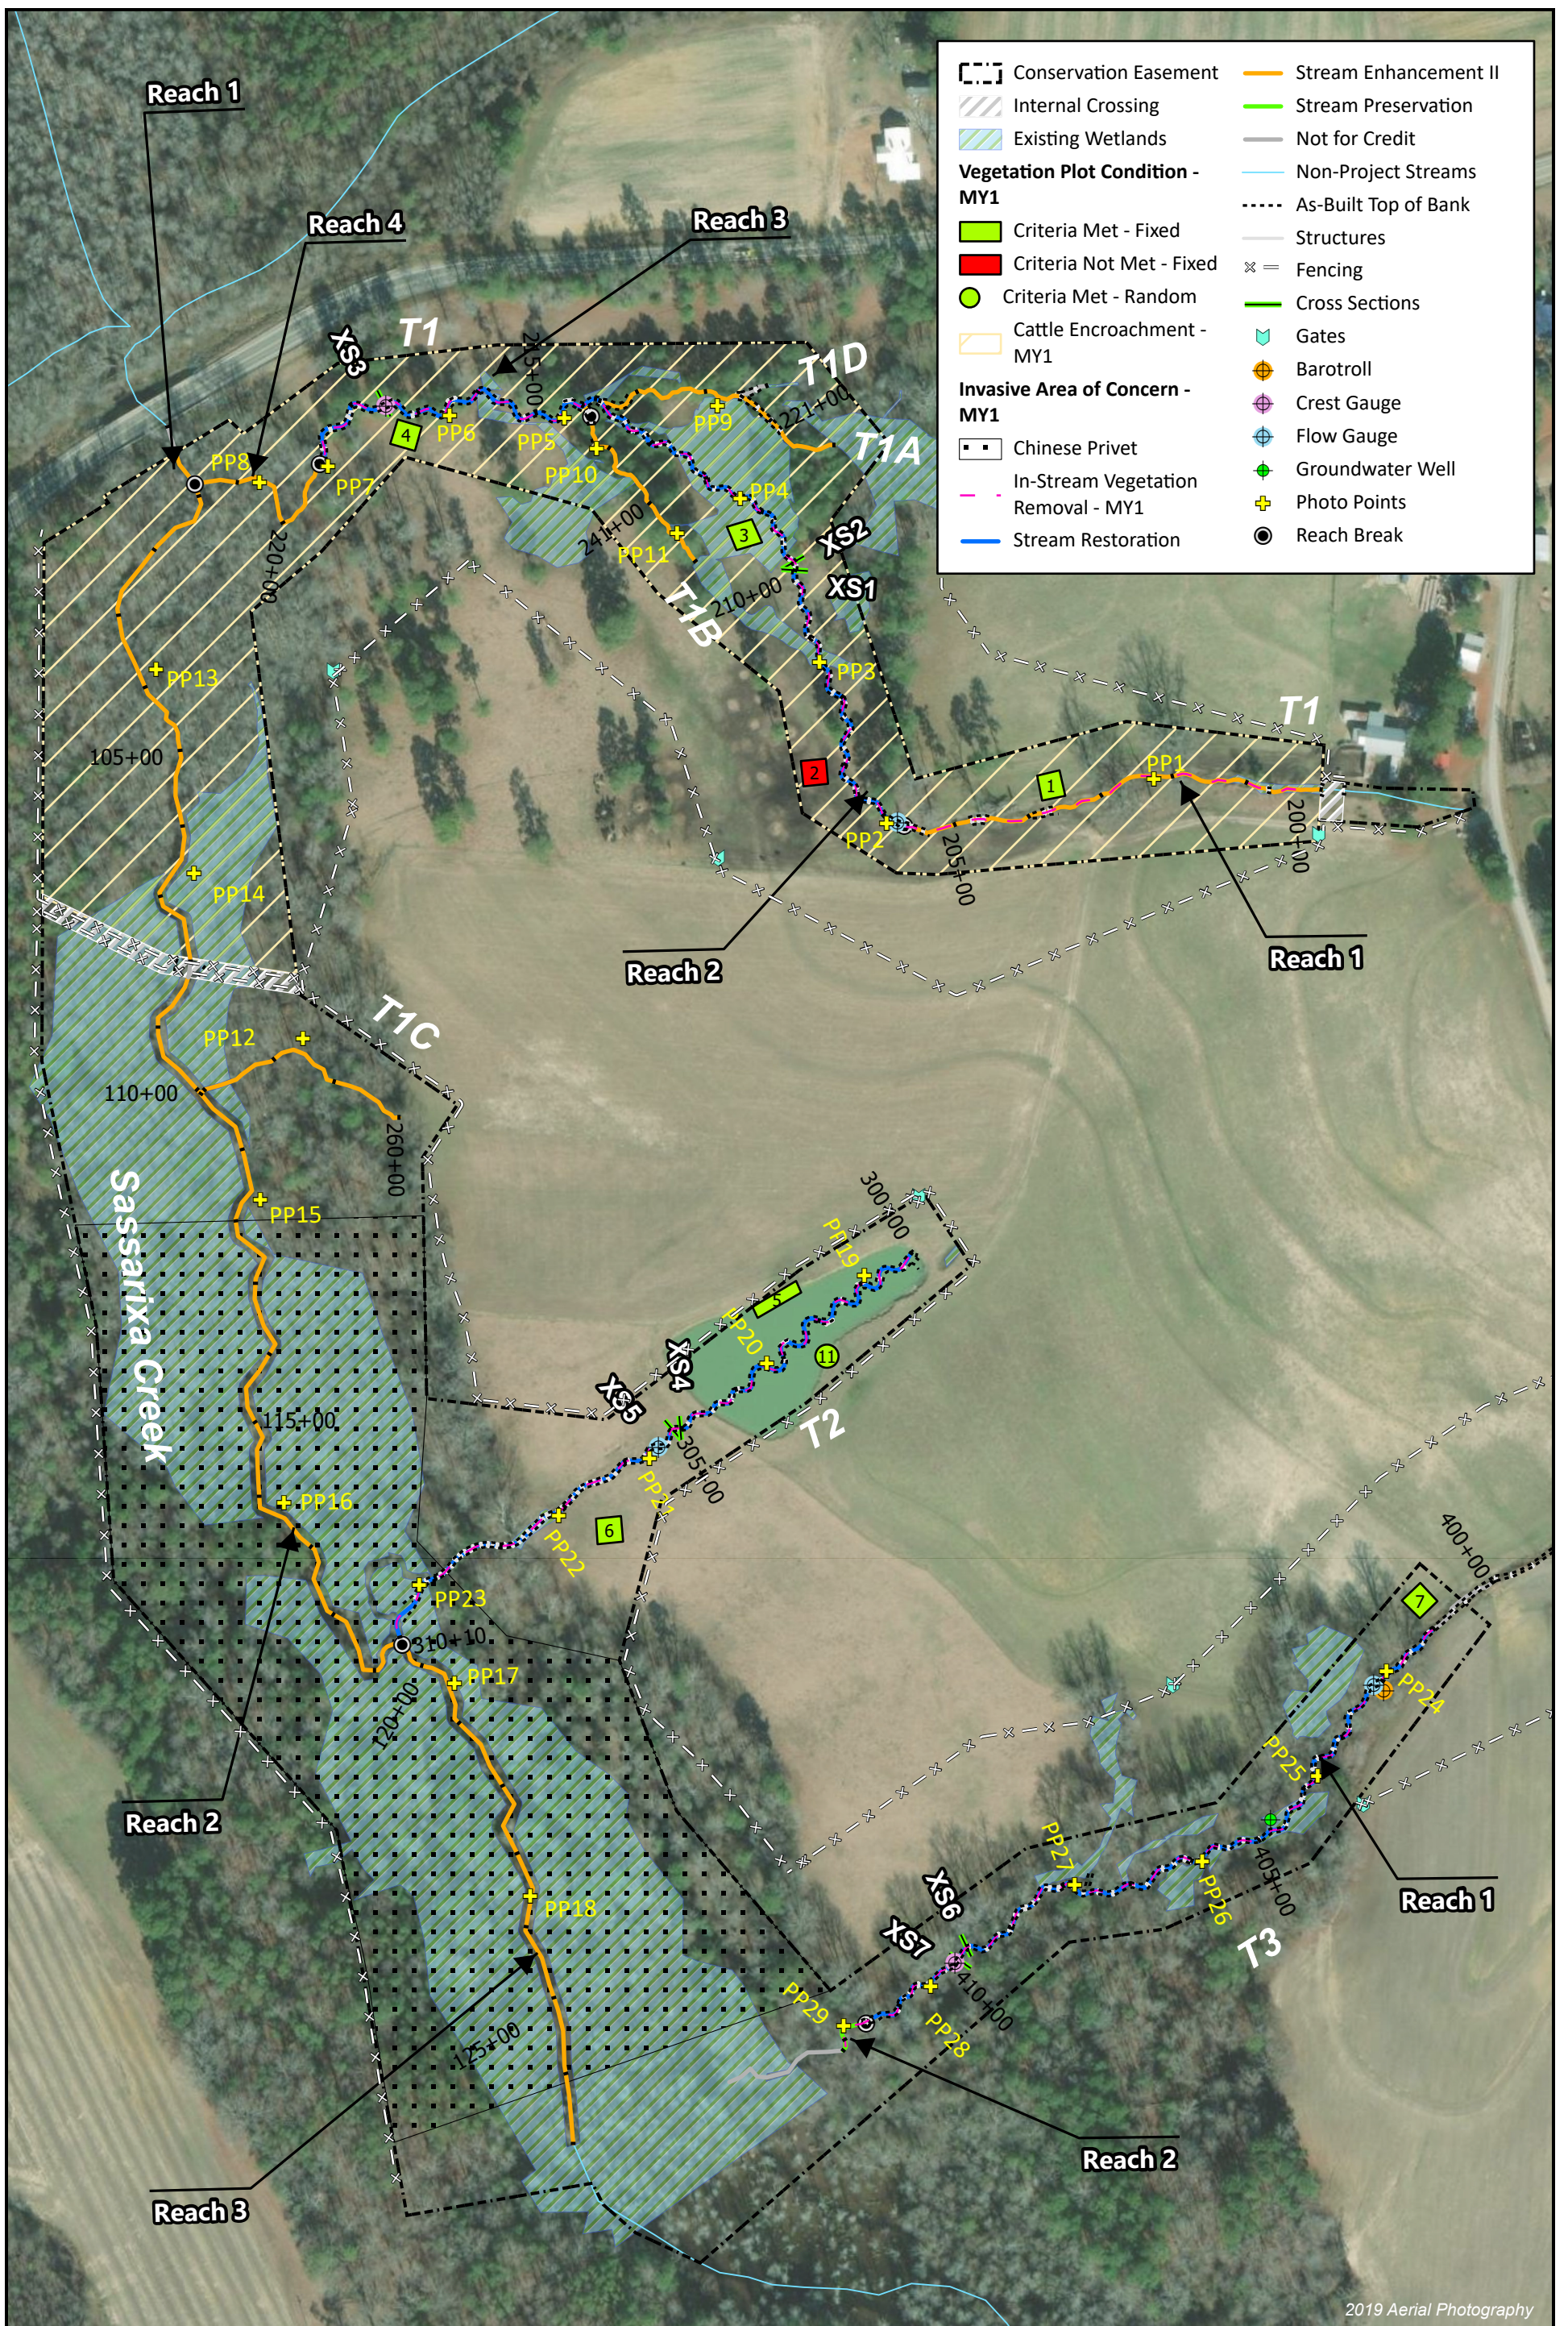
Figure 1a. Current Condition Plan View  
 Sassarixa Swamp Mitigation Site  
 DMS Project No. 100040  
 Monitoring Year 1 - 2021

Before construction, Chinese privet (*Ligustrum sinense*) was treated along Sassarixa Creek during the winter of 2020/2021 using a combination of methods including foliar and cut stump applications. Out of the 27.00 acres that was originally treated, resprouts did emerge along the lower half of Sassarixa Creek totaling 11.99 acres (Figure 1a). A follow up treatment will occur during MY2 to treat the resprouts.

Several cattle were observed within the Site throughout July 2021. Cattle had access to 11.39 acres of the Site between the Sassarixa Creek ford crossing to the top of T1 (Figure 1a). The cattle were entering the Site through the high tensile fence along the Sassarixa Creek ford crossing. The landowner has agreed to keep the outside gates closed unless supervising the cattle crossing Sassarixa Creek. No cattle have been seen in the easement since July 2021, indicating the easement encroachment has been resolved. No major damage occurred to the Site due to cattle encroachment, except for several dented easement signs.

The spring and summer of 2021 had below average rainfall. Due to dry conditions and lack of shade before woody vegetation has become established, *Murdanina* (Figure 1a-b) was observed in most tributaries. Wildlands was proactive with in-stream vegetation management and treated T1 Reach 1-3,
