# MONITORING YEAR 4 ANNUAL REPORT Final

## SCALY BARK CREEK MITIGATION SITE

Stanly County, NC  
DENR Contract 002030  
NCEEP Project Number 94148

Data Collection Period: May 2014-July 2014  
Draft Submission Date: September 3, 2014  
Final Submission Date: September 29, 2014

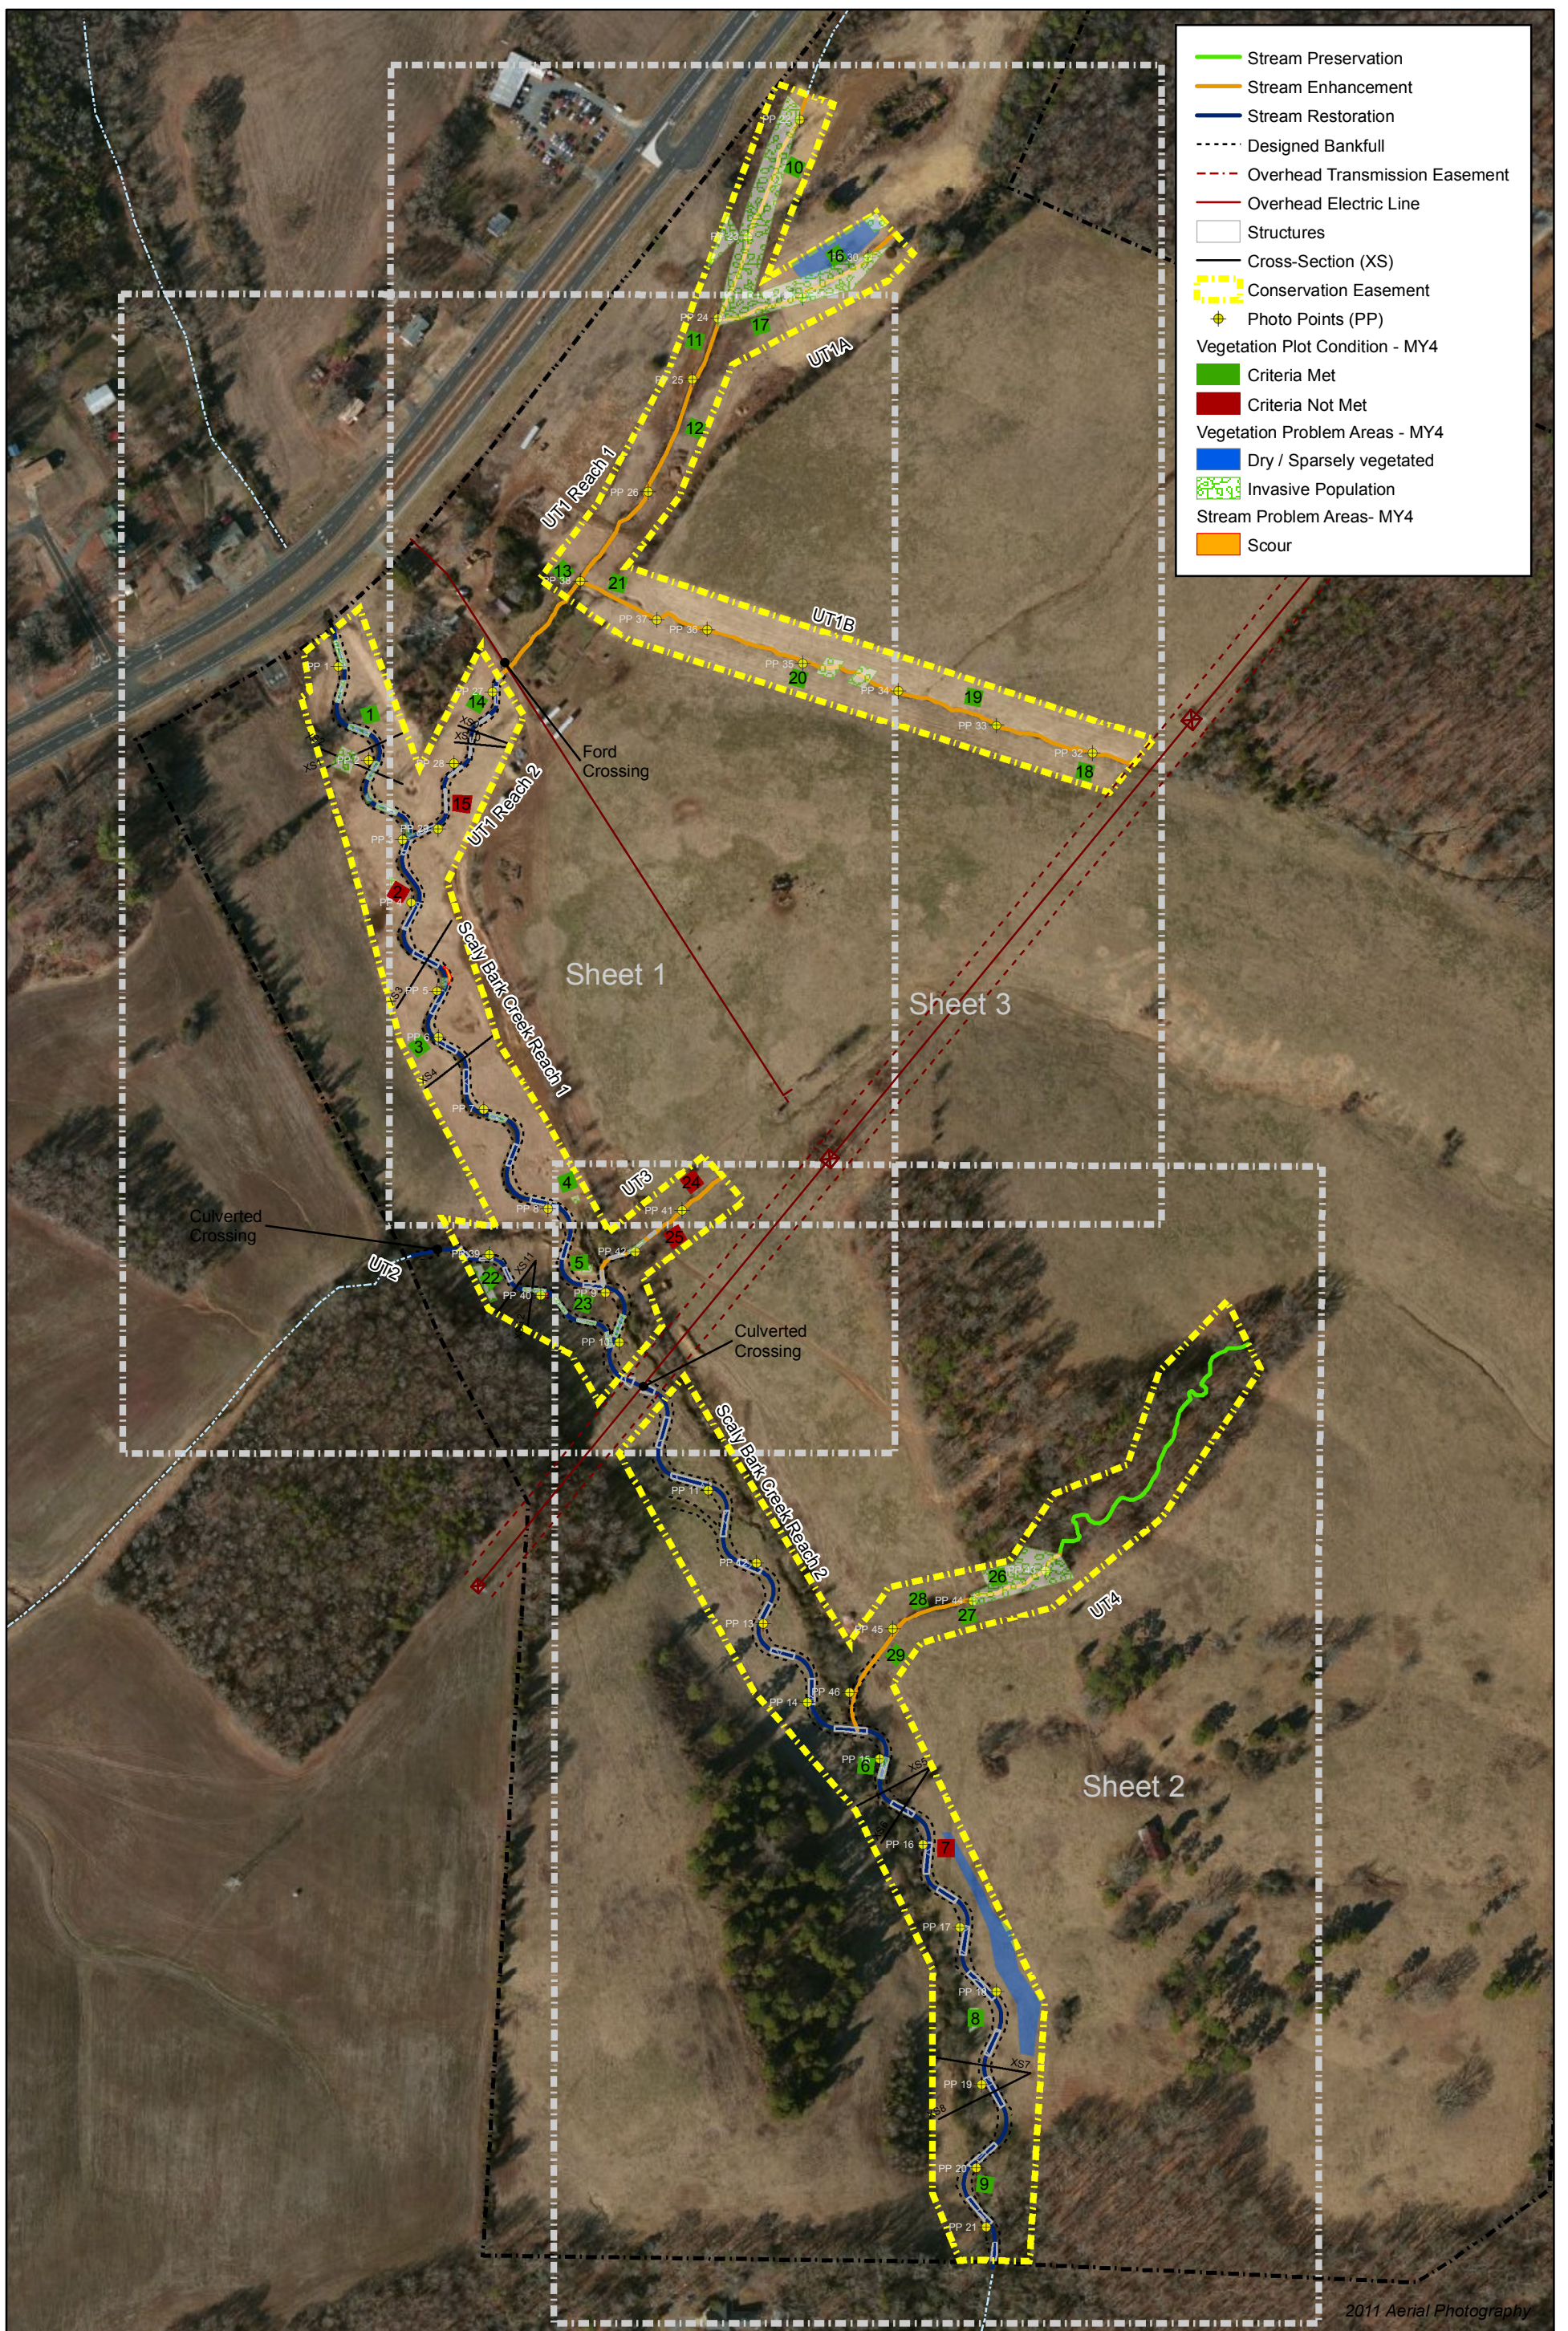
Figure 3.0 Integrated Current Condition Plan View (Key)  
 Scaly Bark Creek Mitigation Site  
 EEP Project Number 94148  
 Monitoring Year 4

There are distinct areas with characteristically low herbaceous growth and dry soil conditions along UT1 Reach 1 and Scaly Bark Reach 2. Along UT4 and UT1B, there are distinct areas with exceptionally dense herbaceous cover that has affected the survival rate of planted stems during MY2 and MY3. These sections will continue to be monitored closely to maximize survivability of planted stems. The non-native invasive aquatic weed muskgrass (*Chara* sp.) was found in pools in Scaly Bark reach 1. Both non-native and native plant species were observed within several riffles in Scaly Bark Reach 1 and Reach 2 and UT2: (rice cut grass (*Leersia oryzoides*), smartweed (*Polygonum hydropiperoides*), aquatic mint (*Mentha aquatic*), wartremoving herb (*Murdannia keisak*), and Asian dayflower (*Commelina communis*). Please refer to Appendix 2 and Figures 3.0-3.3 for the Current Condition Plan View, which outlines these areas of concern.

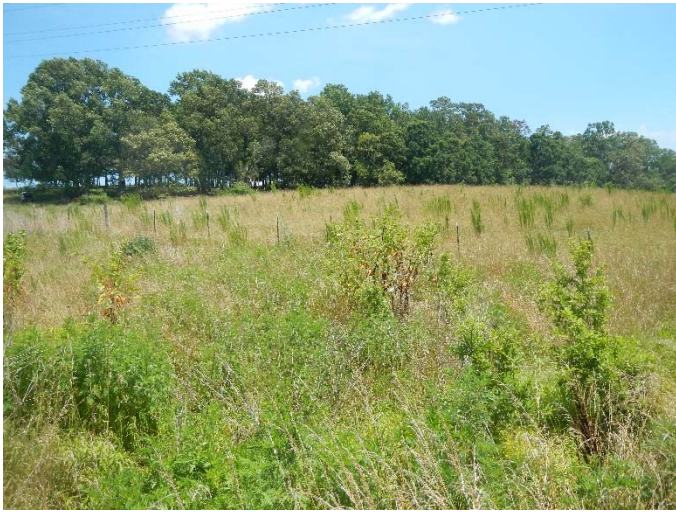
Vegetation Plot 24 (7/8/2014)

26, 27, 28, and 29). For MY4, the average stem density resulted in 394 stems per acre which meets the 320 stem/acre success criteria. Of the 5 plots which did not reach the MY4 success criteria (plots 2, 7, 15, 24, 25), only one (plot 7) met the MY5 success criteria of 260 stems per acre. The low survival of plots that did not meet success criteria is presumably due to resource competition with thick herbaceous cover or, in one case (Plot 7), excessively dry/compact soil conditions. Most of the remaining plants in these plots, except plot 7, have strong vigor ratings indicating that they are likely to survive in upcoming monitoring years. Volunteers are not included in the site's stem density results; however, strong recruitment of volunteers was observed in MY4. Please refer to Appendix 3 for vegetation summary tables and raw data tables and Appendix 2 for vegetation plot photographs and the vegetation condition assessment table.

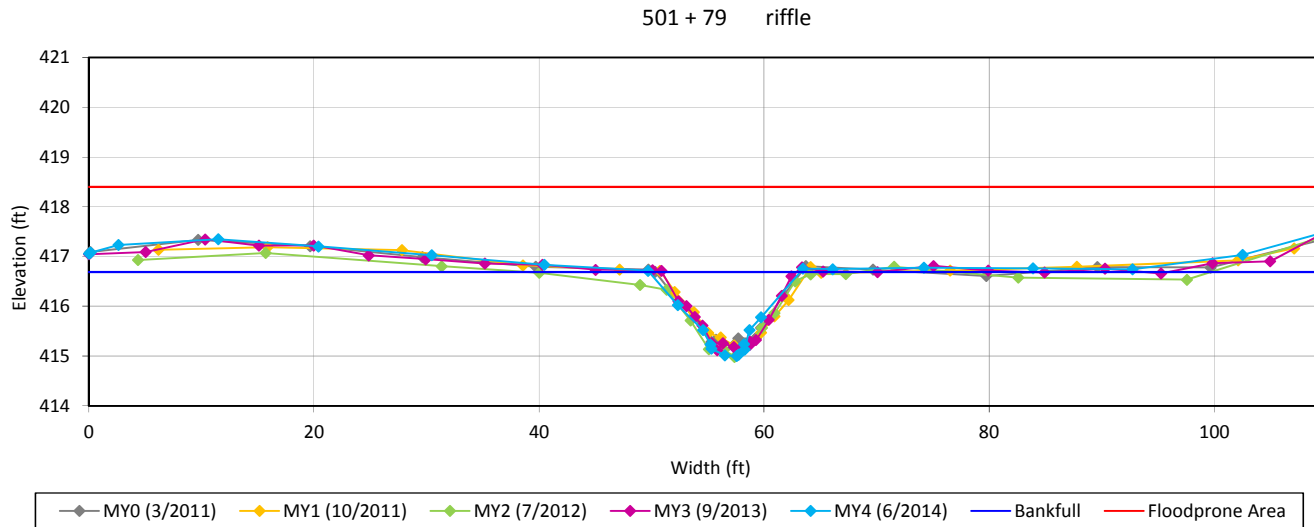
Cross Section 12-UT2

- 12.1 x-section area (ft.sq.)
- 13.5 width (ft)
- 0.9 mean depth (ft)
- 1.7 max depth (ft)
- 14.2 wetted perimeter (ft)
- 0.9 hyd radi (ft)
- 15.1 width-depth ratio

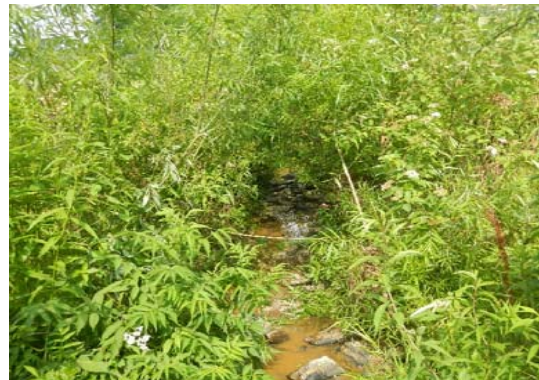
View Downstream (6/2014)
