FINAL-MY2 Monitoring Report

Seniard Creek Mitigation Site

NCDMS Project No. 100017

Subject: Draft MY2 Monitoring Report
Seniard Creek Site, Henderson County
French Broad River CU 06010105
DMS Project ID No. 100017 / DEQ Contract #7189

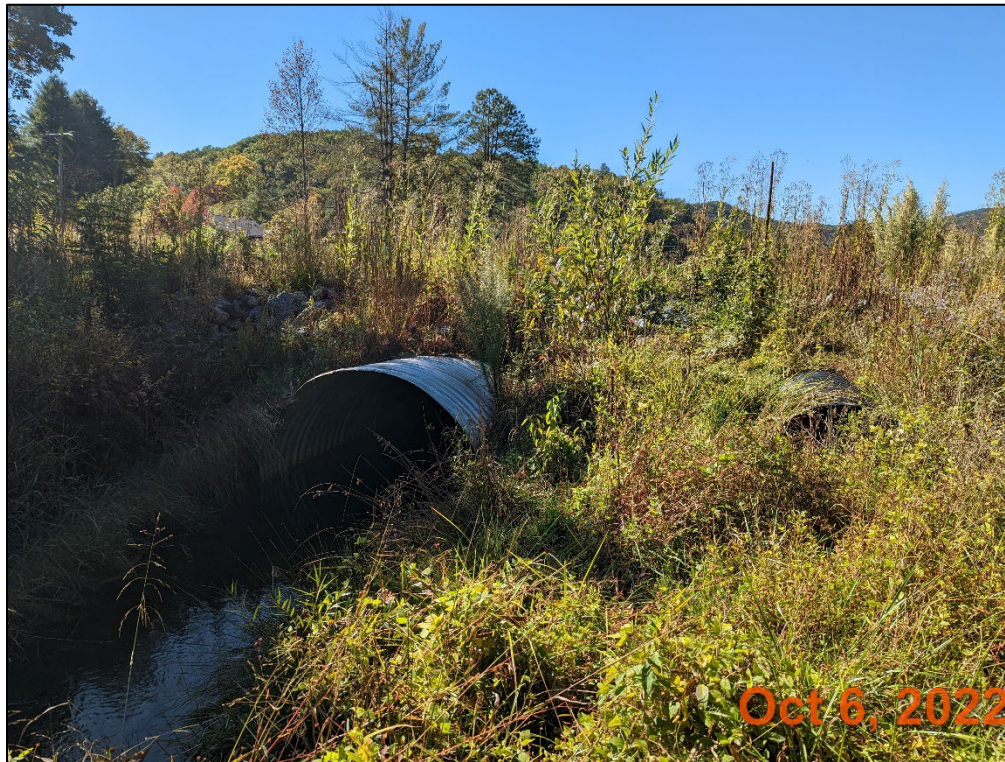
Photo Point 7.3 Facing downstream Sitton Branch culvert.

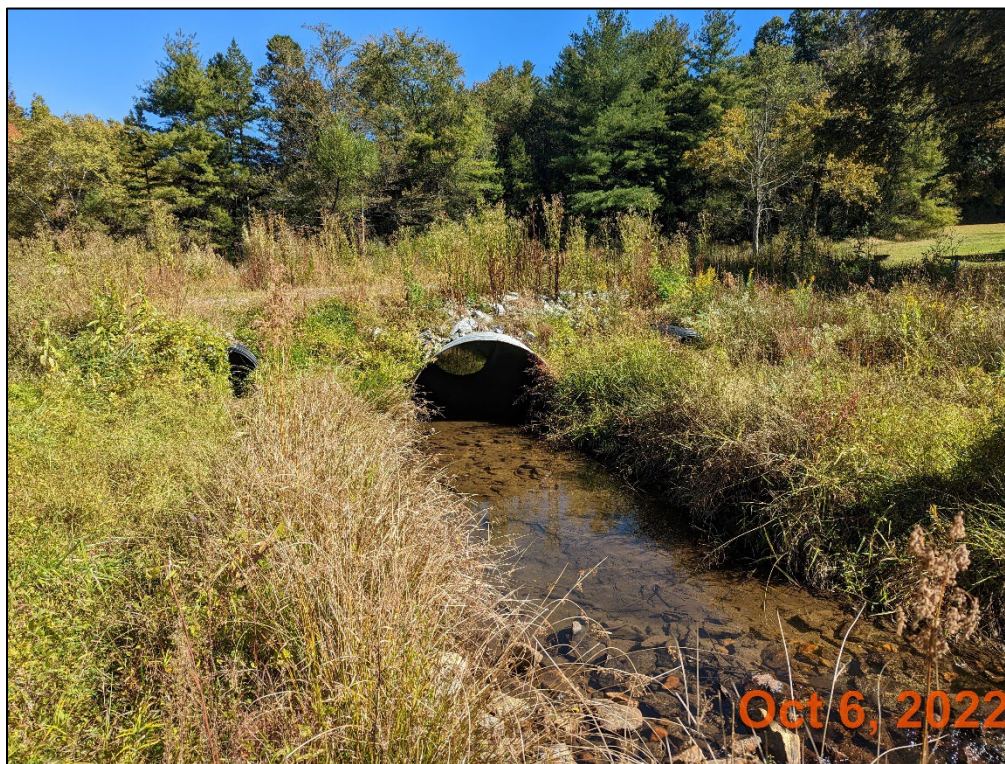
Photo Point 7.3 Facing upstream Sitton Branch culvert.

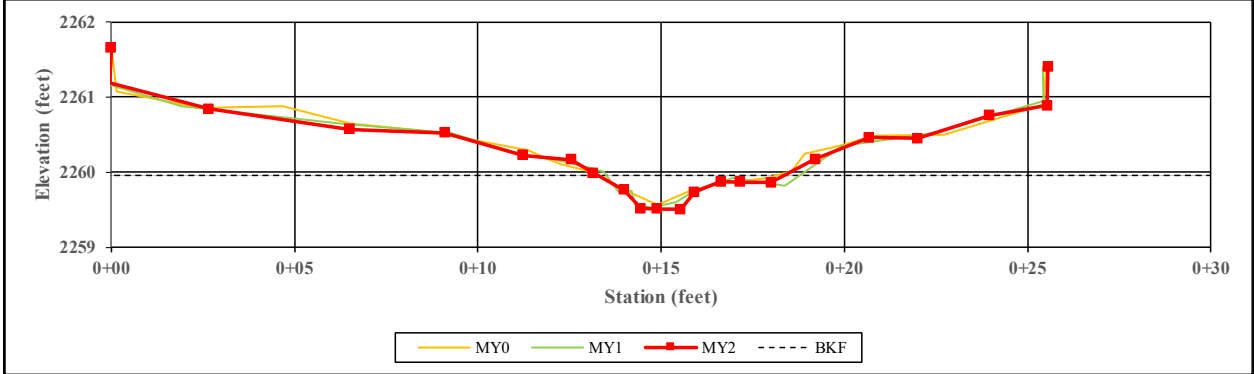
Project Name: Seniard **XS Number:** 11 **Station:** 402+31
Reach Name: David Branch 1B **XS Type:** Riffle

CHANNEL DIMENSIONS SUMMARY	MY0	MY1	MY2	MY3	MY4	MY5	MY6	MY7
Bankful Width (ft)	4.7	3.0	4.0	-	-	-	-	-
Floodprone Width (ft)	10.0	10.0	10.0	-	-	-	-	-
Bankfull Mean Depth (ft)	0.2	0.3	0.2	-	-	-	-	-
Bankfull Max Depth (ft)	0.4	0.5	0.5	-	-	-	-	-
Bankfull Cross-Sectional Area (ft ²)	1.0	1.0	1.0	-	-	-	-	-
Width/Depth Ratio	22.2	9.1	16.1	-	-	-	-	-
Entrenchment Ratio	2.1	3.3	2.5	-	-	-	-	-
Bank Height Ratio	1.0	1.0	1.0	-	-	-	-	-

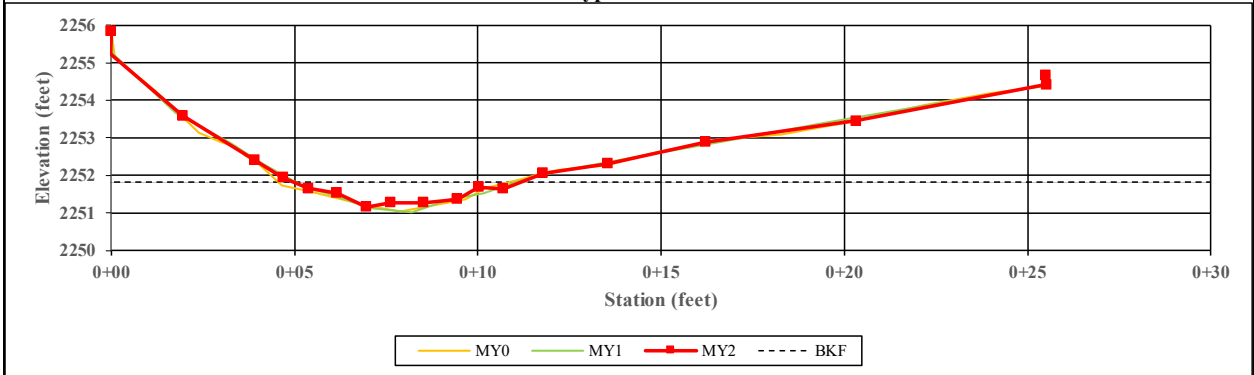
Project Name: Seniard **XS Number:** 12 **Station:** 403+24
Reach Name: David Branch 1B **XS Type:** Pool

CHANNEL DIMENSIONS SUMMARY	MY0	MY1	MY2	MY3	MY4	MY5	MY6	MY7
Bankful Width (ft)	4.8	4.1	4.1	-	-	-	-	-
Floodprone Width (ft)	10.0	10.0	10.0	-	-	-	-	-
Bankfull Mean Depth (ft)	0.4	0.5	0.5	-	-	-	-	-
Bankfull Max Depth (ft)	0.6	0.7	0.6	-	-	-	-	-
Bankfull Cross-Sectional Area (ft ²)	1.9	1.9	1.9	-	-	-	-	-
Width/Depth Ratio	12.3	9.0	8.9	-	-	-	-	-
Entrenchment Ratio	2.1	2.4	2.5	-	-	-	-	-
Bank Height Ratio	1.0	1.0	0.8	-	-	-	-	-

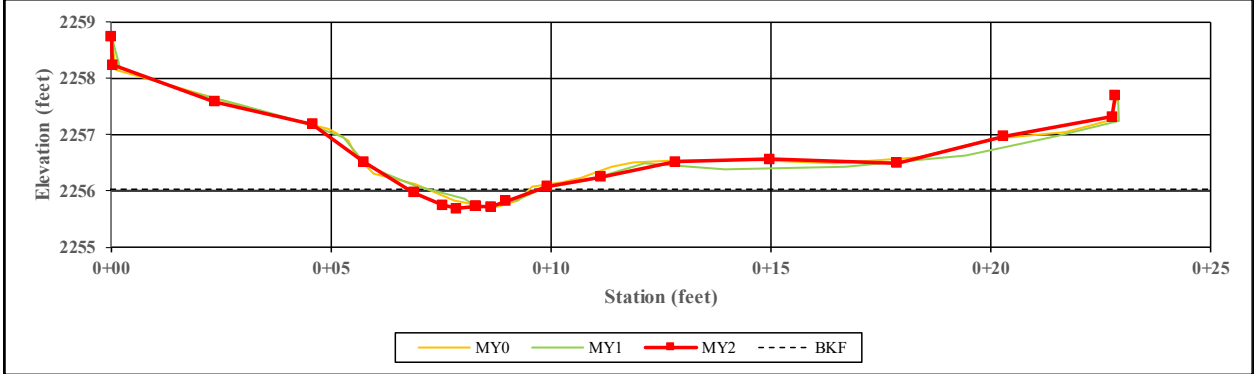
Project Name: Seniard **XS Number:** 13 **Station:** 601+41
Reach Name: Whitaker Branch 1 **XS Type:** Riffle

CHANNEL DIMENSIONS SUMMARY	MY0	MY1	MY2	MY3	MY4	MY5	MY6	MY7
Bankful Width (ft)	1.8	1.8	2.1	-	-	-	-	-
Floodprone Width (ft)	10.0	10.0	10.0	-	-	-	-	-
Bankfull Mean Depth (ft)	0.3	0.3	0.3	-	-	-	-	-
Bankfull Max Depth (ft)	0.4	0.4	0.3	-	-	-	-	-
Bankfull Cross-Sectional Area (ft ²)	0.5	0.5	0.5	-	-	-	-	-
Width/Depth Ratio	6.1	6.7	8.1	-	-	-	-	-
Entrenchment Ratio	5.6	5.5	4.8	-	-	-	-	-
Bank Height Ratio	1.0	0.9	1.1	-	-	-	-	-

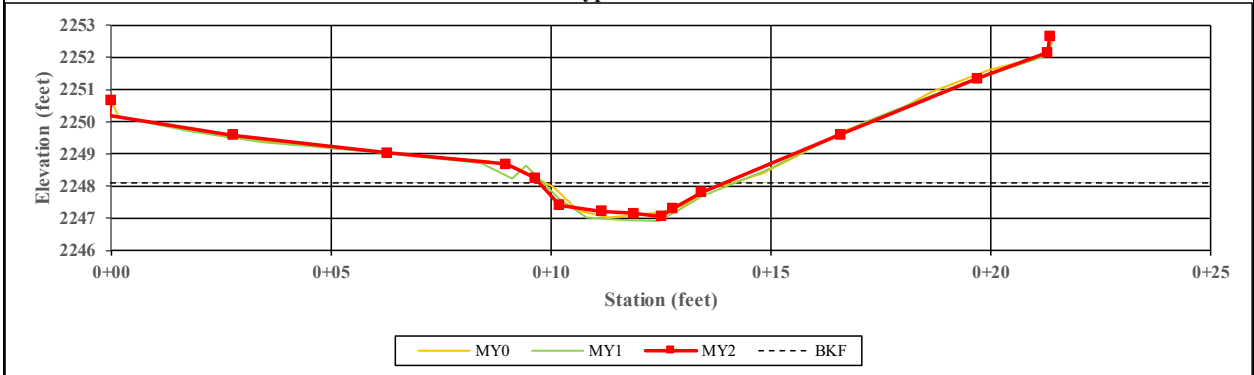
Project Name: Seniard **XS Number:** 14 **Station:** 602+64
Reach Name: Whitaker Branch 1 **XS Type:** Pool

CHANNEL DIMENSIONS SUMMARY	MY0	MY1	MY2	MY3	MY4	MY5	MY6	MY7
Bankful Width (ft)	3.5	3.3	2.6	-	-	-	-	-
Floodprone Width (ft)	10.0	10.0	10.0	-	-	-	-	-
Bankfull Mean Depth (ft)	0.7	0.7	0.9	-	-	-	-	-
Bankfull Max Depth (ft)	0.9	0.9	1.0	-	-	-	-	-
Bankfull Cross-Sectional Area (ft ²)	2.3	2.3	2.3	-	-	-	-	-
Width/Depth Ratio	5.2	4.5	2.9	-	-	-	-	-
Entrenchment Ratio	2.9	3.1	3.9	-	-	-	-	-
Bank Height Ratio	1.0	0.8	0.7	-	-	-	-	-

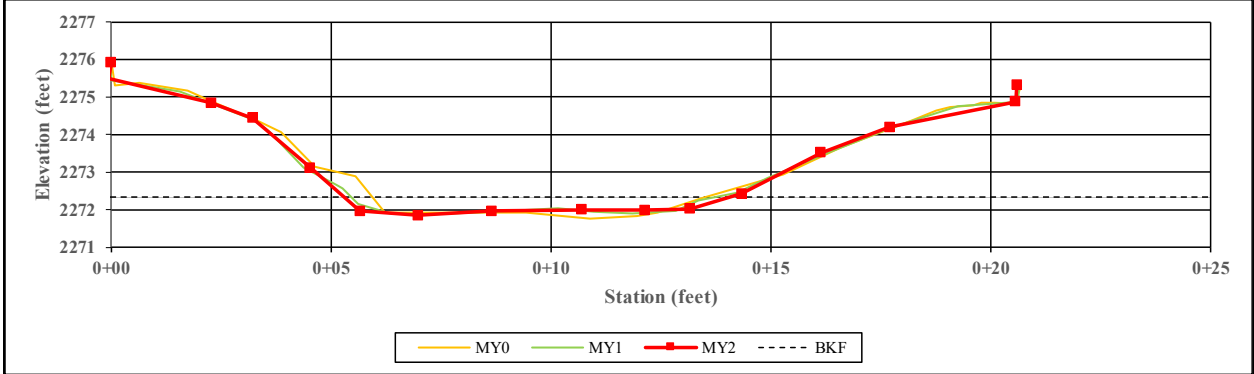
Project Name: Seniard **XS Number:** 15 **Station:** 702+67
Reach Name: Redmond Branch 1A **XS Type:** Riffle

CHANNEL DIMENSIONS SUMMARY	MY0	MY1	MY2	MY3	MY4	MY5	MY6	MY7
Bankful Width (ft)	7.2	7.7	7.5	-	-	-	-	-
Floodprone Width (ft)	10.0	10.0	10.0	-	-	-	-	-
Bankfull Mean Depth (ft)	0.4	0.4	0.4	-	-	-	-	-
Bankfull Max Depth (ft)	0.5	0.4	0.5	-	-	-	-	-
Bankfull Cross-Sectional Area (ft ²)	2.8	2.8	2.8	-	-	-	-	-
Width/Depth Ratio	18.7	21.4	20.0	-	-	-	-	-
Entrenchment Ratio	1.4	1.3	1.3	-	-	-	-	-
Bank Height Ratio	1.0	0.8	0.8	-	-	-	-	-

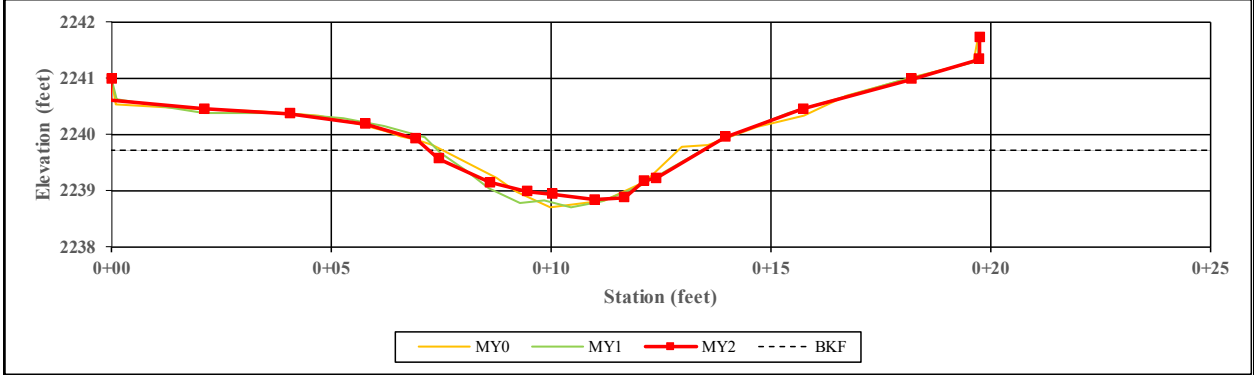
Project Name: Seniard **XS Number:** 16 **Station:** 709+81
Reach Name: Redmond Branch 1A **XS Type:** Pool

CHANNEL DIMENSIONS SUMMARY	MY0	MY1	MY2	MY3	MY4	MY5	MY6	MY7
Bankful Width (ft)	4.2	4.5	5.0	-	-	-	-	-
Floodprone Width (ft)	10.0	10.0	10.0	-	-	-	-	-
Bankfull Mean Depth (ft)	0.8	0.7	0.7	-	-	-	-	-
Bankfull Max Depth (ft)	1.1	1.0	0.9	-	-	-	-	-
Bankfull Cross-Sectional Area (ft ²)	3.2	3.2	3.2	-	-	-	-	-
Width/Depth Ratio	5.5	6.5	7.6	-	-	-	-	-
Entrenchment Ratio	2.4	2.2	2.0	-	-	-	-	-
Bank Height Ratio	1.0	1.1	1.2	-	-	-	-	-

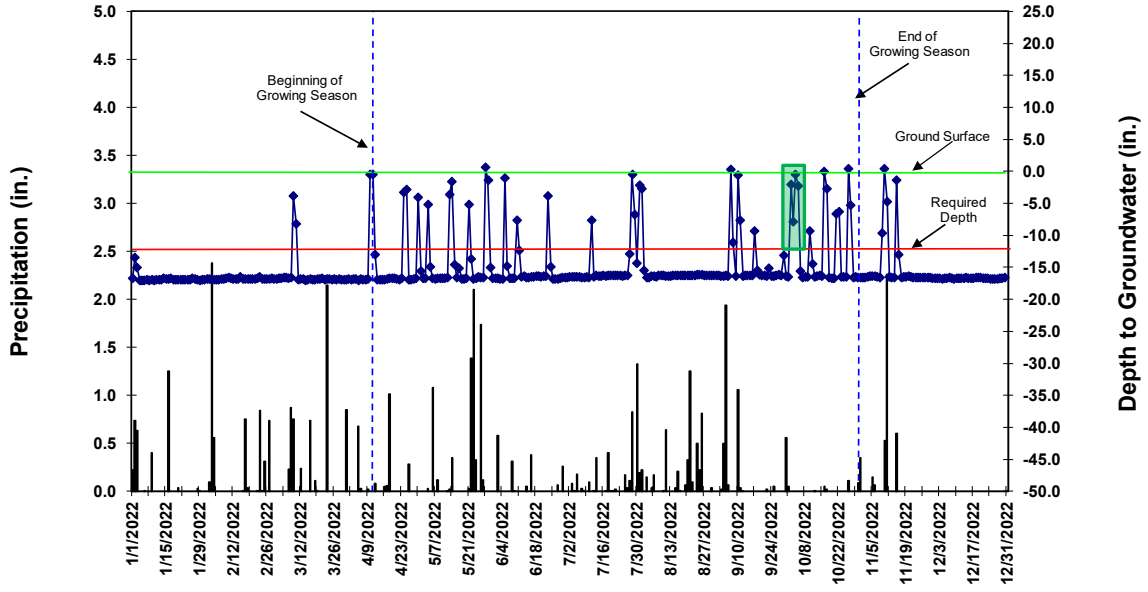
Gauge ID: **GG1** Reported Growing Season Days: 201
 Total Number of Consecutive Days Water Table within 12 inches of Soil Surface: **4** 10/02-10/05
 Percentage of Growing Season Water Table within 12 inches of Soil Surface: **2%**

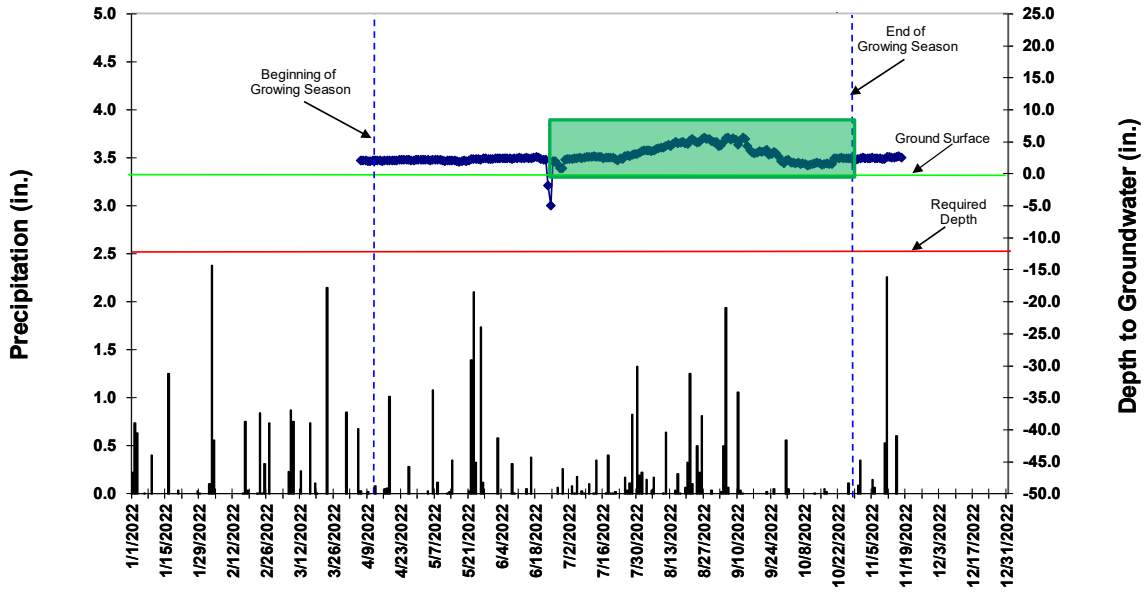
Gauge ID: **GG2** Reported Growing Season Days: 201
 Total Number of Consecutive Days Water Table within 12 inches of Soil Surface: **201** 07/10-10/26
 Percentage of Growing Season Water Table within 12 inches of Soil Surface: **100%**
