**Shadrick Creek Restoration Project**  
**Annual Monitoring/Closeout Report**

Monitoring Year 5 of 5

Shadrick Creek Stream Restoration Project  
NCDMS Contract No. 7343  
NCDMS Project No. 92916  
DWR# 10-0465v2  
USACE Action ID: 2010-00764  
McDowell County, North Carolina  
Data Collected: April 2022 – November 2022  
Date Submitted: December 2022

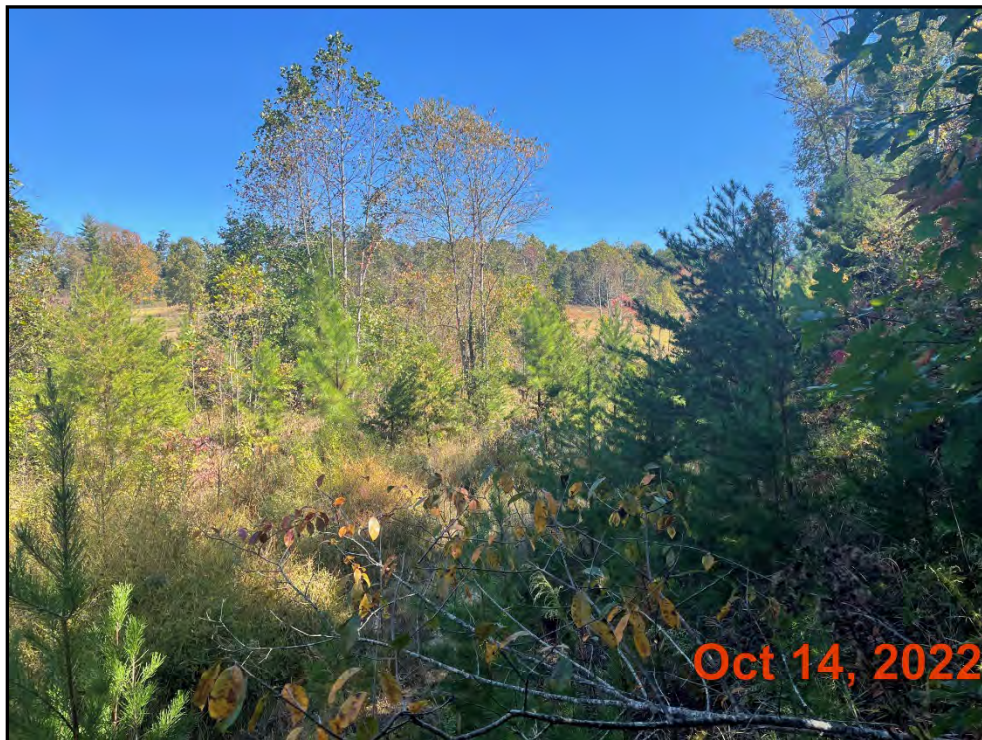
UT-1 – Permanent Photo Station 1 Looking Downstream

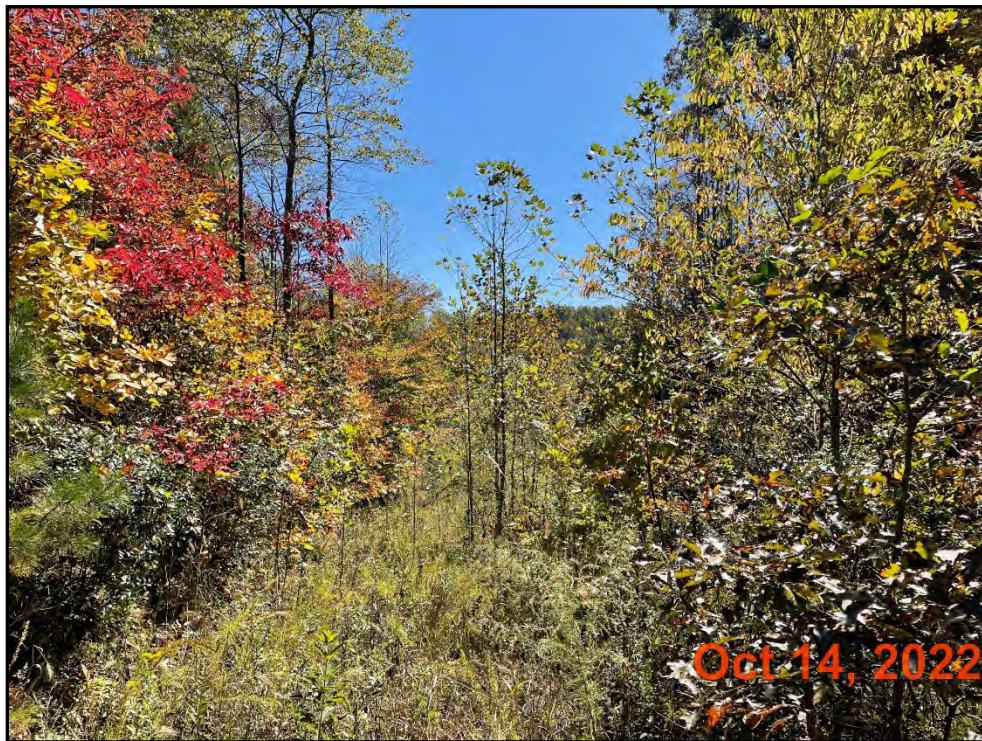
UT-1 – Permanent Photo Station 2  
Looking Downstream

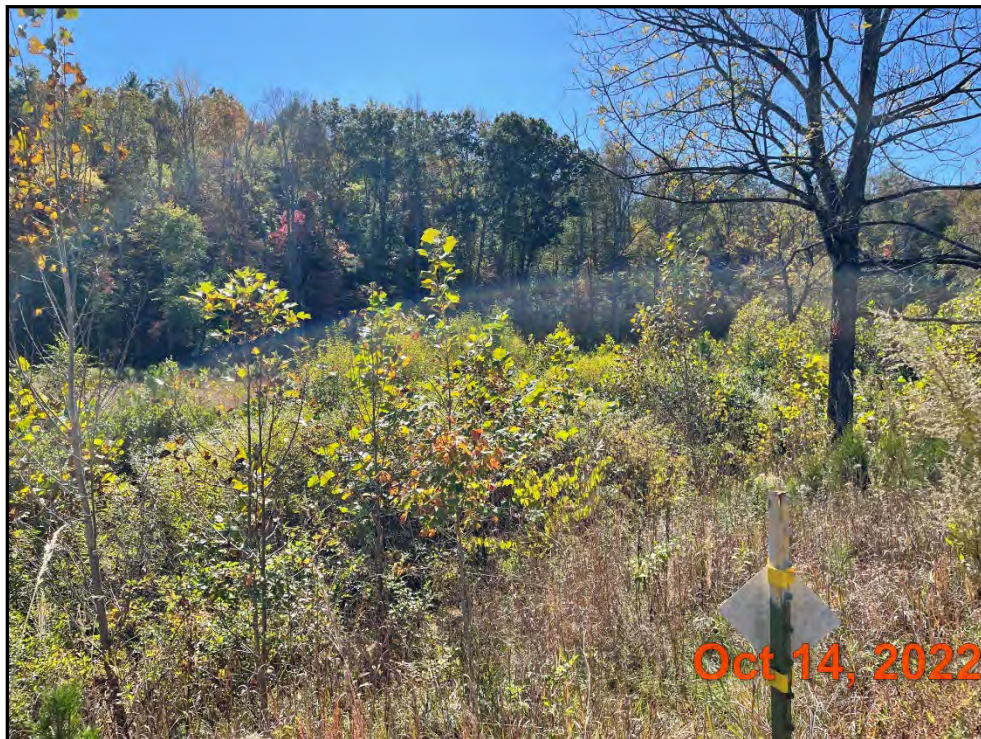
Shadrick Creek Reach 1 – Permanent Photo Station 6  
Looking Upstream

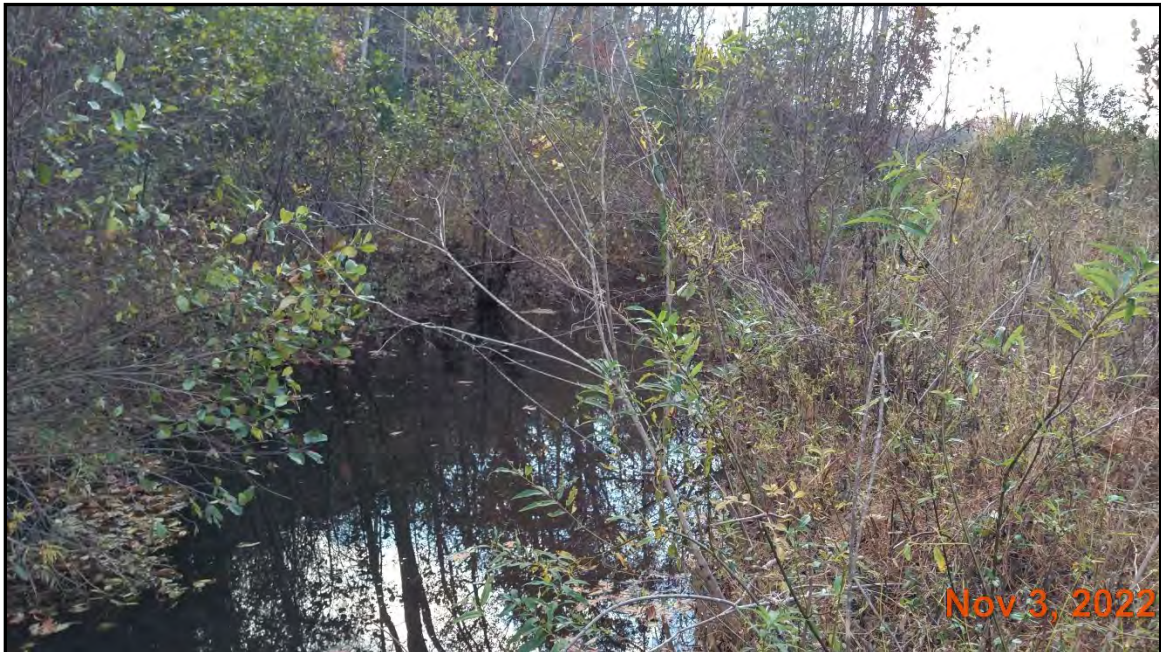
Shadrick Creek Reach 1 – Permanent Photo Station 12  
Looking Upstream Shadrick Creek from confluence of UT-9 Reach 2

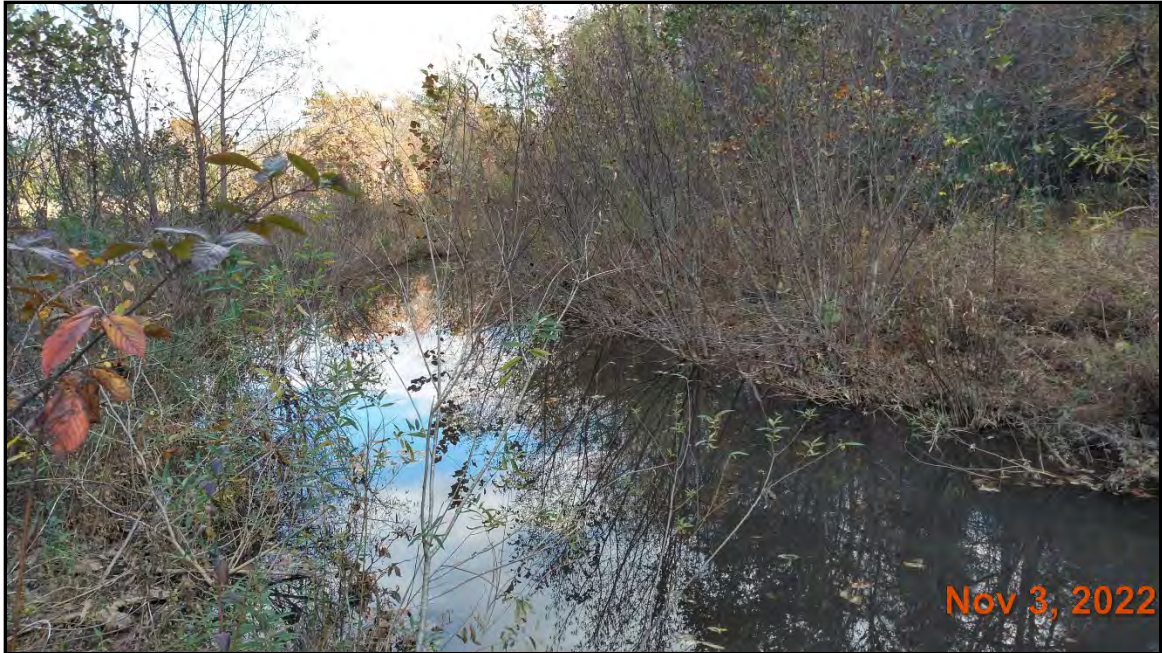
Shadrick Creek Reach 1 – Permanent Photo Station 12  
Looking Downstream Shadrick Creek from confluence of UT-9 Reach 2

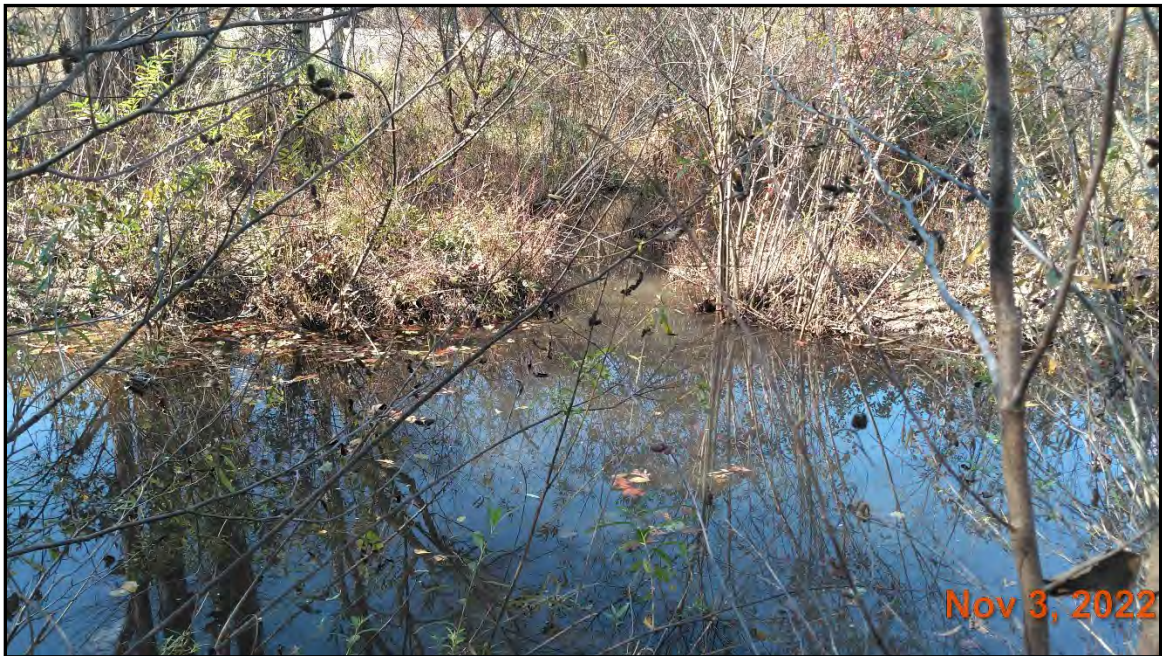
Shadrick Creek Reach 1 – Permanent Photo Station 12  
Looking Upstream UT-9 Reach 2 from the confluence with Shadrick Creek

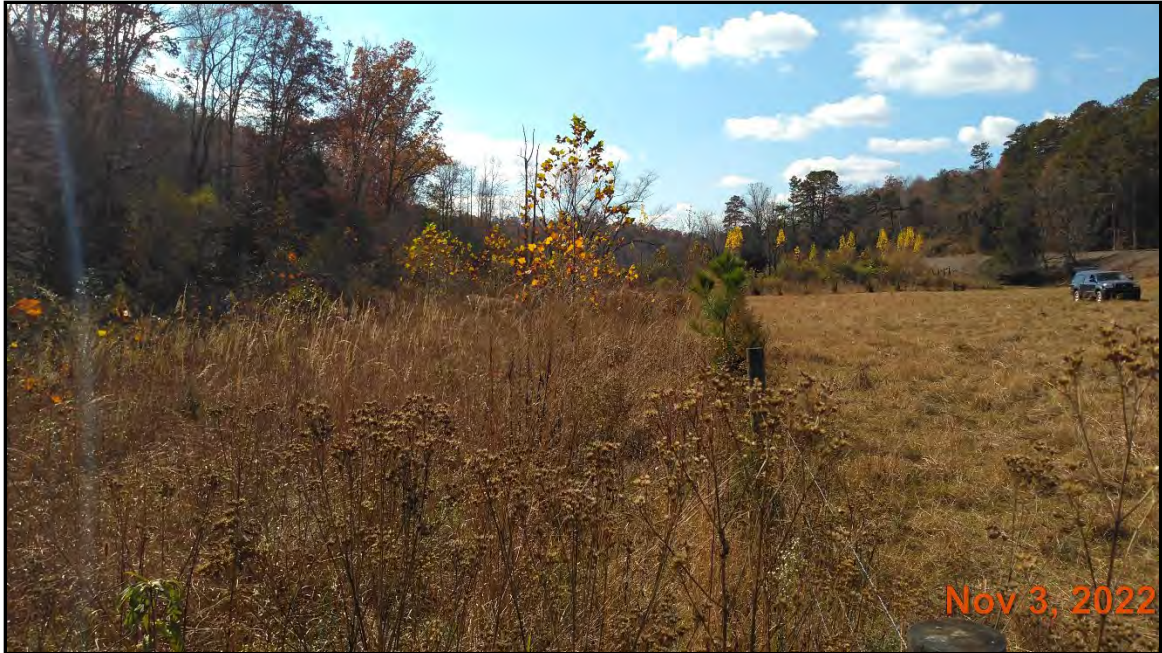
Shadrick Creek Reach 1 – Permanent Photo Station 13  
Looking Upstream

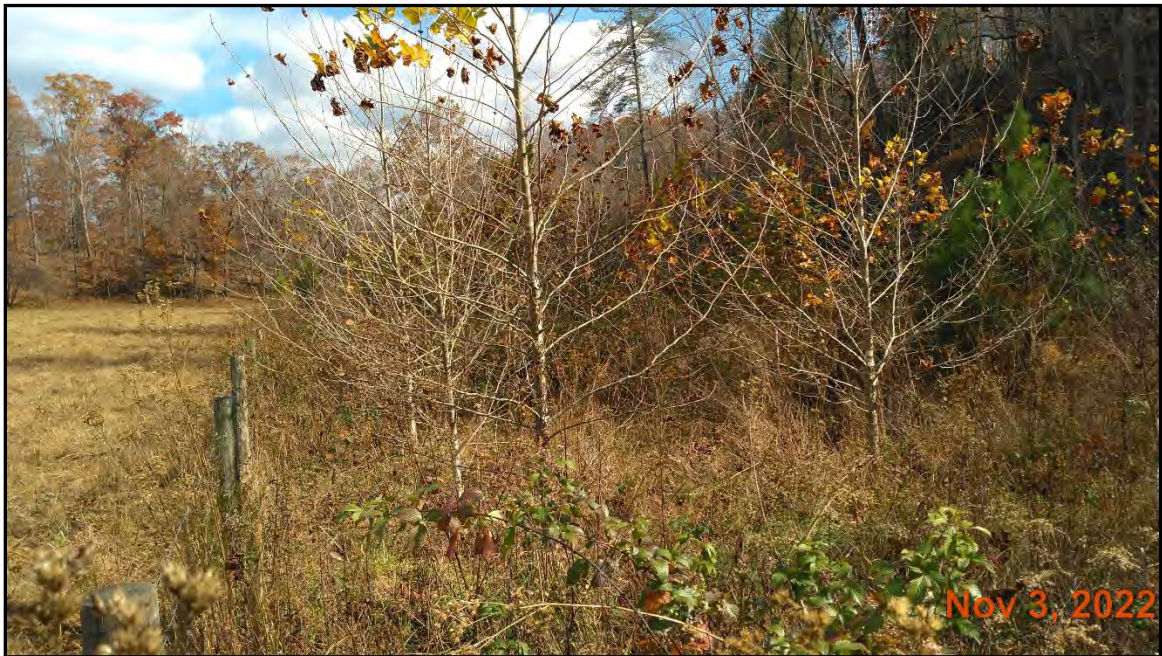
Shadrick Creek Reach 1 – Permanent Photo Station 13  
Looking Downstream

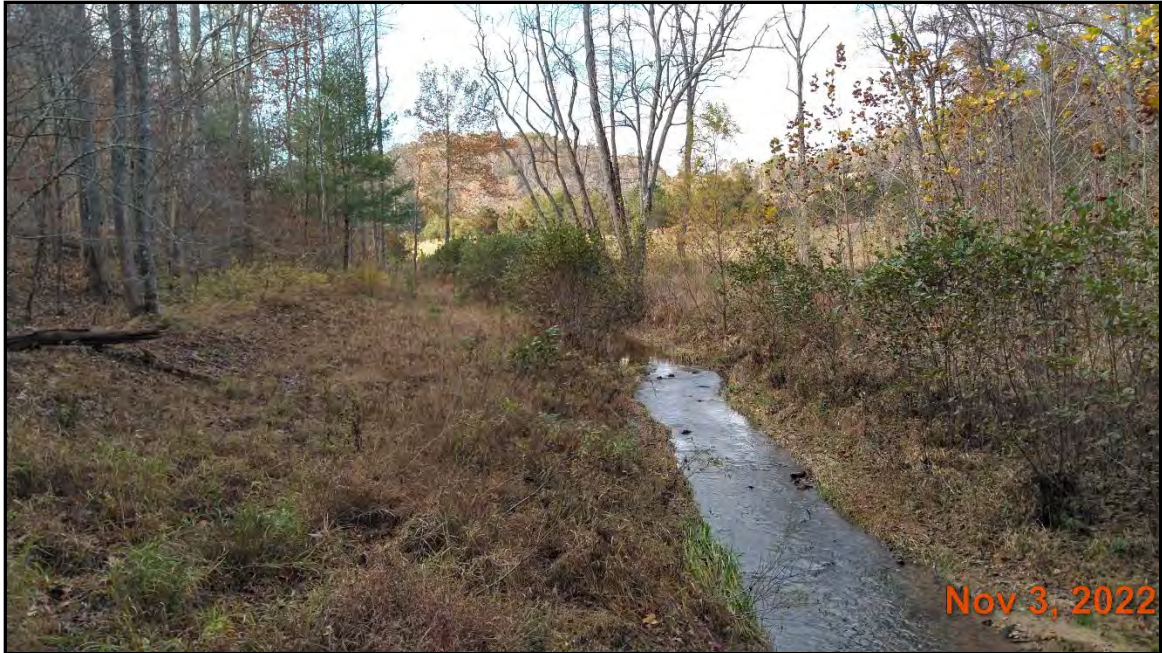
Shadrick Creek Reach 1 – Permanent Photo Station 14  
Looking Upstream

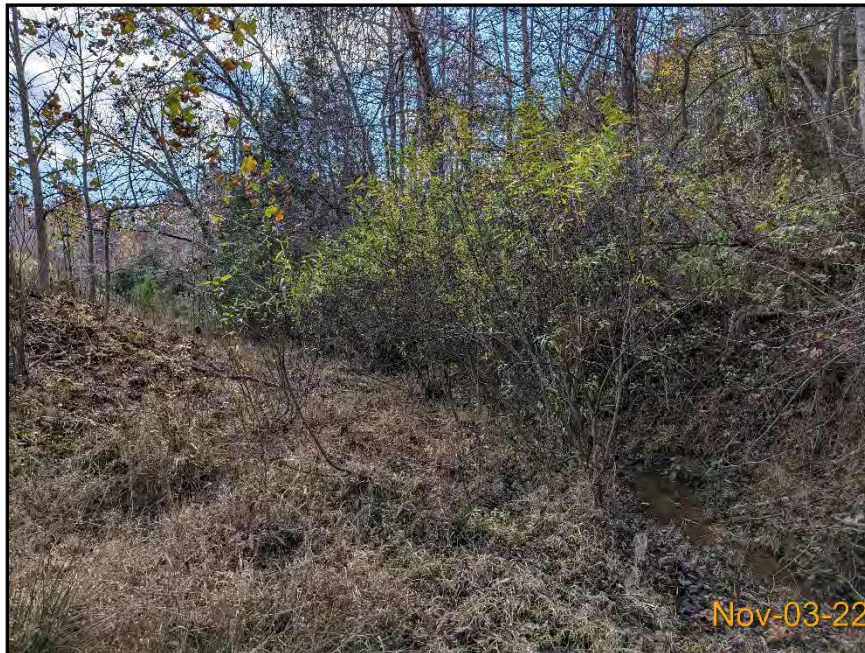
UT-10 – Permanent Photo Station 21 Supplemental  
Looking Upstream at head of project and 2021 Repair Area

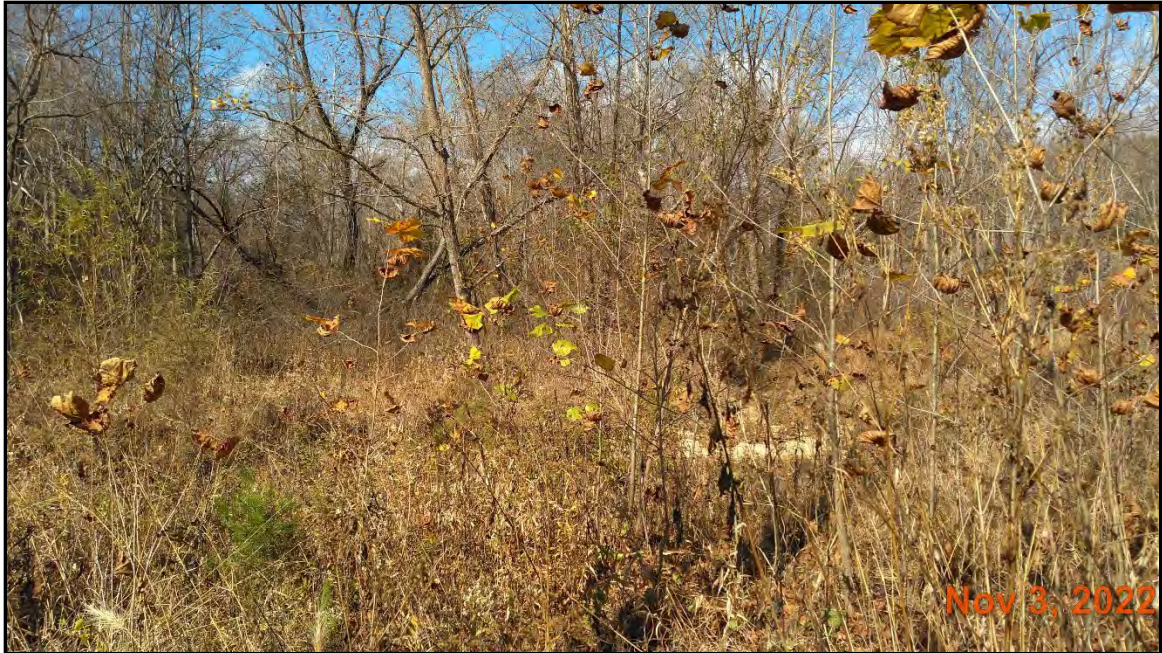
Shadrick Creek Reach 2 – Permanent Photo Station 23 Supplemental  
Looking Upstream towards 2021 Repair Area

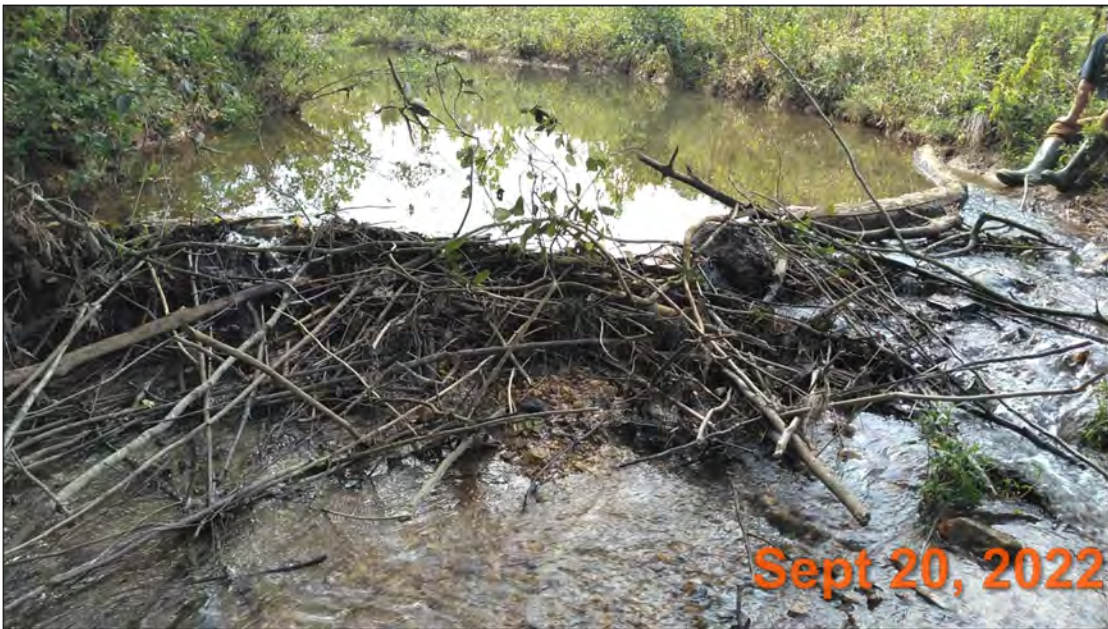
Shadrick Creek Reach 1 –Secondary beaver dam Station 36+50

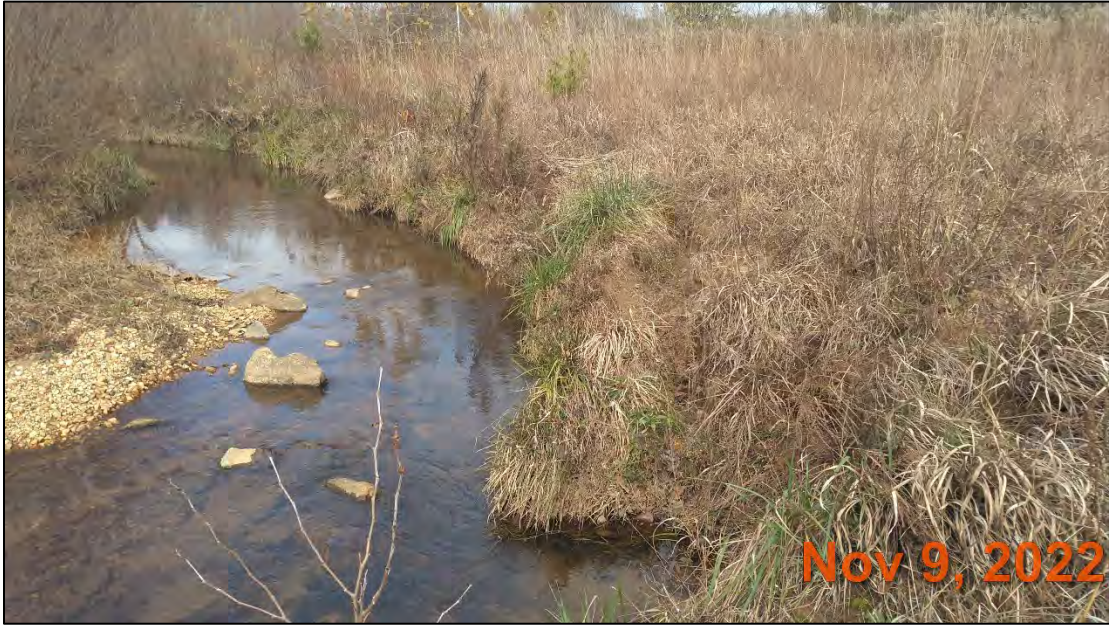
Bank Slump, Shadrick Reach 3, Station 113+75

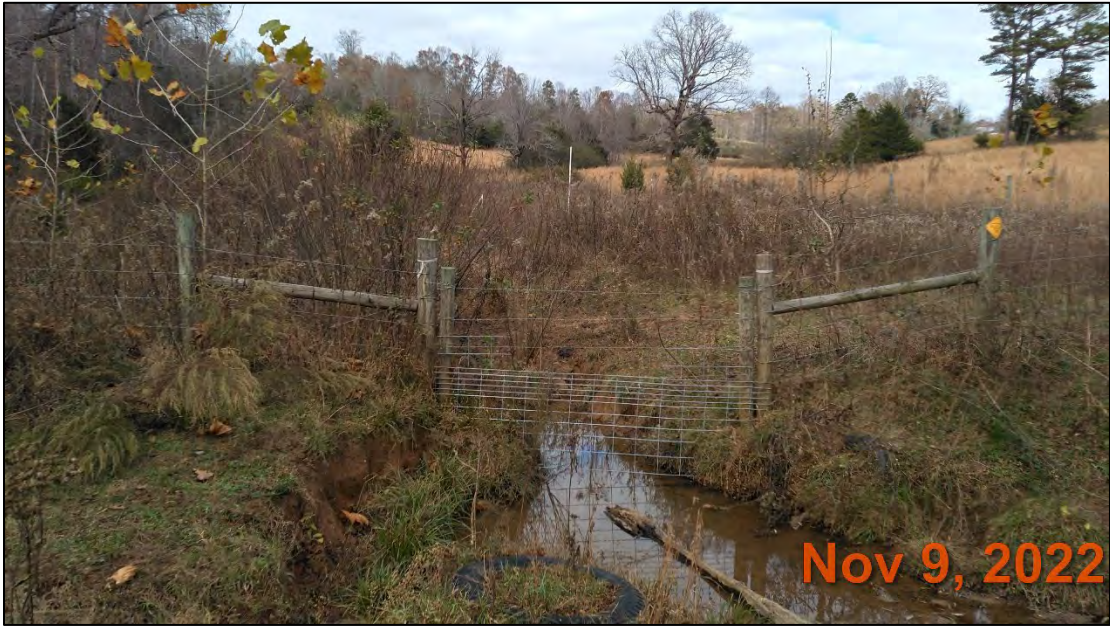
UT 10 cattle exclusion added to existing fence.

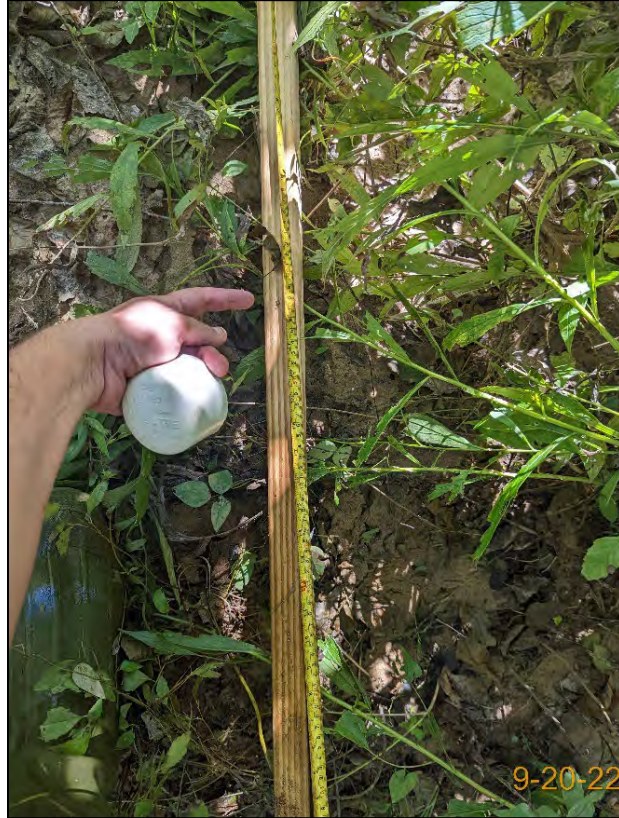
Photo #1 – Shadrick Creek Reach 1 Crest Gauge at 1.8 feet (Recorded bankfull + 0.7 feet)
