Shadrick Creek Restoration Project

Annual Monitoring Report

Monitoring Year 1 of 5

NCDMS Contract No. 7343

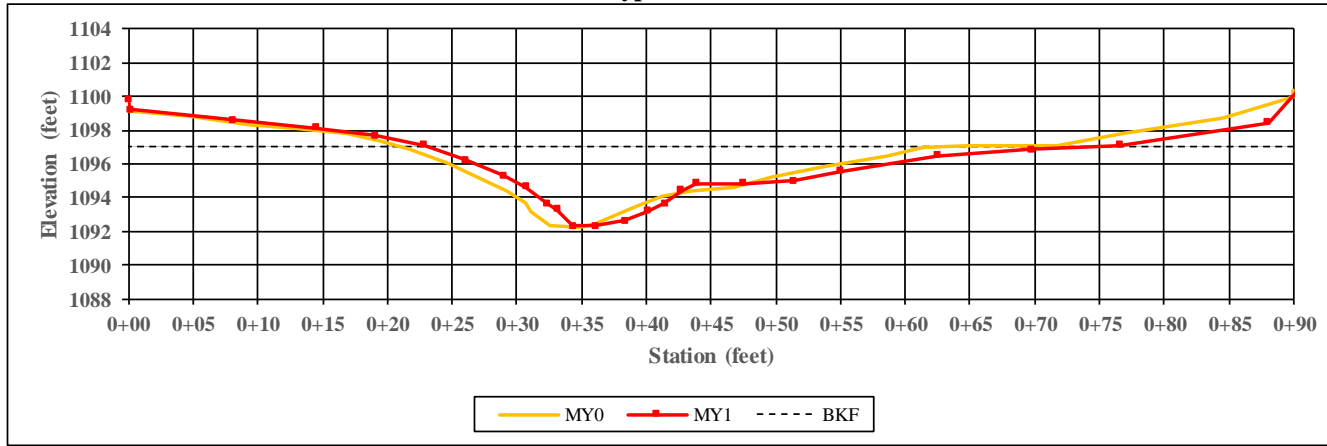
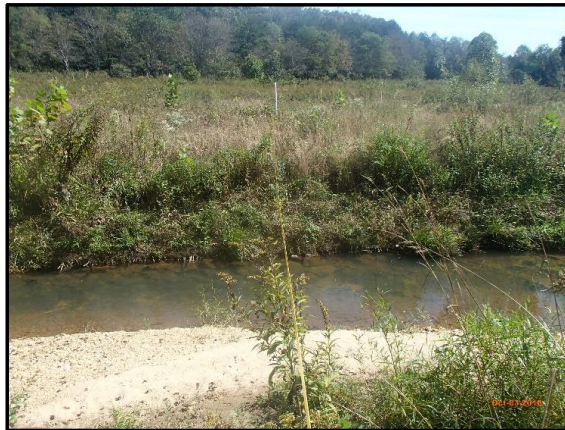
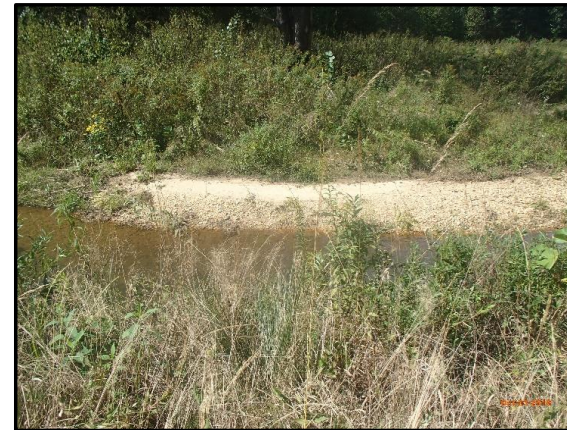
XS Number: 18
XS Type: Pool

Geomorphic data for MY1 was collected during October 2018. Summary tables and cross-section data plots related to stream morphology are located in Appendix D. Cross-sectional dimensions remained relatively stable between baseline conditions and MY1 monitoring efforts. The most substantial changes took place at cross-sections 1, 13, and 17. Cross-section 1 had the bankfull width decrease by 1.0 foot and the width/ depth ratio decreased by 2.8. Cross-sections 13 and 17 had the bankfull width increase by 1.4 feet and 1.6 feet and the width/ depth ratio increase by 6.7 and 1.5 respectively (Appendix D, Table 11a). Riffle dimensions for each reach also remained relatively similar between baseline conditions and MY1 monitoring. The most notable changes took place within UT-9 Reach 2, and UT-10. UT-9 Reach 2 saw a decrease in the bankfull width by 0.5 foot and the width/ depth ratio decreased by 2.8. Bankfull width on UT-10 increased by 1.5 feet due to a slight bit of scour along the bankfull bench (Appendix D, Table 11b).

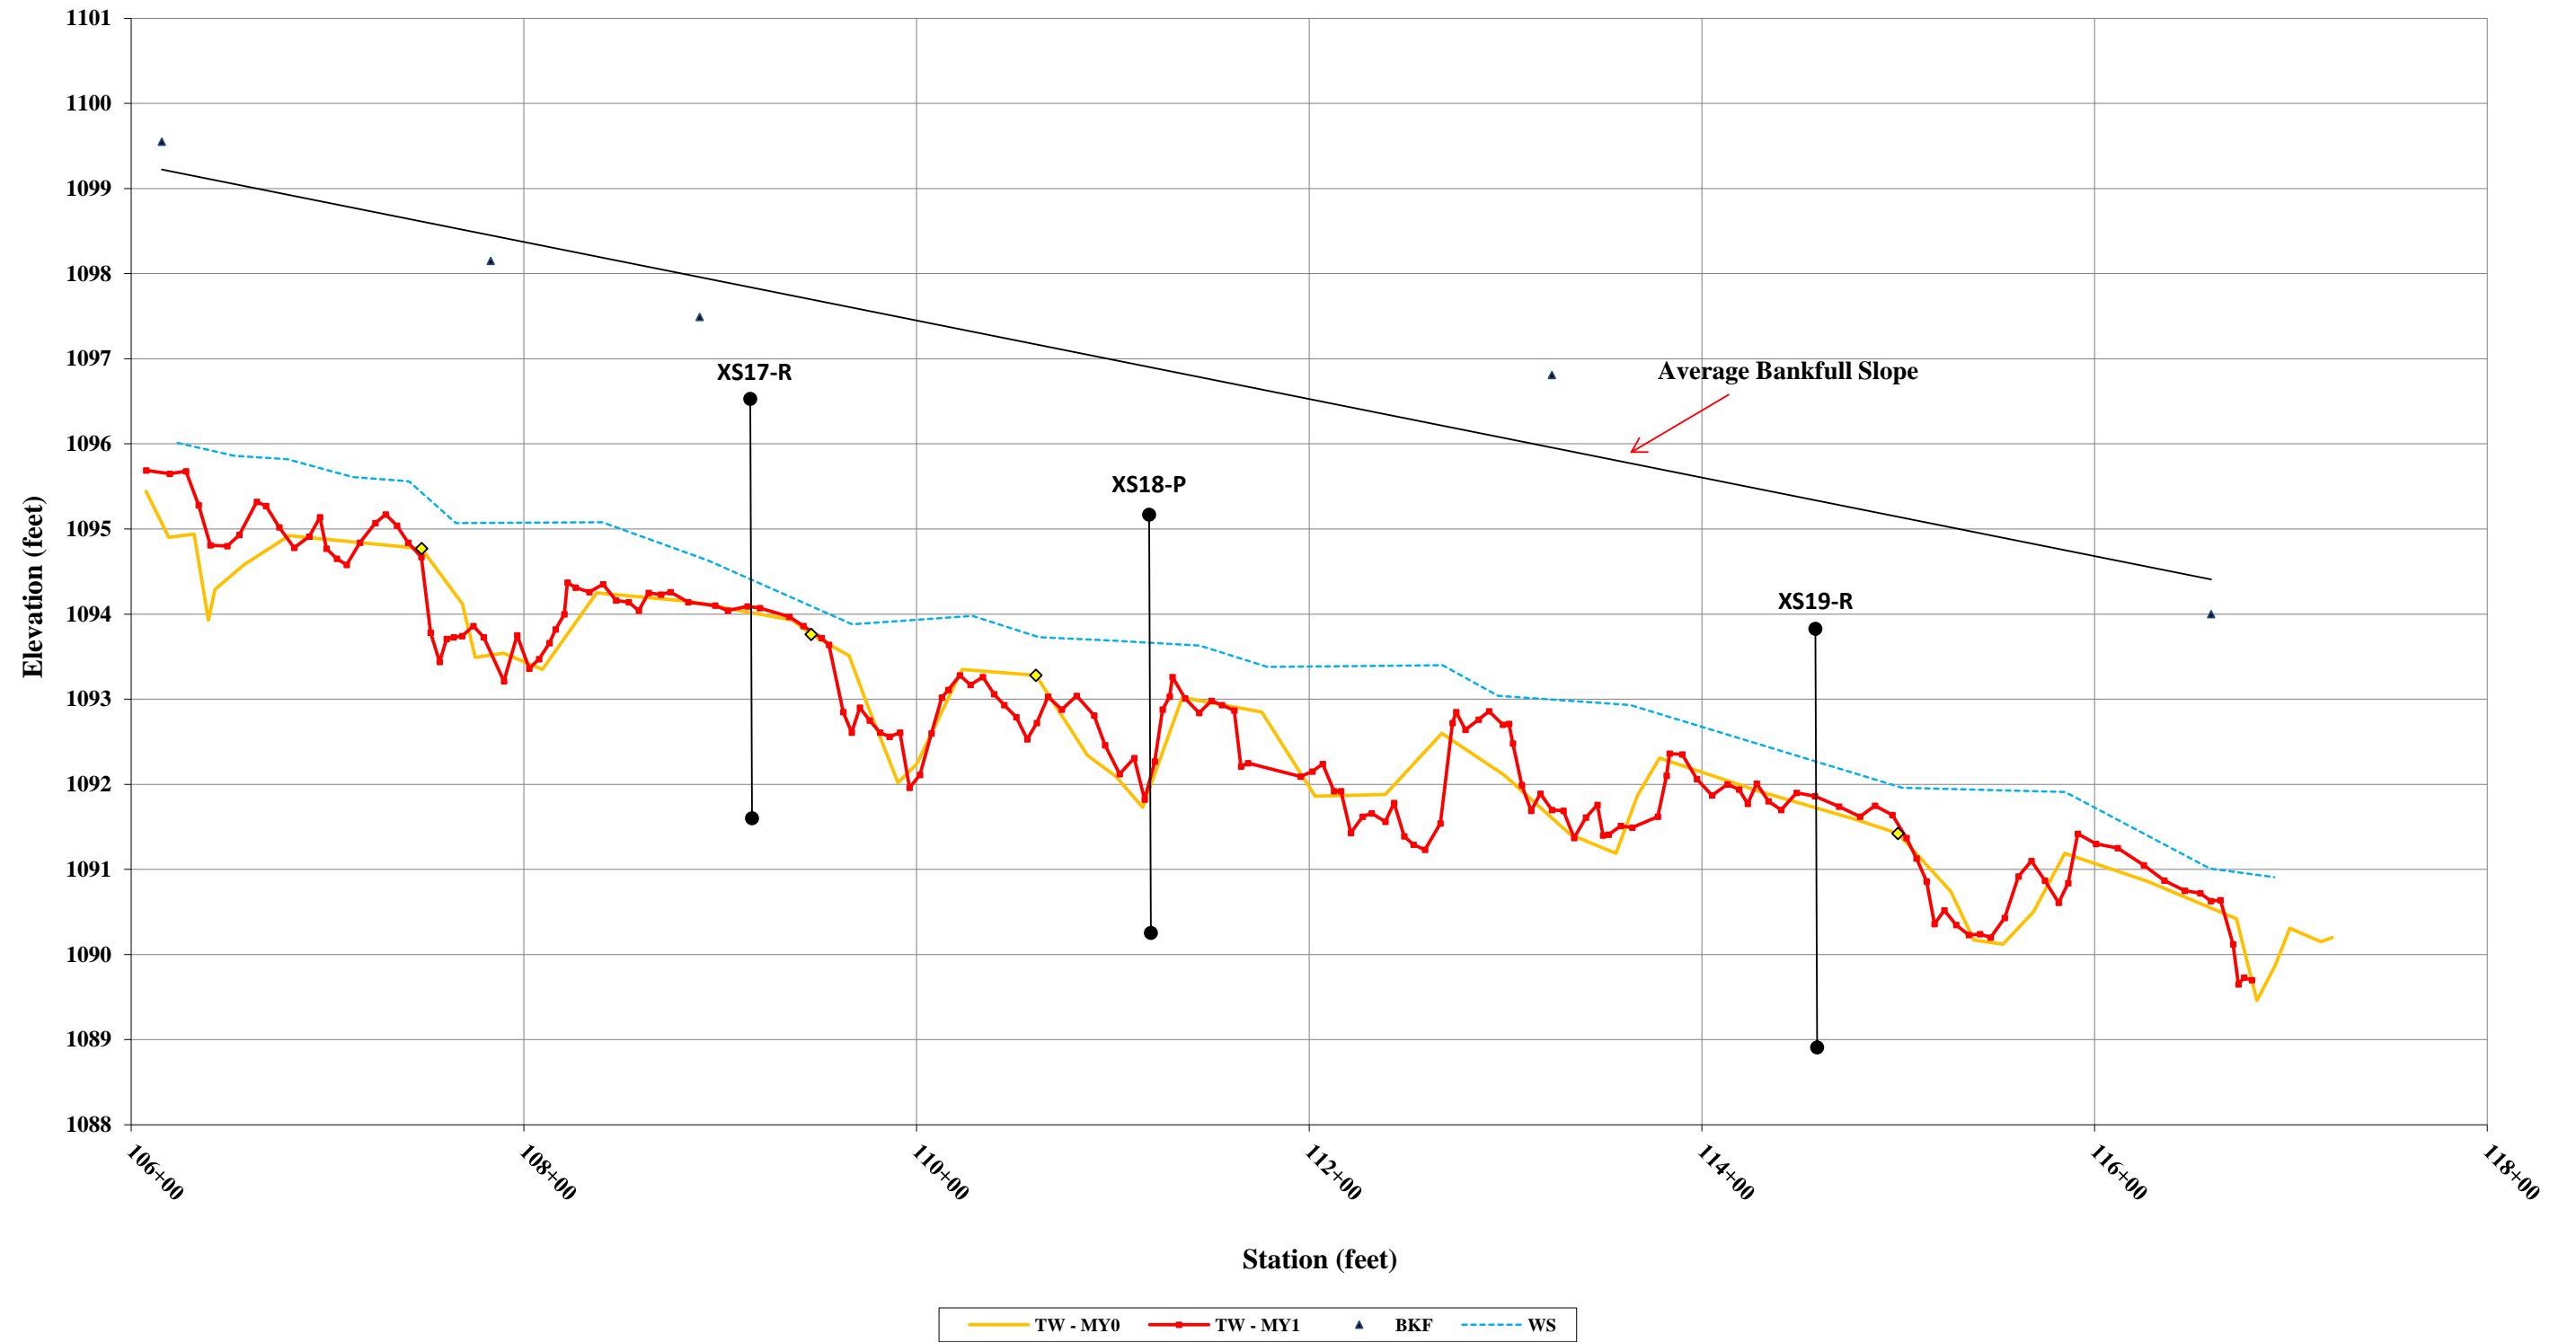
**Shadrick Creek - Shadrick Reach 3
Longitudinal Profile
Staioning 106+23 to 117+27**

Creek Reach 3 indicates that the stream has remained stable since baseline conditions. Riffle slopes and water surface slopes have remained almost the same since baseline. Mean riffle lengths have decreased by 7.3 feet and mean pool lengths have increased by 10.9 feet. UT-9 Reach 2 dimensions have also indicated that mean riffle lengths are shortening and mean pool lengths are increasing by 5.4 feet and 2.8 feet respectively. These changes are to be expected in the first couple years after baseline completion as the stream channel adjusts. Longitudinal profile data will continue to be collected and analyzed in future monitoring years for unhealthy trends.
