Shadrick Creek Restoration Project

Annual Monitoring Report

Monitoring Year 2 of 5

Shadrick Creek Stream Restoration Project

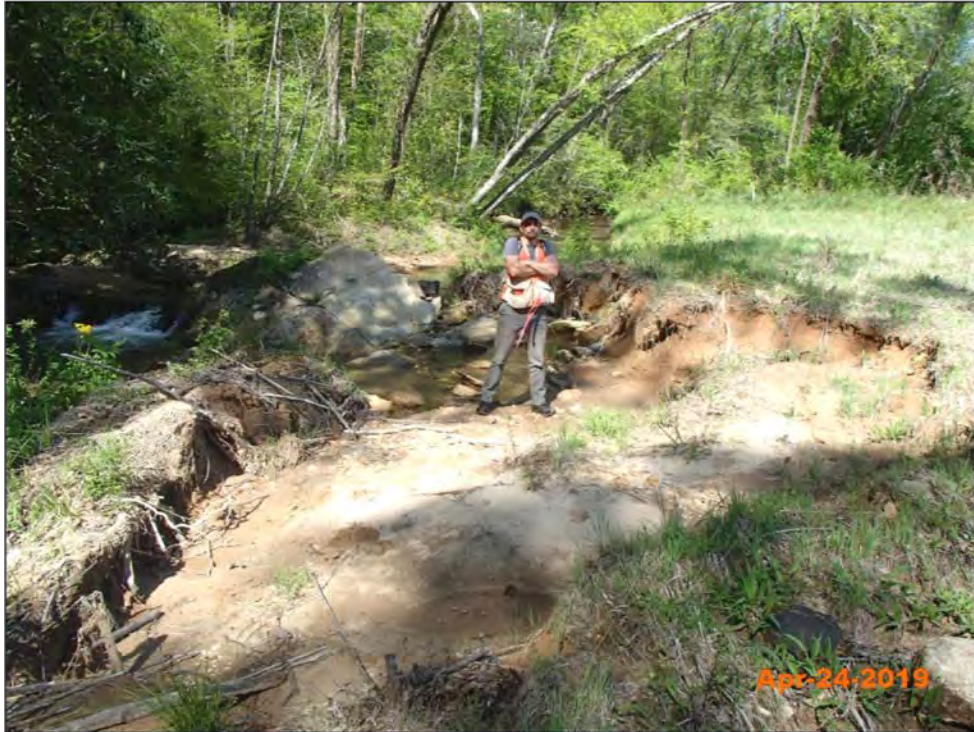
Shadrick Creek Reach 1 – Bank Erosion Station 11+00

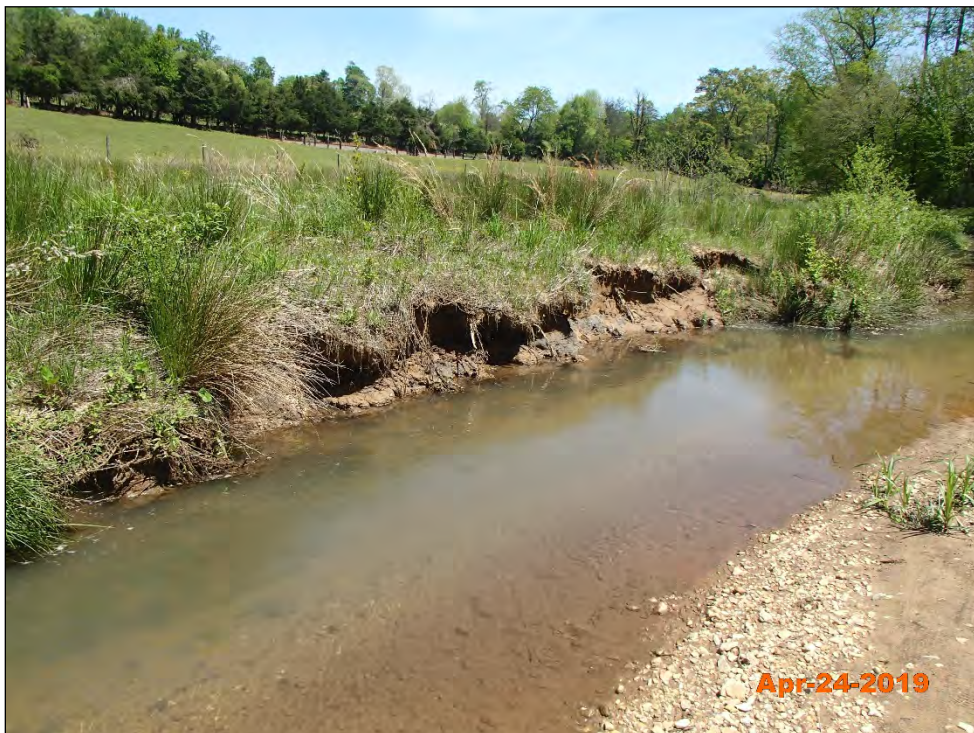
Shadrick Creek Reach 1 – Bank Erosion Station 33+75

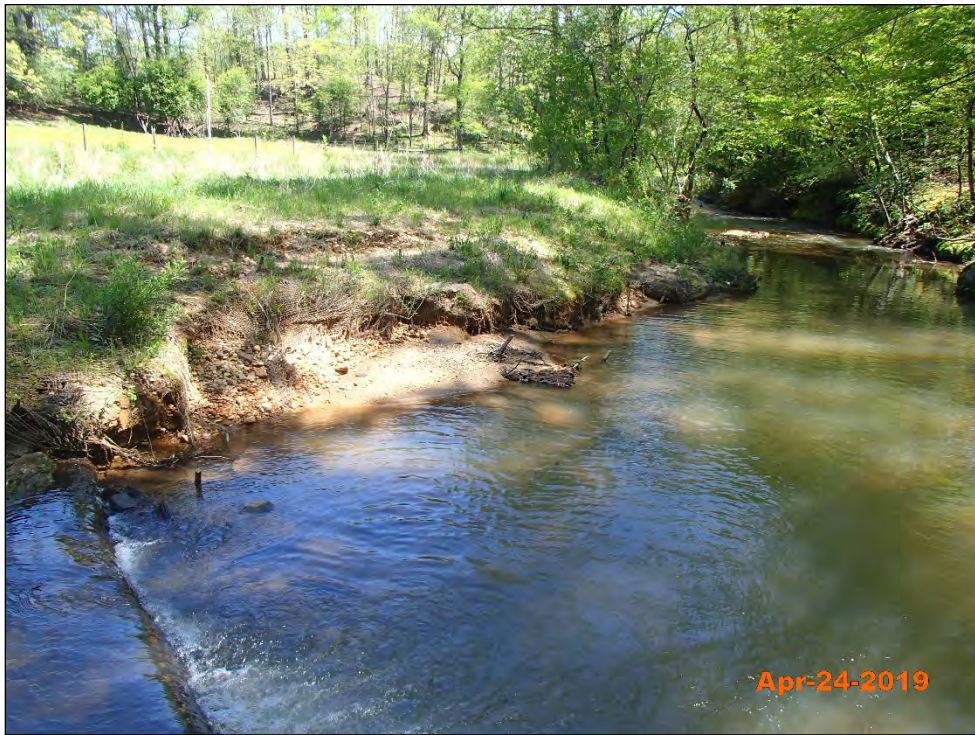
Shadrick Creek Reach 1 – Bank Erosion Station 37+50

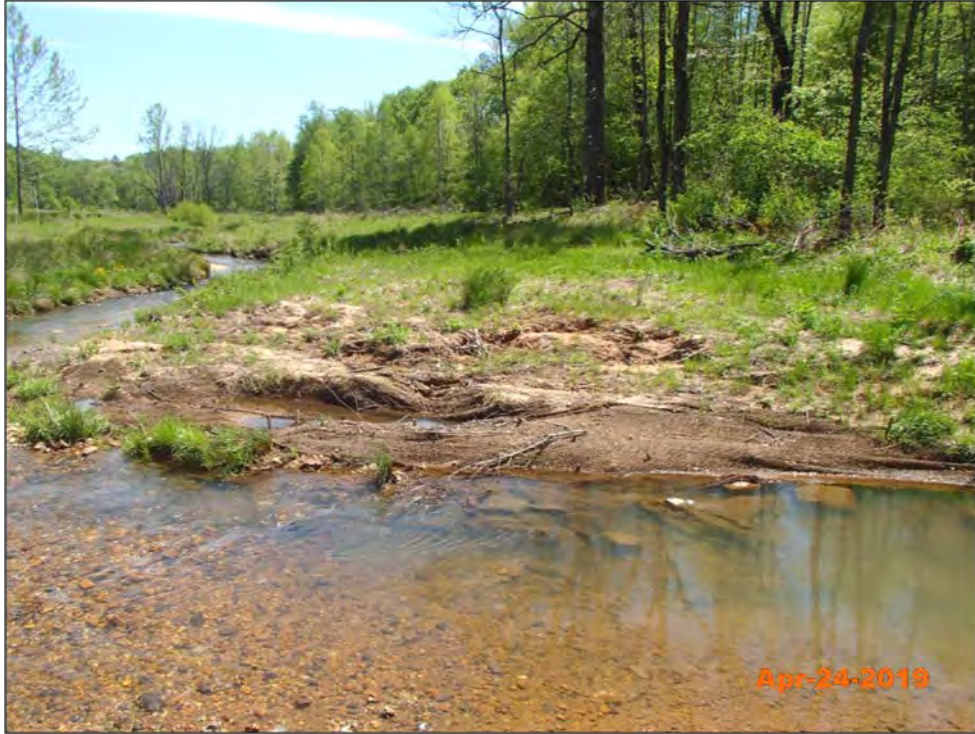
Shadrick Creek Reach 1 – Bank Erosion Station 39+00

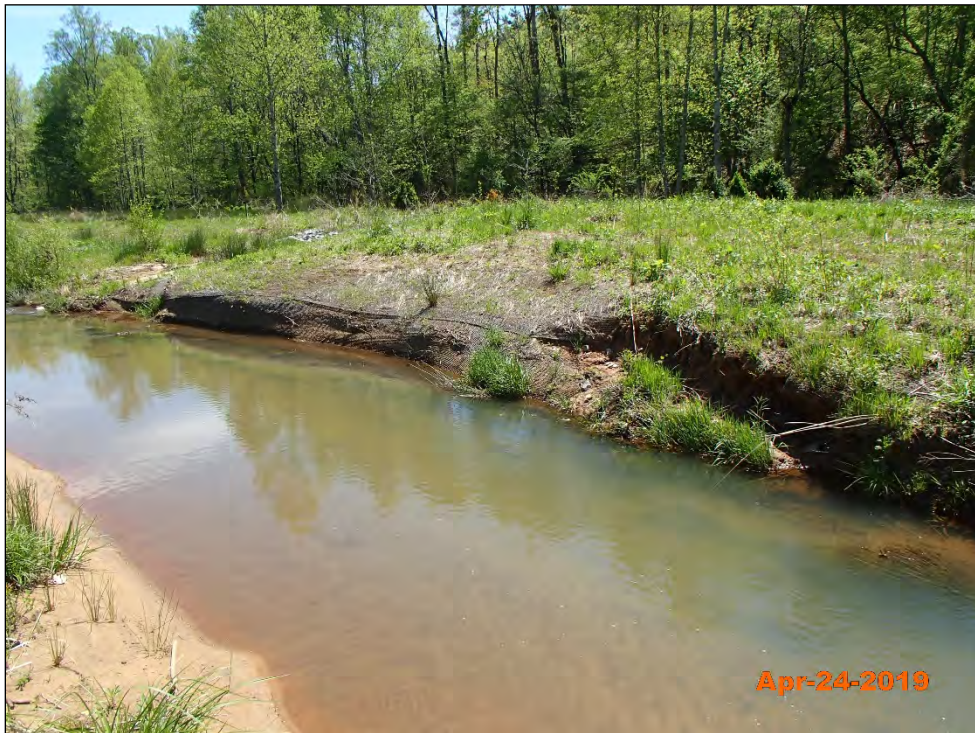
Shadrick Creek Reach 2 – Bank Erosion Station 101+25

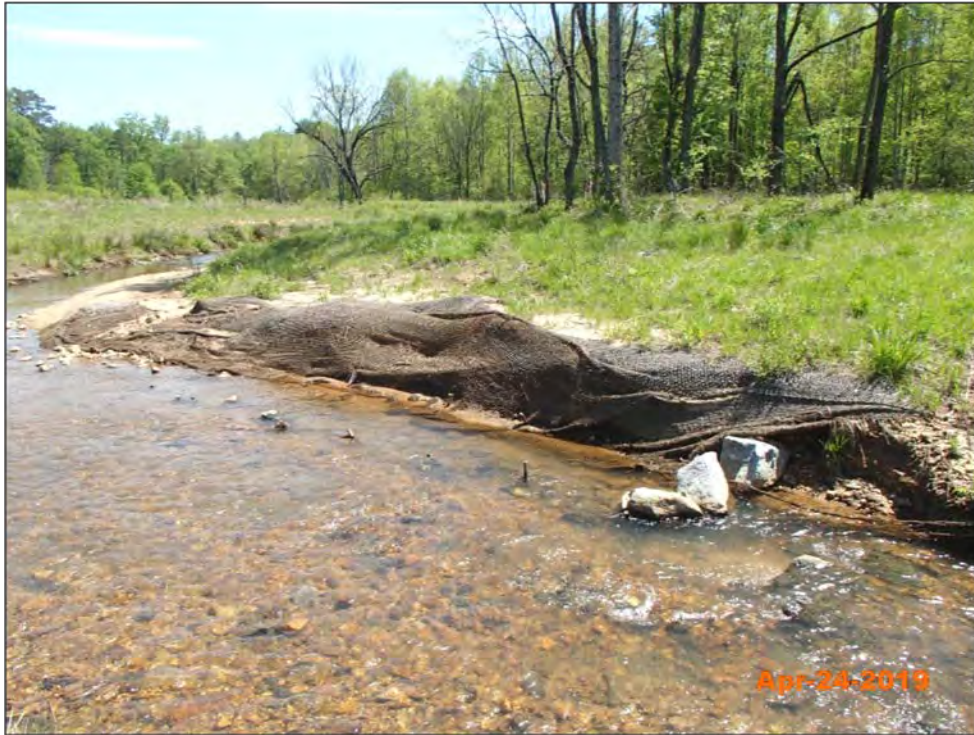
Shadrick Creek Reach 2 – Bank Erosion Station 105+50

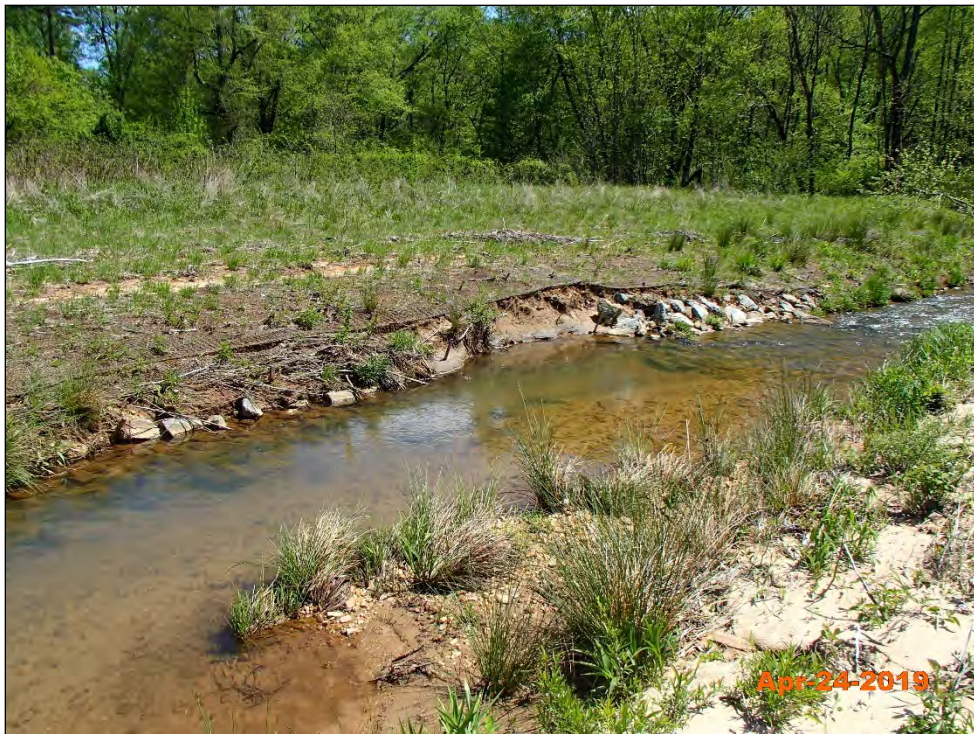
Shadrick Creek Reach 3 – Bank Erosion Station 107+50
