Shadrick Creek Restoration Project

Annual Monitoring Report

Monitoring Year 3 of 5

McDowell County, North Carolina

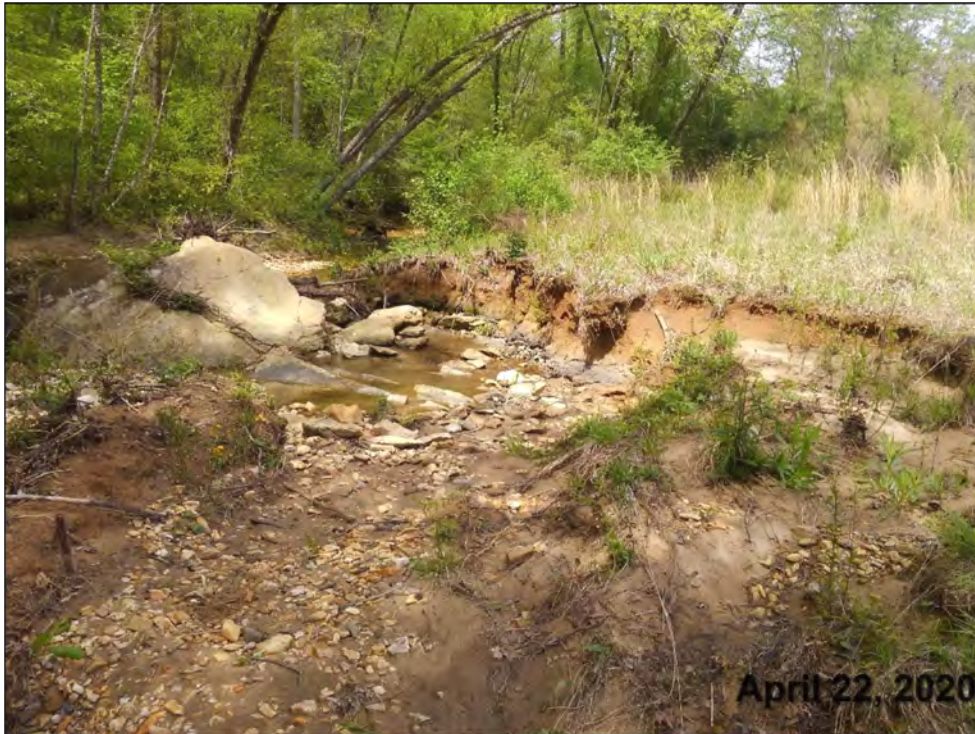
Shadrick Creek Reach 1 – Bank Erosion Station 11+00

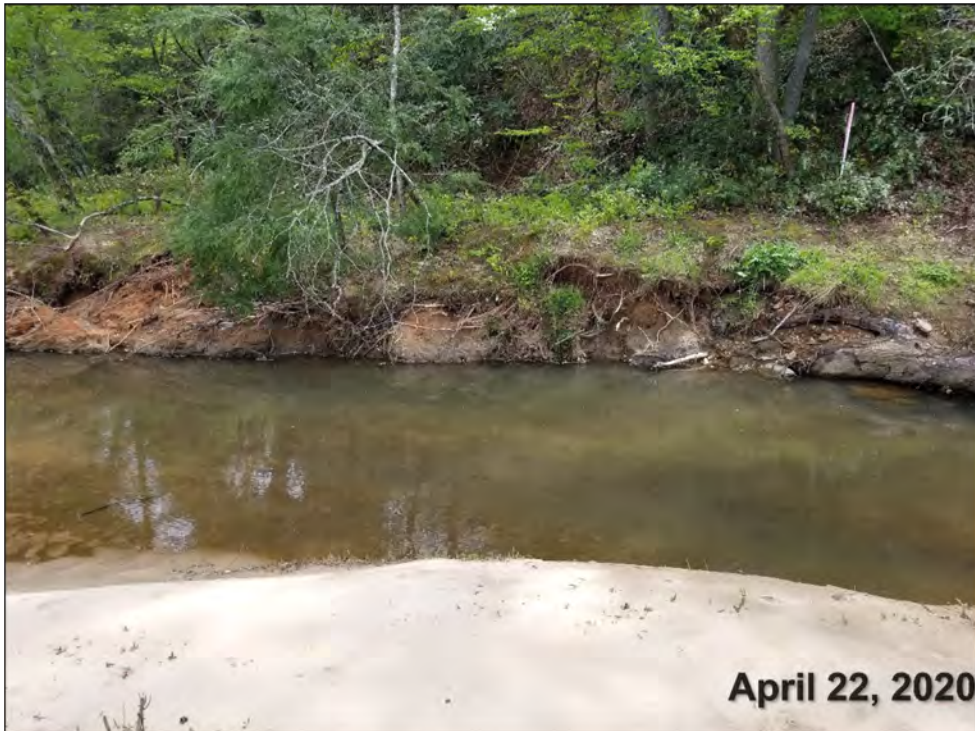
Shadrick Creek Reach 1 – Bank Erosion Station 37+50

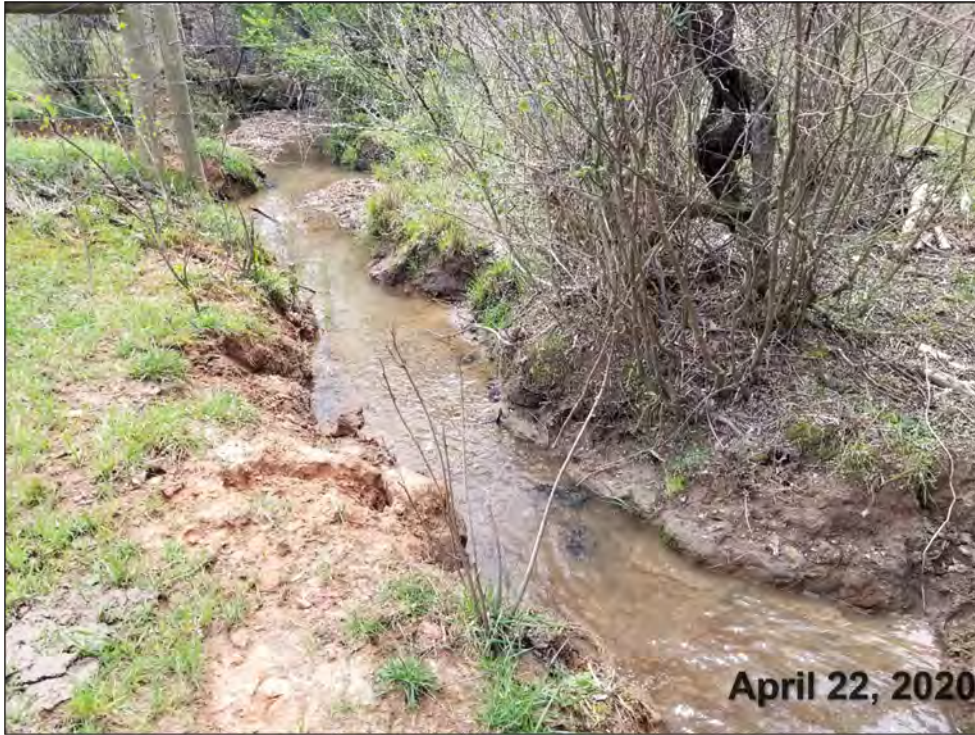
An initial incident of cattle encroachment on UT9 was identified in January 2019. DMS implemented fence repairs in March 2019 to prevent further encroachment. One area of easement encroachment by cattle was identified during April 2020. The lowest strand of barbed wire was broken along the downstream extent of UT9 Reach 1 above the crossing. This portion of wire was repaired in the field to provide temporary exclusion. DMS will investigate this area of encroachment and employ new measures to ensure cattle are excluded from the easement. No additional areas of encroachment were noted in subsequent site visits in MY3.

UT 9 – Evidence of cattle bypassing fenced crossing.

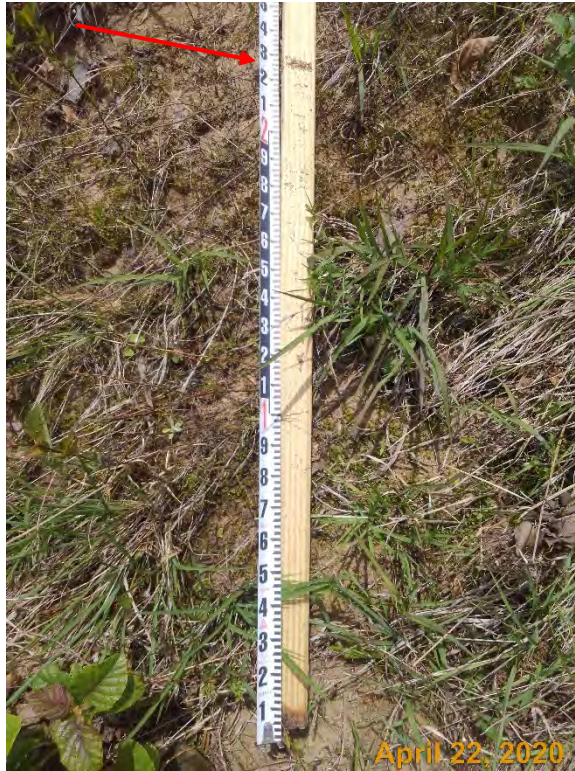
Photo #1 – Shadrick Creek Reach 1 Crest Gauge at 2.26 feet (Recorded bankfull 1.2 feet)

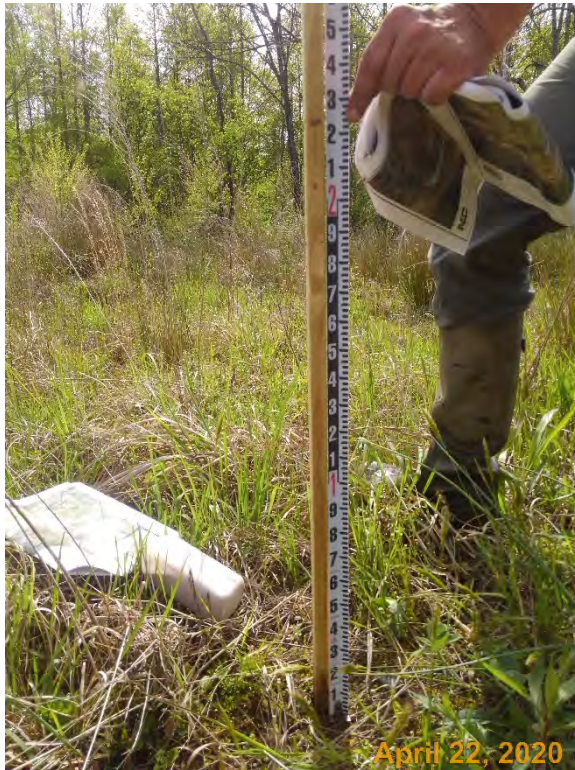
Photo #2 – Shadrick Creek Reach 3 Crest Gauge at 2.22 feet (Recorded bankfull 1.6 feet)
