MONITORING YEAR 4 ANNUAL REPORT

SHAKE RAG MITIGATION SITE

Madison County, NC
DEQ Contract No. 7190
DMS Project No. 100018
USACE Action ID No. SAW-2017-01570
DWR Certification No. 17-1157
RFP# 16-006991 (September 16, 2016)

Data Collection Period: January – October 2023
Draft Submission Date: November 30, 2023
Final Submission Date: January 4, 2024

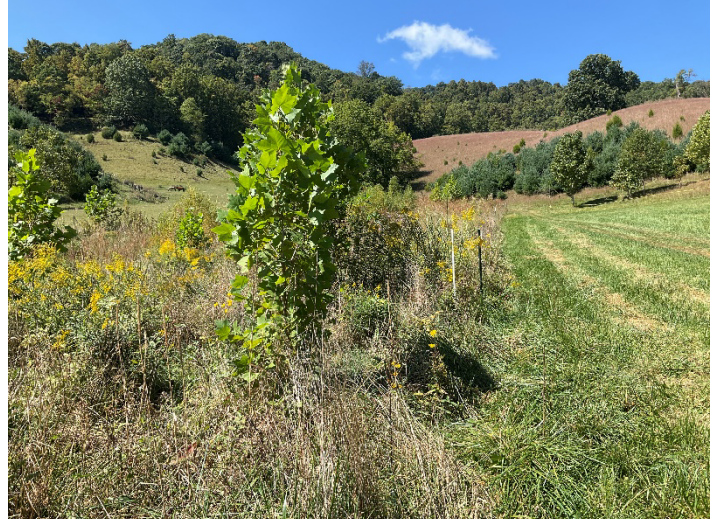
Posts added along CE Boundary – UT4, view up-valley (10/02/2023)

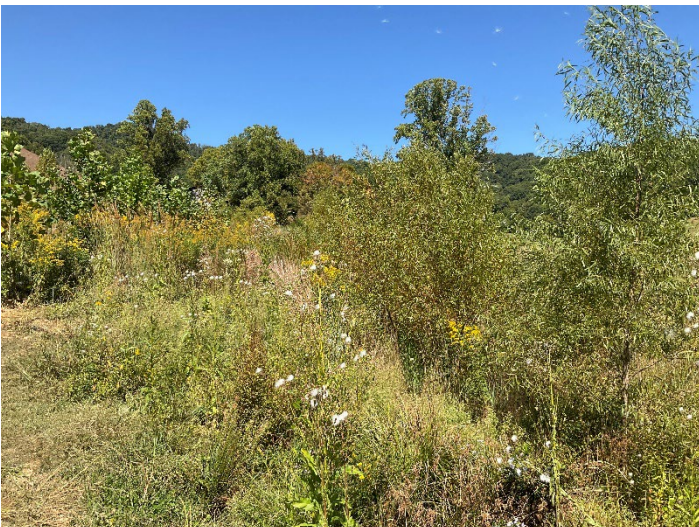
Encroachment resolved – UT4, view up-valley (10/02/2023)

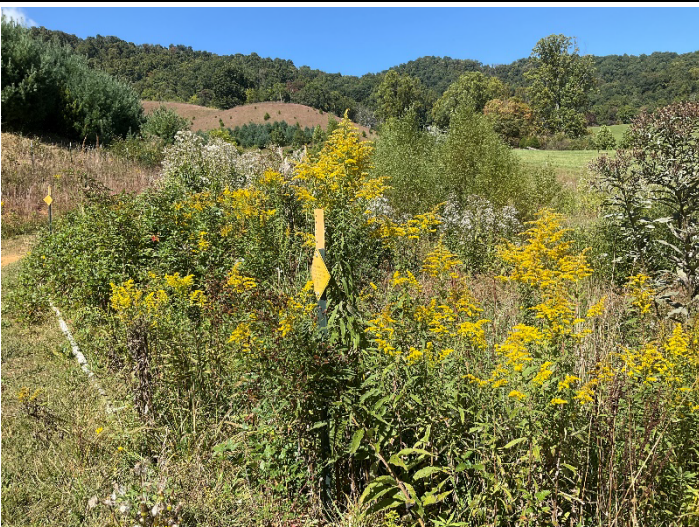
Pipe removed from easement – UT4, view up-valley (10/02/2023)
