FINAL
MY3 (2023) MONITORING REPORT

SHAW'S RUN MITIGATION SITE
Columbus County, North Carolina
Lumber River Basin
Cataloging Unit 03040203

DMS Project No. 100055
Full Delivery Contract No. 7515
DMS RFP No. 16-007337
USACE Action ID No. SAW-2018-01169
DWR Project No. 2018-0866

Data Collection: January – November 2023
Submission: January 2024

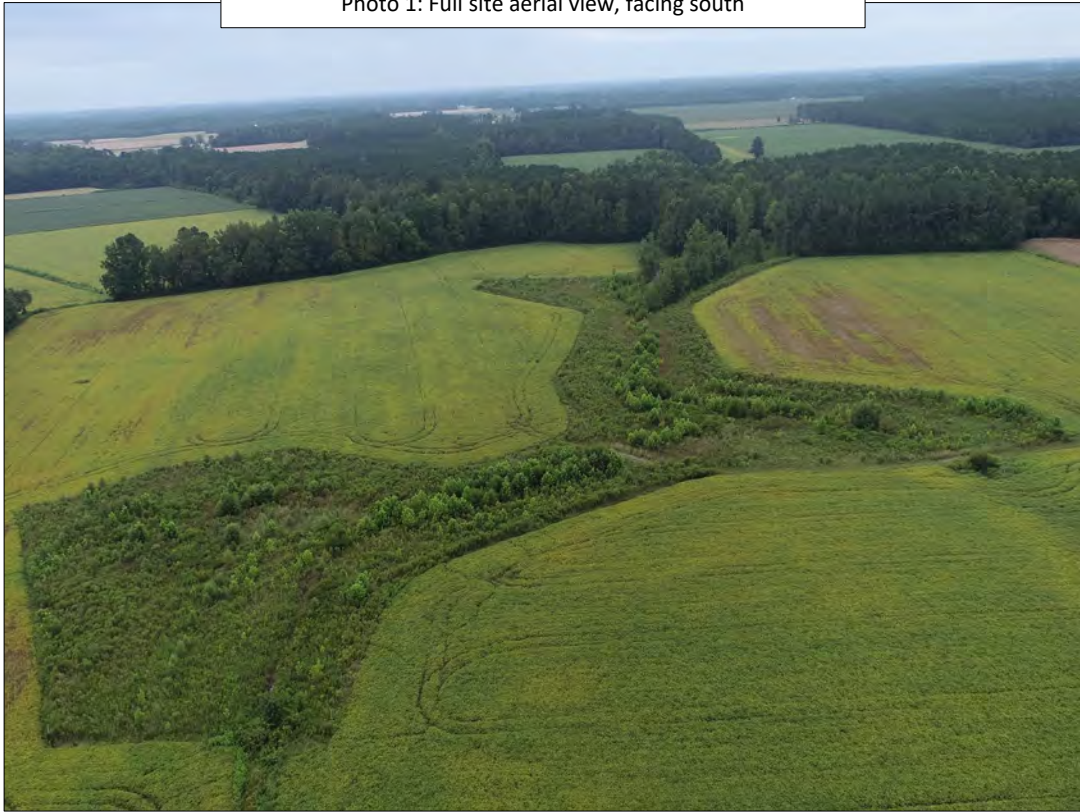
Photo 1: Full site aerial view, facing south

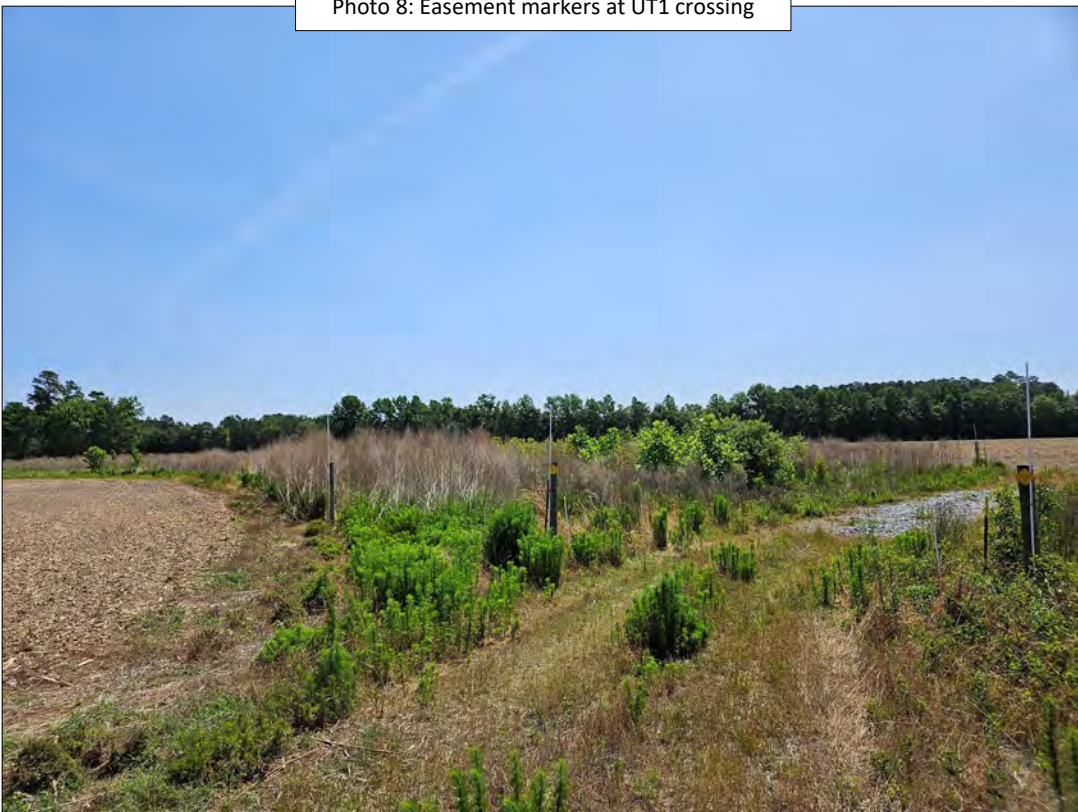
Photo 8: Easement markers at UT1 crossing

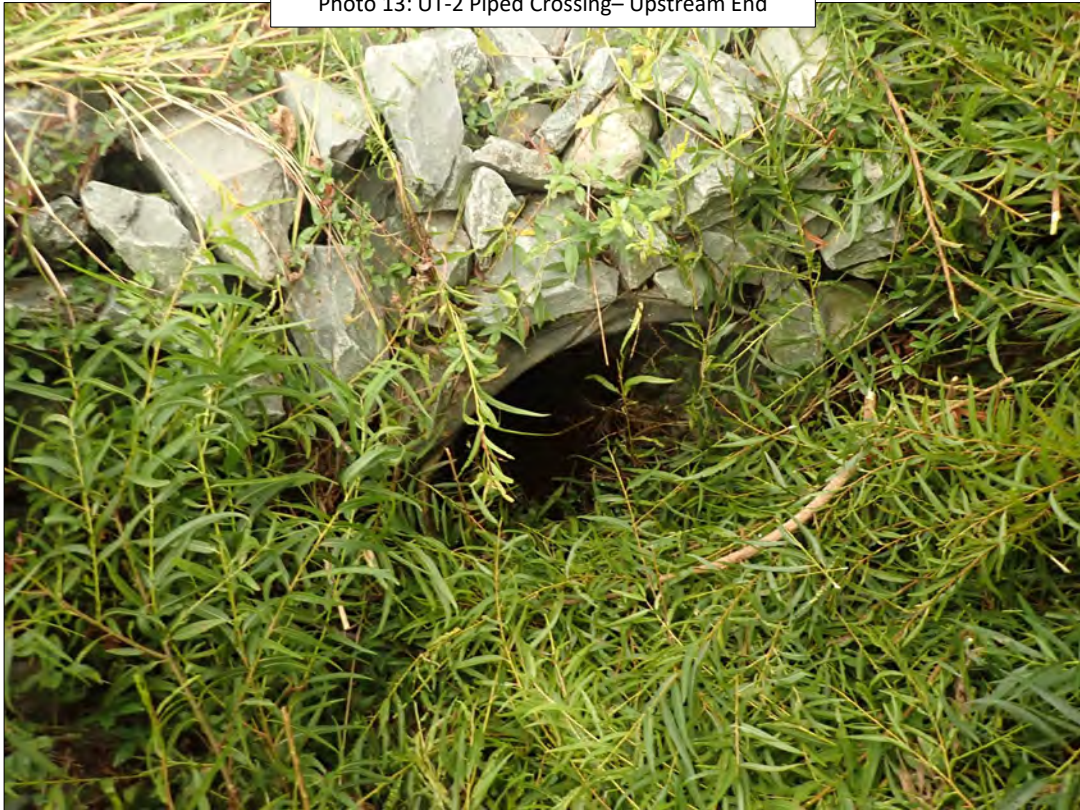
Photo 13: UT-2 Piped Crossing– Upstream End
