Silas Creek Stream Restoration Project Year 1 Monitoring Report Winston Salem, North Carolina

North Carolina Department of Environment and Natural Resources
Ecosystem Enhancement Program

This is Year 1 of the 5-year monitoring plan for Silas Creek and Buena Vista Branch.

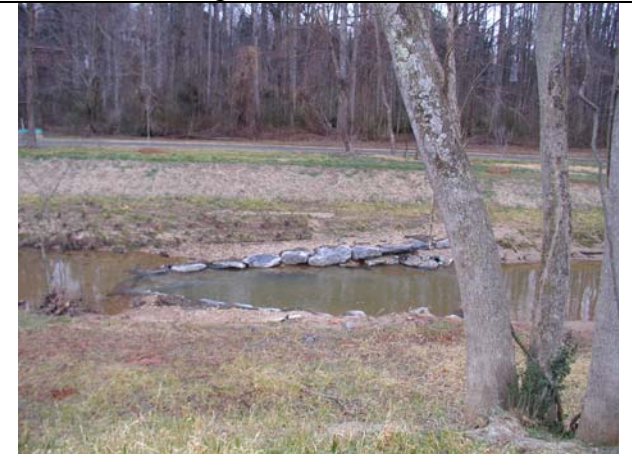
Photo 99-X8 (Left Bank)

X8 has deepened by 1.1 feet, which is consistent with the trend noted in the X5 and X7 pool locations.

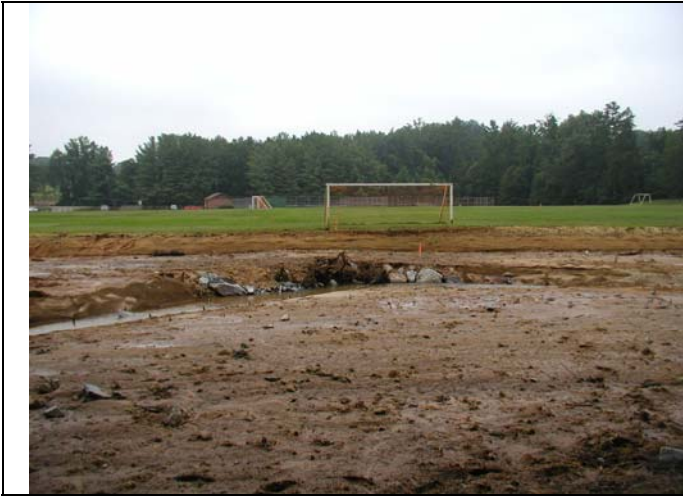
Photo 109- BVB X1 (Left Bank)

The pool cross-section (X2) is located within this upper section and is currently filling in (bankfull max depth has decreased from 3.6 feet to 2.6 feet) from the deposition. The riffle cross-section (X1) has narrowed (As-Built conditions measured 16.6 feet while 2004 results indicated 15.0 feet) and bankfull max depth has decreased slightly by 0.2 feet. Other than the excessive sedimentation, no signs of instability were noted throughout the reach and both cross sections are adjusting within normal parameters.

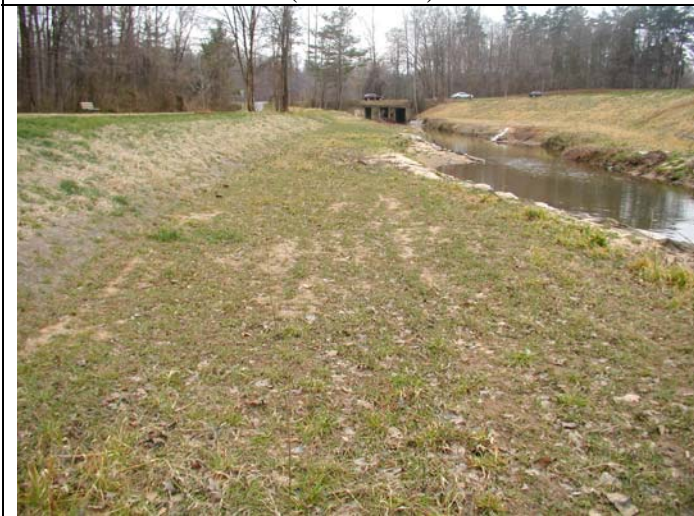
Photo 113- Vegetation Plot 1 (Silas Creek) looking downstream

Live stake survival within the Silas Creek vegetation monitoring plot indicated a 14% mortality rate (61 out of 71 live stakes were located). Visual inspection of Silas Creek generally suggested similar survival rates or higher. Bare root survival was extremely low within the monitoring plot. Only 7 out of 37 stems were found alive, representing an 81% mortality rate. Bare root survival appeared higher along most sections of the reach than in the monitoring plot but survival was still low. In most cases, the bare root planting was not found, indicating the plant had been washed away either alive or dead. Herbaceous cover within the vegetation monitoring plot was established on the floodplain benches but was nearly bare on the upper terrace slopes. The primary species established included Switchgrass (*Panicum virgatum*) and Soft Rush (*Juncus effusus*) which are expected to continue to spread and colonize in future monitoring years. We recommend at this time bare root species be evaluated reach wide and replacements be installed for unaccounted plantings. Live stakes should be added in a few locations experiencing scour, most notably at stations 26+50 and 35+00, and grass plugs should be added to the terrace slopes.

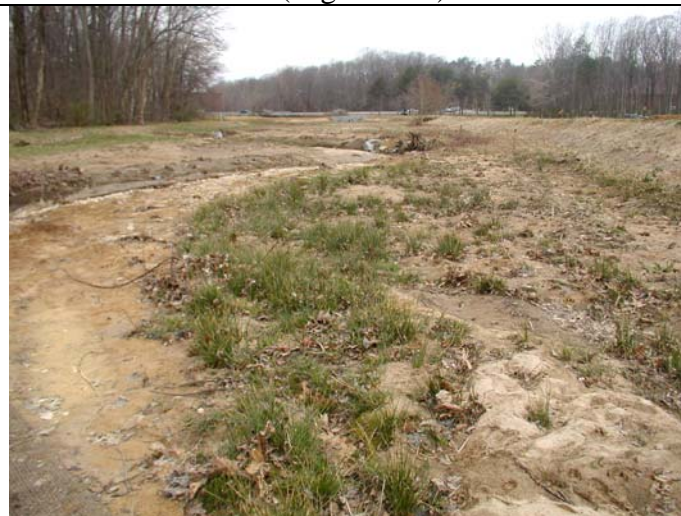
Photo 114- Vegetation Plot BV (Buena Vista Branch) looking downstream

Live stake monitoring in the Buena Vista Branch vegetation monitoring plot indicated a 16% mortality rate (38 out of 45 live stakes were located). In general, live stakes appear to be doing well within this reach and are establishing appropriate cover. Similar to Silas Creek, bare root survival was extremely low within the monitoring plot. Only 4 out of 30 stems were found alive, representing an 87% mortality rate. The vegetation monitoring plot was in the upper section of Buena Vista Branch where heavy deposition occurred. This may be responsible for some mortality but survival appeared to be low throughout the reach. In most cases, the bare root plantings were not found, indicating the plants had

been washed away either alive or dead. Herbaceous cover within the vegetation monitoring plot was established on the floodplain benches and partially established on the upper terrace slopes. The primary species established included Switchgrass (*Panicum virgatum*) and Soft Rush (*Juncus effusus*) which are expected to continue to spread and colonize in future monitoring years. We recommend at this time that bare root species be evaluated reach wide and replacements installed for unaccounted plantings.
