**Silas Creek Stream Restoration
2006 Monitoring Report
Monitoring Year Three**

Ecosystem Enhancement Program Project Number 00335

Submitted: January 19, 2007

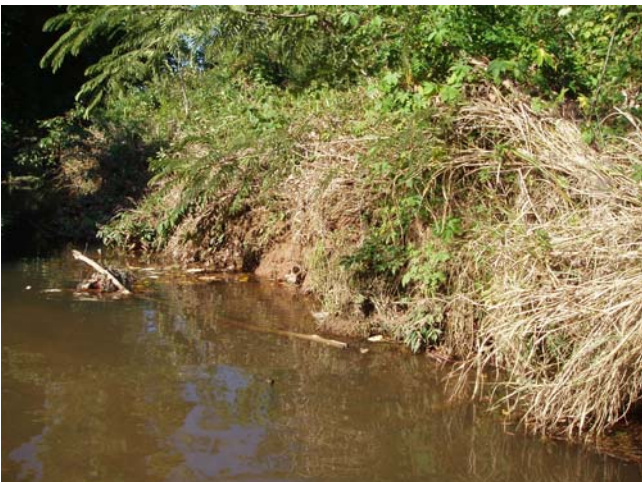
2006 Problem #	Feature Issue	Station	Suspected Cause
R3PA1	Bank erosion/Scour	33+20	Bank angle too steep
R3PA2	Bank erosion/Scour	34+50	Bank angle too steep
R3PA3	Bank erosion/Scour	37+80 to 38+10	Bank angle too steep
