**Silas Creek Stream Restoration  
Final 2007 Monitoring Report  
Monitoring Year Four**

**Ecosystem Enhancement Program Project Number 00335**

Submitted: February 22, 2008

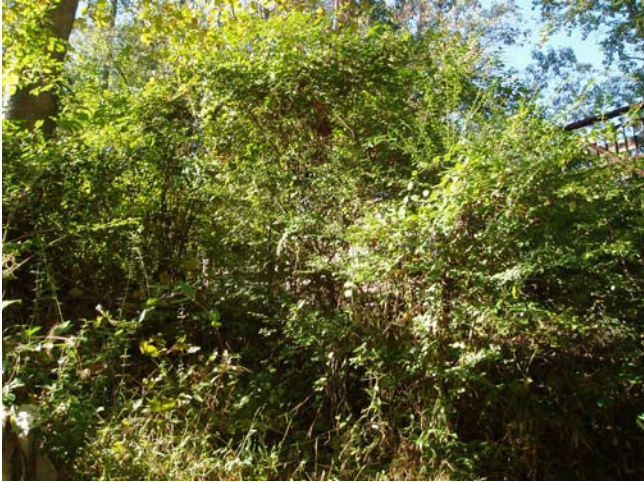
R1VPA1, R1VPA2

Vegetative Problem Areas – Reach 1			
Silas Creek 00335			
2006 Problem #	Feature/Issue	Station #/Range	Probable Cause
R1VPA1	Invasive population	11+10	Privet, honeysuckle, rose
R1VPA2	Invasive population	11+50	Privet, honeysuckle, rose
R1VPA3	Invasive population	13+00	Bamboo
R1VPA4	Invasive population	13+00	Mimosa
R1VPA5	Bare Slope	13+80	Herbaceous veg. not established
R1VPA6	Bare Slope	13+90	Herbaceous veg. not established
R1VPA7	Bare Slope	17+10	Herbaceous veg. not established
R1VPA8	Invasive population	19+50	Japanese knotweed, honeysuckle

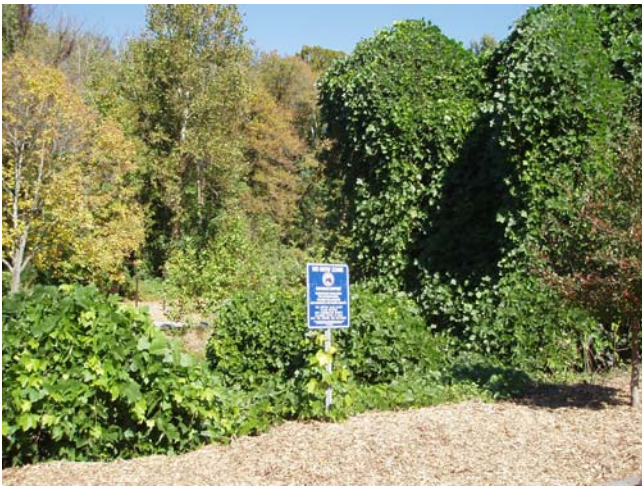
Vegetative Problem Areas – Reach 3 Silas Creek 00335			
2006 Problem #	Feature/Issue	Station #/Range	Probable Cause
R3VPA1	Invasive population	33+80 to 34+80	Kudzu
R3VPA2	Invasive population	39+00	Mimosa
R3VPA3	Invasive population	39+00	Rose
R3VPA4	Invasive population	33+90 to 34+80	Mimosa
R3VPA5	Bare bank	42+50	No woody vegetation
R3VPA6	Bare bank	44+00	No woody vegetation

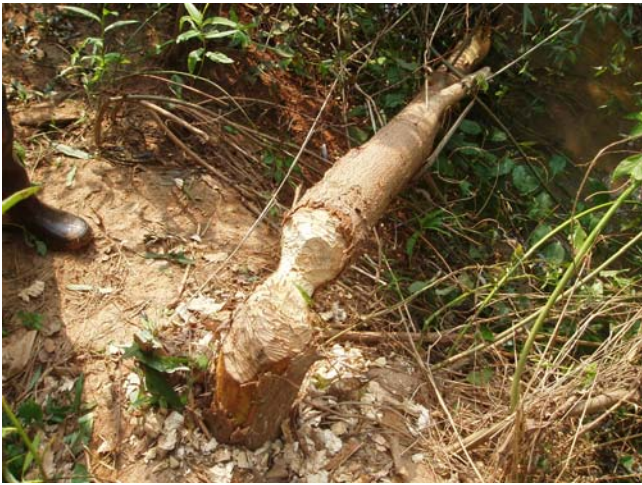
BVNVPA1

Planted vegetation along Buena Vista Branch has been impacted by the presence of beavers. Two large beaver dams were observed along the reach (one damaged, the other in-tact). Beaver activity is evident along the entirety of the upstream portions of Buena Vista Branch. Beaver are taking both planted and non-planted stems for use in dams.

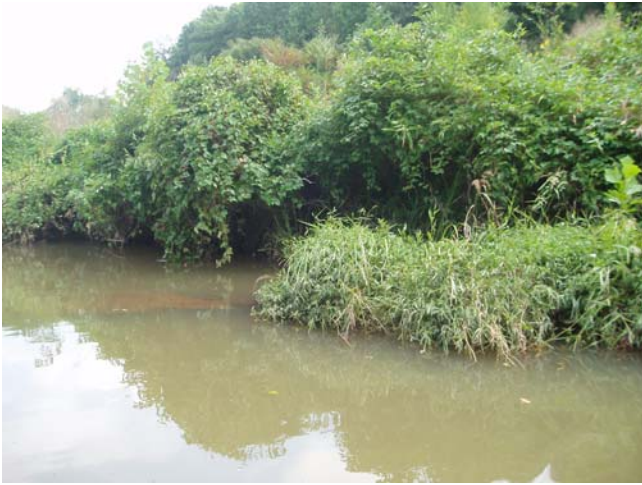
Problem #	Feature Issue	Station	Suspected Cause
R1PA1	Vane failure	10+00	Improper design and/or construction
R1PA2	Bar formation/Aggradation	10+70	Inability to transport sediment
R1PA3	Vane erosion/failure	14+10	Improper design and/or construction
R1PA4	Bar formation/Aggradation	14+10	Inability to transport sediment
R1PA5	Vane failure	16+80	Improper design and/or construction

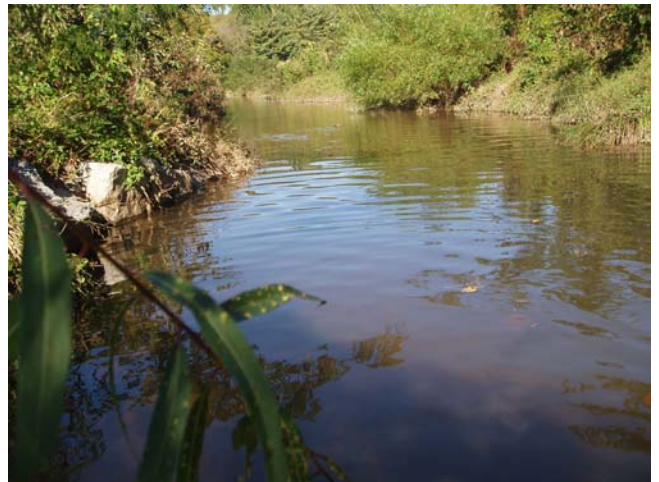
<b>Table B1b. Stream Problem Areas – Reach 2</b>			
<b>Silas Creek</b>			
<b>EEP Project Number 00335</b>			
<b>Feature Issue</b>	<b>Station</b>	<b>Suspected Cause</b>	<b>Photo #</b>
Bank erosion/scour	20+00	Bank angle too steep	R2PA1
Vane failure	20+10	Channel downcutting	R2PA2
Debris collection	20+00	Box bridge blocking debris movement	R2PA3
Vane failure	23+50	Channel downcutting	R2PA4
Vane failure	24+00	Channel downcutting	R2PA5
Vane failure	24+40	Channel downcutting	R2PA6
Structure failure	25+00 to 25+50	Channel downcutting	R2PA7
Bank erosion/scour	25+10	Bank angle too steep	R2PA8
Bank erosion/scour, turbidity	25+80	Confluence with Buena Vista Branch	R2PA9
Vane failure	26+30	Channel downcutting	R2PA10
Vane failure	27+50	Channel downcutting	R2PA11

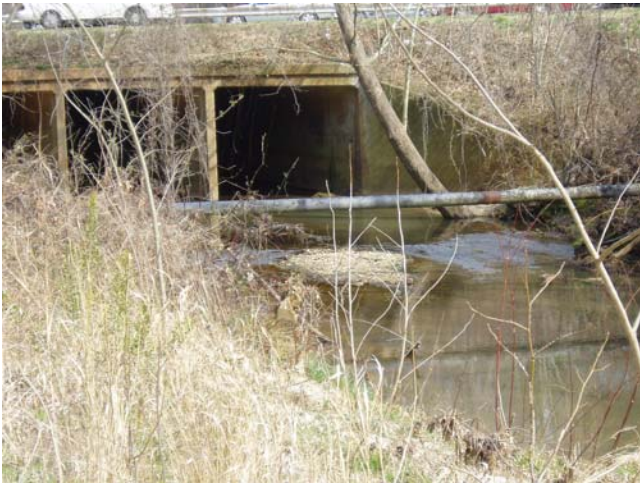
<b>Table B1c. Stream Problem Areas – Reach 3</b>			
<b>Silas Creek</b>			
<b>EEP Project Number 00335</b>			
<b>Feature Issue</b>	<b>Station</b>	<b>Suspected Cause</b>	<b>Photo #</b>
Bar formation/Aggradation	30+80	Inability to transport sediment	R3PA1
Bank erosion/Scour	33+20	Bank angle too steep	R3PA2
Bank erosion/Scour	34+50	Bank angle too steep	R3PA3
Bar formation/Aggradation	37+05	Inability to transport sediment	R3PA4
Bank erosion/Scour	37+80 to 38+10	Bank angle too steep	R3PA5
Bank erosion/scour	38+70	Bank angle too steep	R3PA6
Bank erosion/scour	40+70	Bank angle too steep	R3PA7
Bank erosion/scour	41+30	Bank angle too steep	R3PA8
Vane failure	41+00	Channel downcutting	R3PA9
Bank sloughing	42+00	Bank angle too steep	R3PA10
Bank erosion/scour	43+80	Bank angle too steep	R3PA11

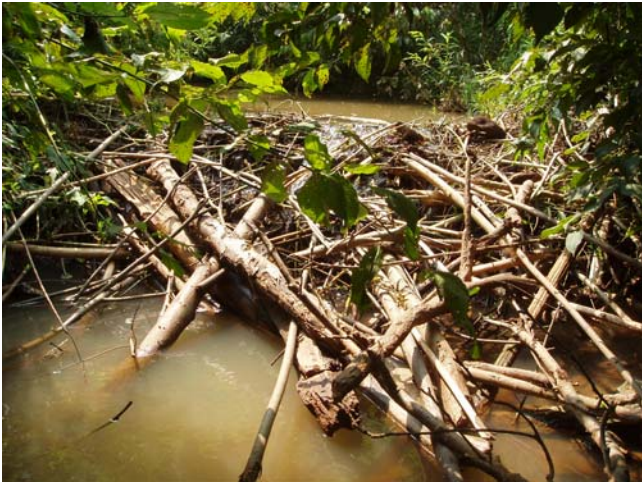
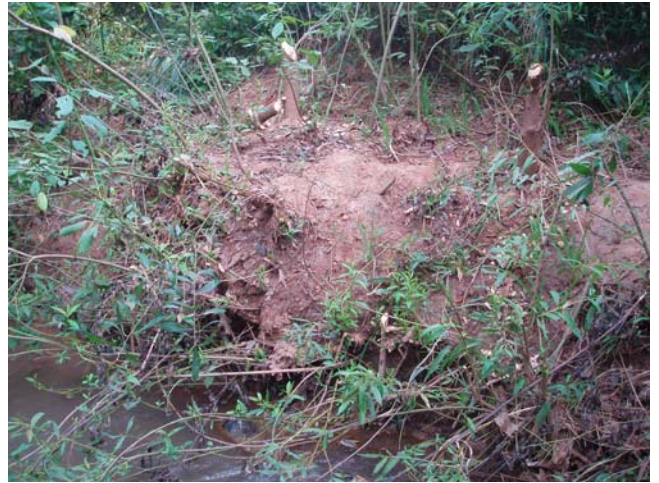
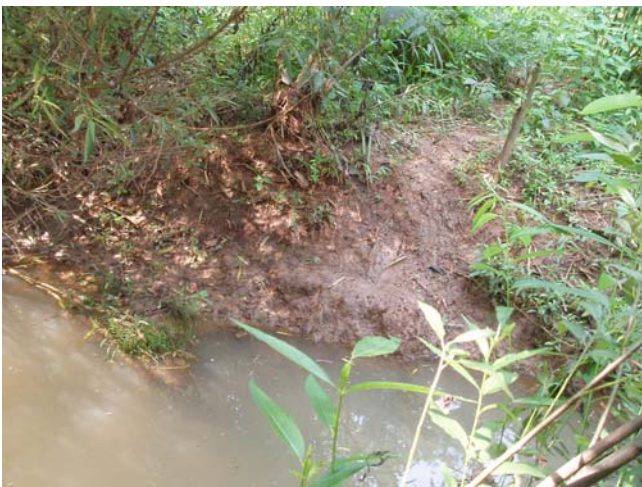
Stream Problem Areas – Buena Vista Branch			
Silas Creek 00335			
Problem #	Feature Issue	Station	Suspected Cause
BVPA1	Channel widening, deepening,	10+00 to 15+00	Beaver presence
BVPA2	Sedimentation on banks	10+00 to 15+00	Beaver dam downstream
BVPA3	Bank erosion	11+10	Improper design and/or construction
BVPA4	Bank erosion	12+50	Bank angle too steep
BVPA5	Bar formation/Aggradation	13+30	Inability to transport sediment
BVPA6	Bar formation/Aggradation	16+00	Inability to transport sediment

<b>Table B1d. Stream Problem Areas – Buena Vista Branch Silas Creek EEP Project Number 00335</b>			
<b>Feature Issue</b>	<b>Station</b>	<b>Suspected Cause</b>	<b>Photo #</b>
Channel widening, deepening, beaver slides	10+00 to 15+00	Beaver presence (dam presence)	BVPA1
Sedimentation on banks	10+00 to 15+00	Beaver dam downstream	BVPA2
Bank erosion	11+10	Improper design and/or construction	BVPA3
Bank erosion	12+50	Bank angle too steep	BVPA4
Bar formation/Aggradation	13+30	Inability to transport sediment	BVPA5
Bar formation/Aggradation	16+00	Inability to transport sediment	BVPA6
