SILVER CREEK RESTORATION PROJECT

ANNUAL MONITORING REPORT FOR 2008 (YEAR 3)

Project Number D04006-5

December 2008

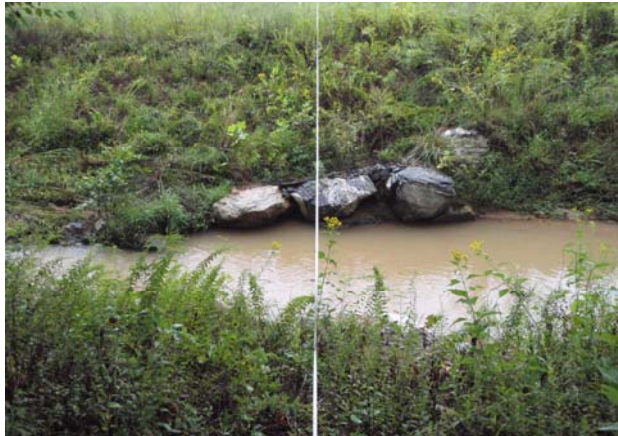
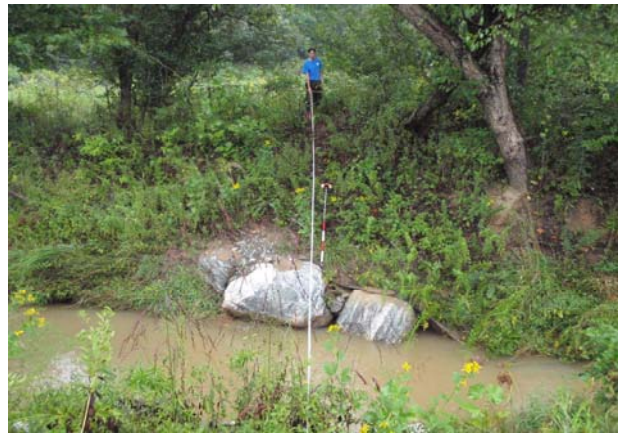
Permanent Cross-section #13 M4

Feature	Stream Type	BKF Area	BKF Width	BKF Depth	Max BKF Depth	W/D	BH Ratio	ER	BKF Elev	TOB Elev
Pool		49.1	12.72	3.86	4.82	3.29	2.1	3	1132	1137.27

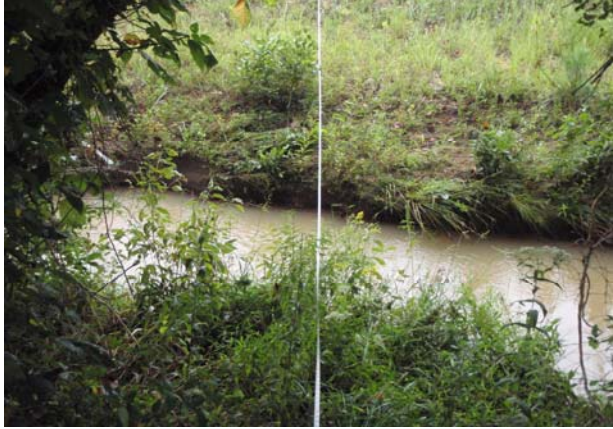
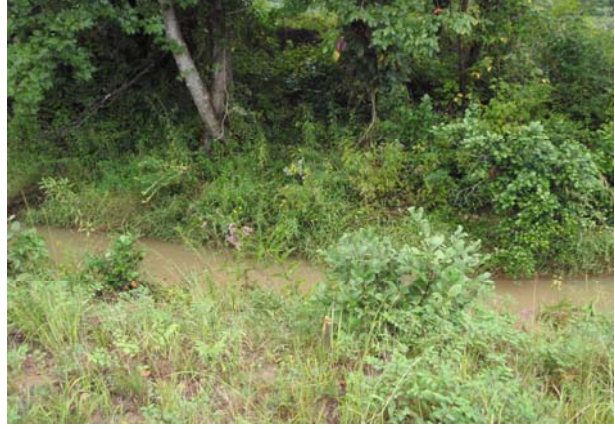
Permanent Cross-section #14 M4

Feature	Stream Type	BKF Area	BKF Width	BKF Depth	Max BKF Depth	W/D	BH Ratio	ER	BKF Elev	TOB Elev
Riffle	Bc	76.3	36.43	2.09	5.29	17.39	1	1.6	1134.2	1134.2

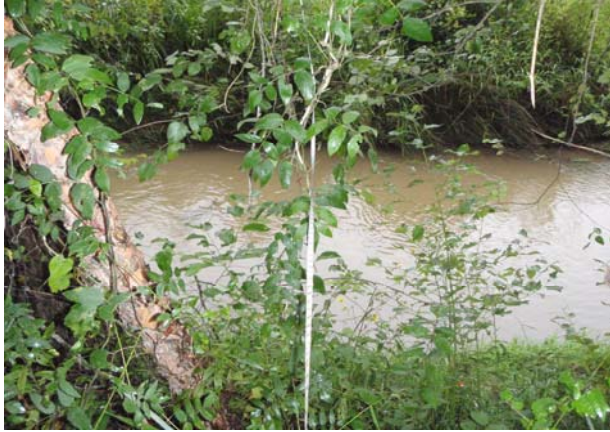
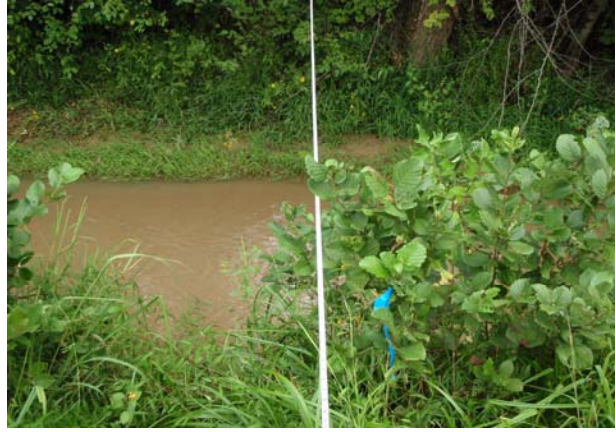
Permanent Cross-section #15 M4
 (Year 3 Data - Collected September 2008)

Feature	Stream Type	BKF Area	BKF Width	BKF Depth	Max BKF Depth	W/D	BH Ratio	ER	BKF Elev	TOB Elev
Riffle		65.8	28.18	2.33	3.74	12.07	2	1.8	1131.82	1135.44

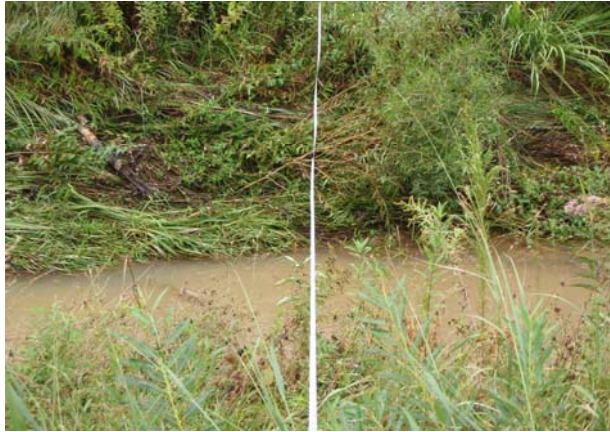
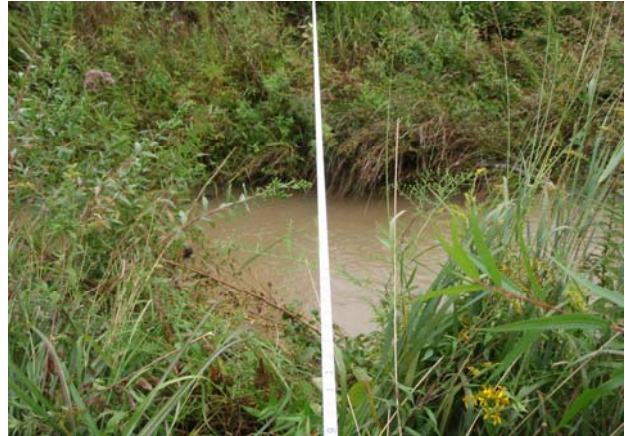
Permanent Cross-section #16 M1

Feature	Stream Type	BKF Area	BKF Width	BKF Depth	Max BKF Depth	W/D	BH Ratio	ER	BKF Elev	TOB Elev
Riffle	E	64.8	25.99	2.49	4.17	10.42	1	2.9	1144.65	1144.61

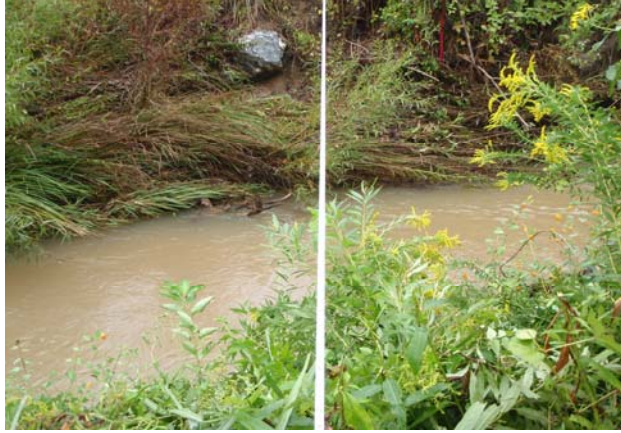
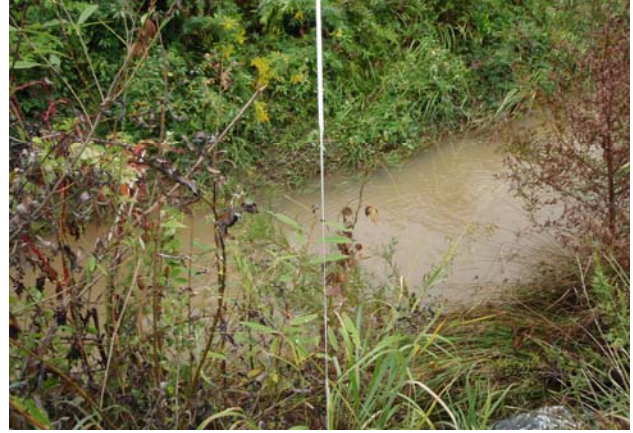
Permanent Cross-section M1 #17
 (Year 3 Data - Collected September 2008)

Feature	Stream Type	BKF Area	BKF Width	BKF Depth	Max BKF Depth	W/D	BH Ratio	ER	BKF Elev	TOB Elev
Pool		85	28.64	2.97	5.21	9.65	1.6	2	1144.03	1147.08

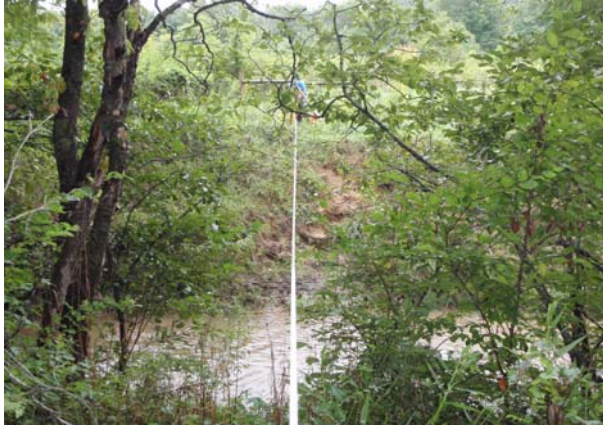
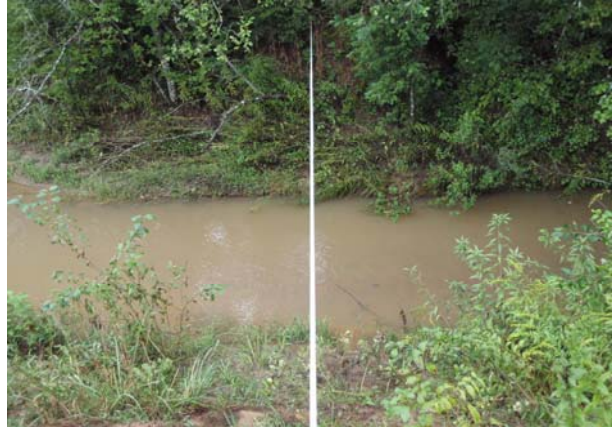
Permanent Cross-section #18 M1
 (Year 3 Data - Collected September 2008)

Feature	Stream Type	BKF Area	BKF Width	BKF Depth	Max BKF Depth	W/D	BH Ratio	ER	BKF Elev	TOB Elev
Riffle	Bc	73.7	27.35	2.7	3.96	10.15	2.3	1.5	1146.9	1152.2
