# SILVER CREEK RESTORATION PROJECT (FINAL) ANNUAL MONITORING REPORT FOR 2010 (YEAR 5)

Project Number D04006-5

**Prepared for:** EBX Neuse-I, LLC      **Prepared by:** Michael Baker Engineering, Inc.

January 2011

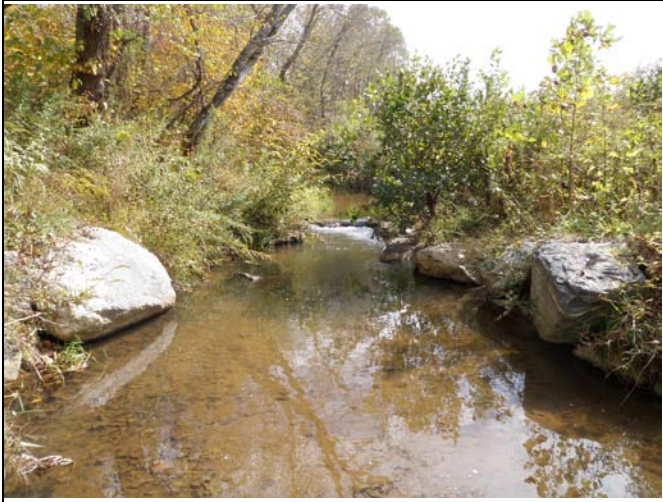
M4 Photo Point 2 – Problem cross-vane at station 66+75
