# Mitigation Plan for Stream Mitigation of Silver Creek and Unnamed Tributary

Silver Creek and Unnamed Tributary  
Burke County, NC  
SCO # D05016-1

**Submitted:** September 11, 2007

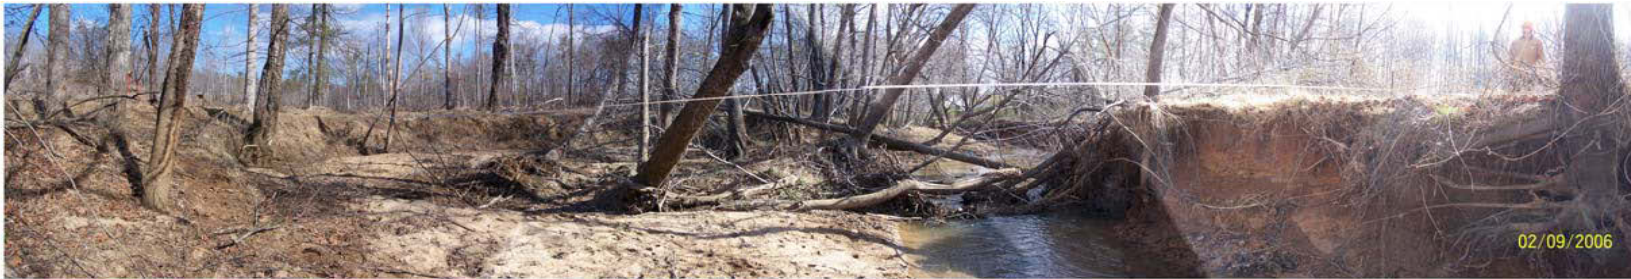
Mainstem Reach – Abandoned Oxbow – Debris Jam – Looking Downstream – Pre-Restoration

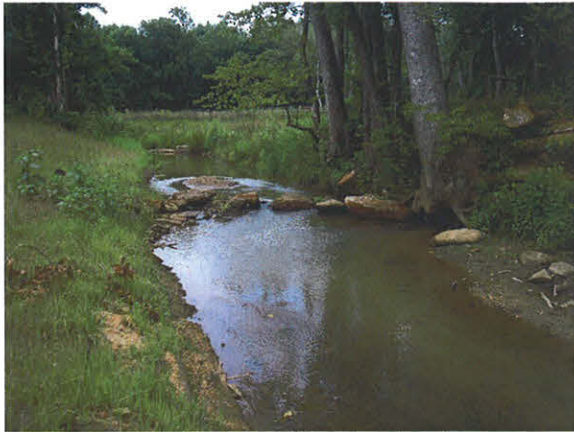
**Photograph No. 1-** J-Hook 1 Looking Upstream

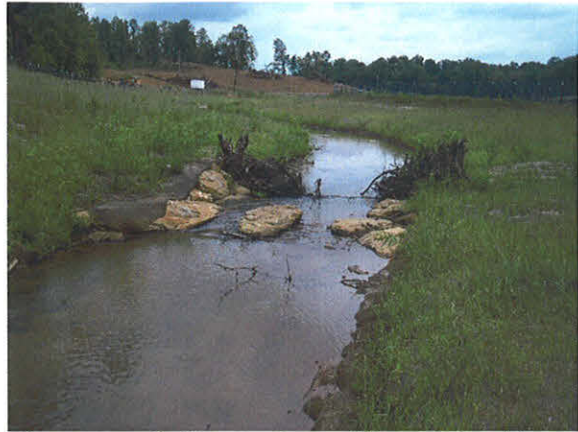
**Photograph No. 2-** Cross Vane 1 Looking Downstream

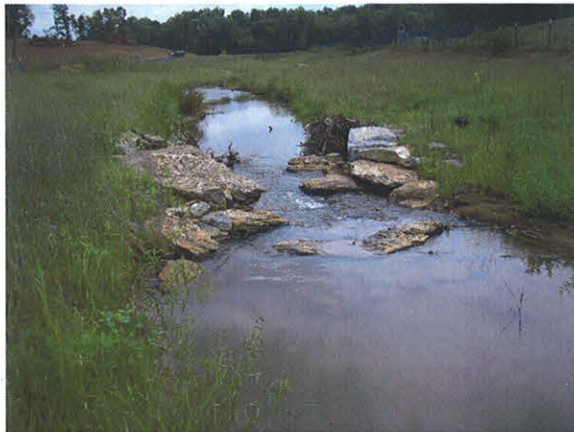
**Photograph No. 3-** Cross Vane 2 Looking Downstream

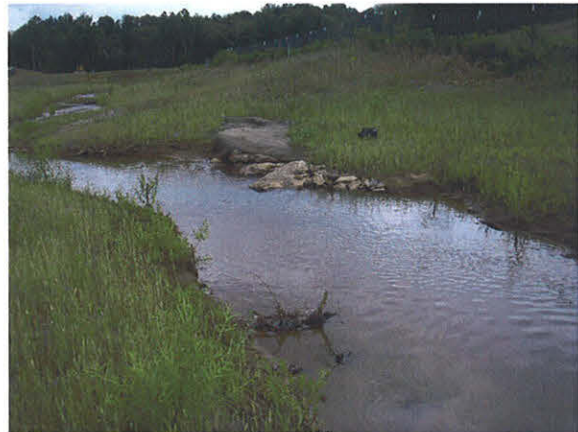
**Photograph No. 4-** Rock Vane 1 Looking Downstream
