Year 1 Monitoring Report for Stream Restoration of Silver Creek and Unnamed Tributaries

Burke County, NC
SCO # D05016-01

Submitted: January 2008

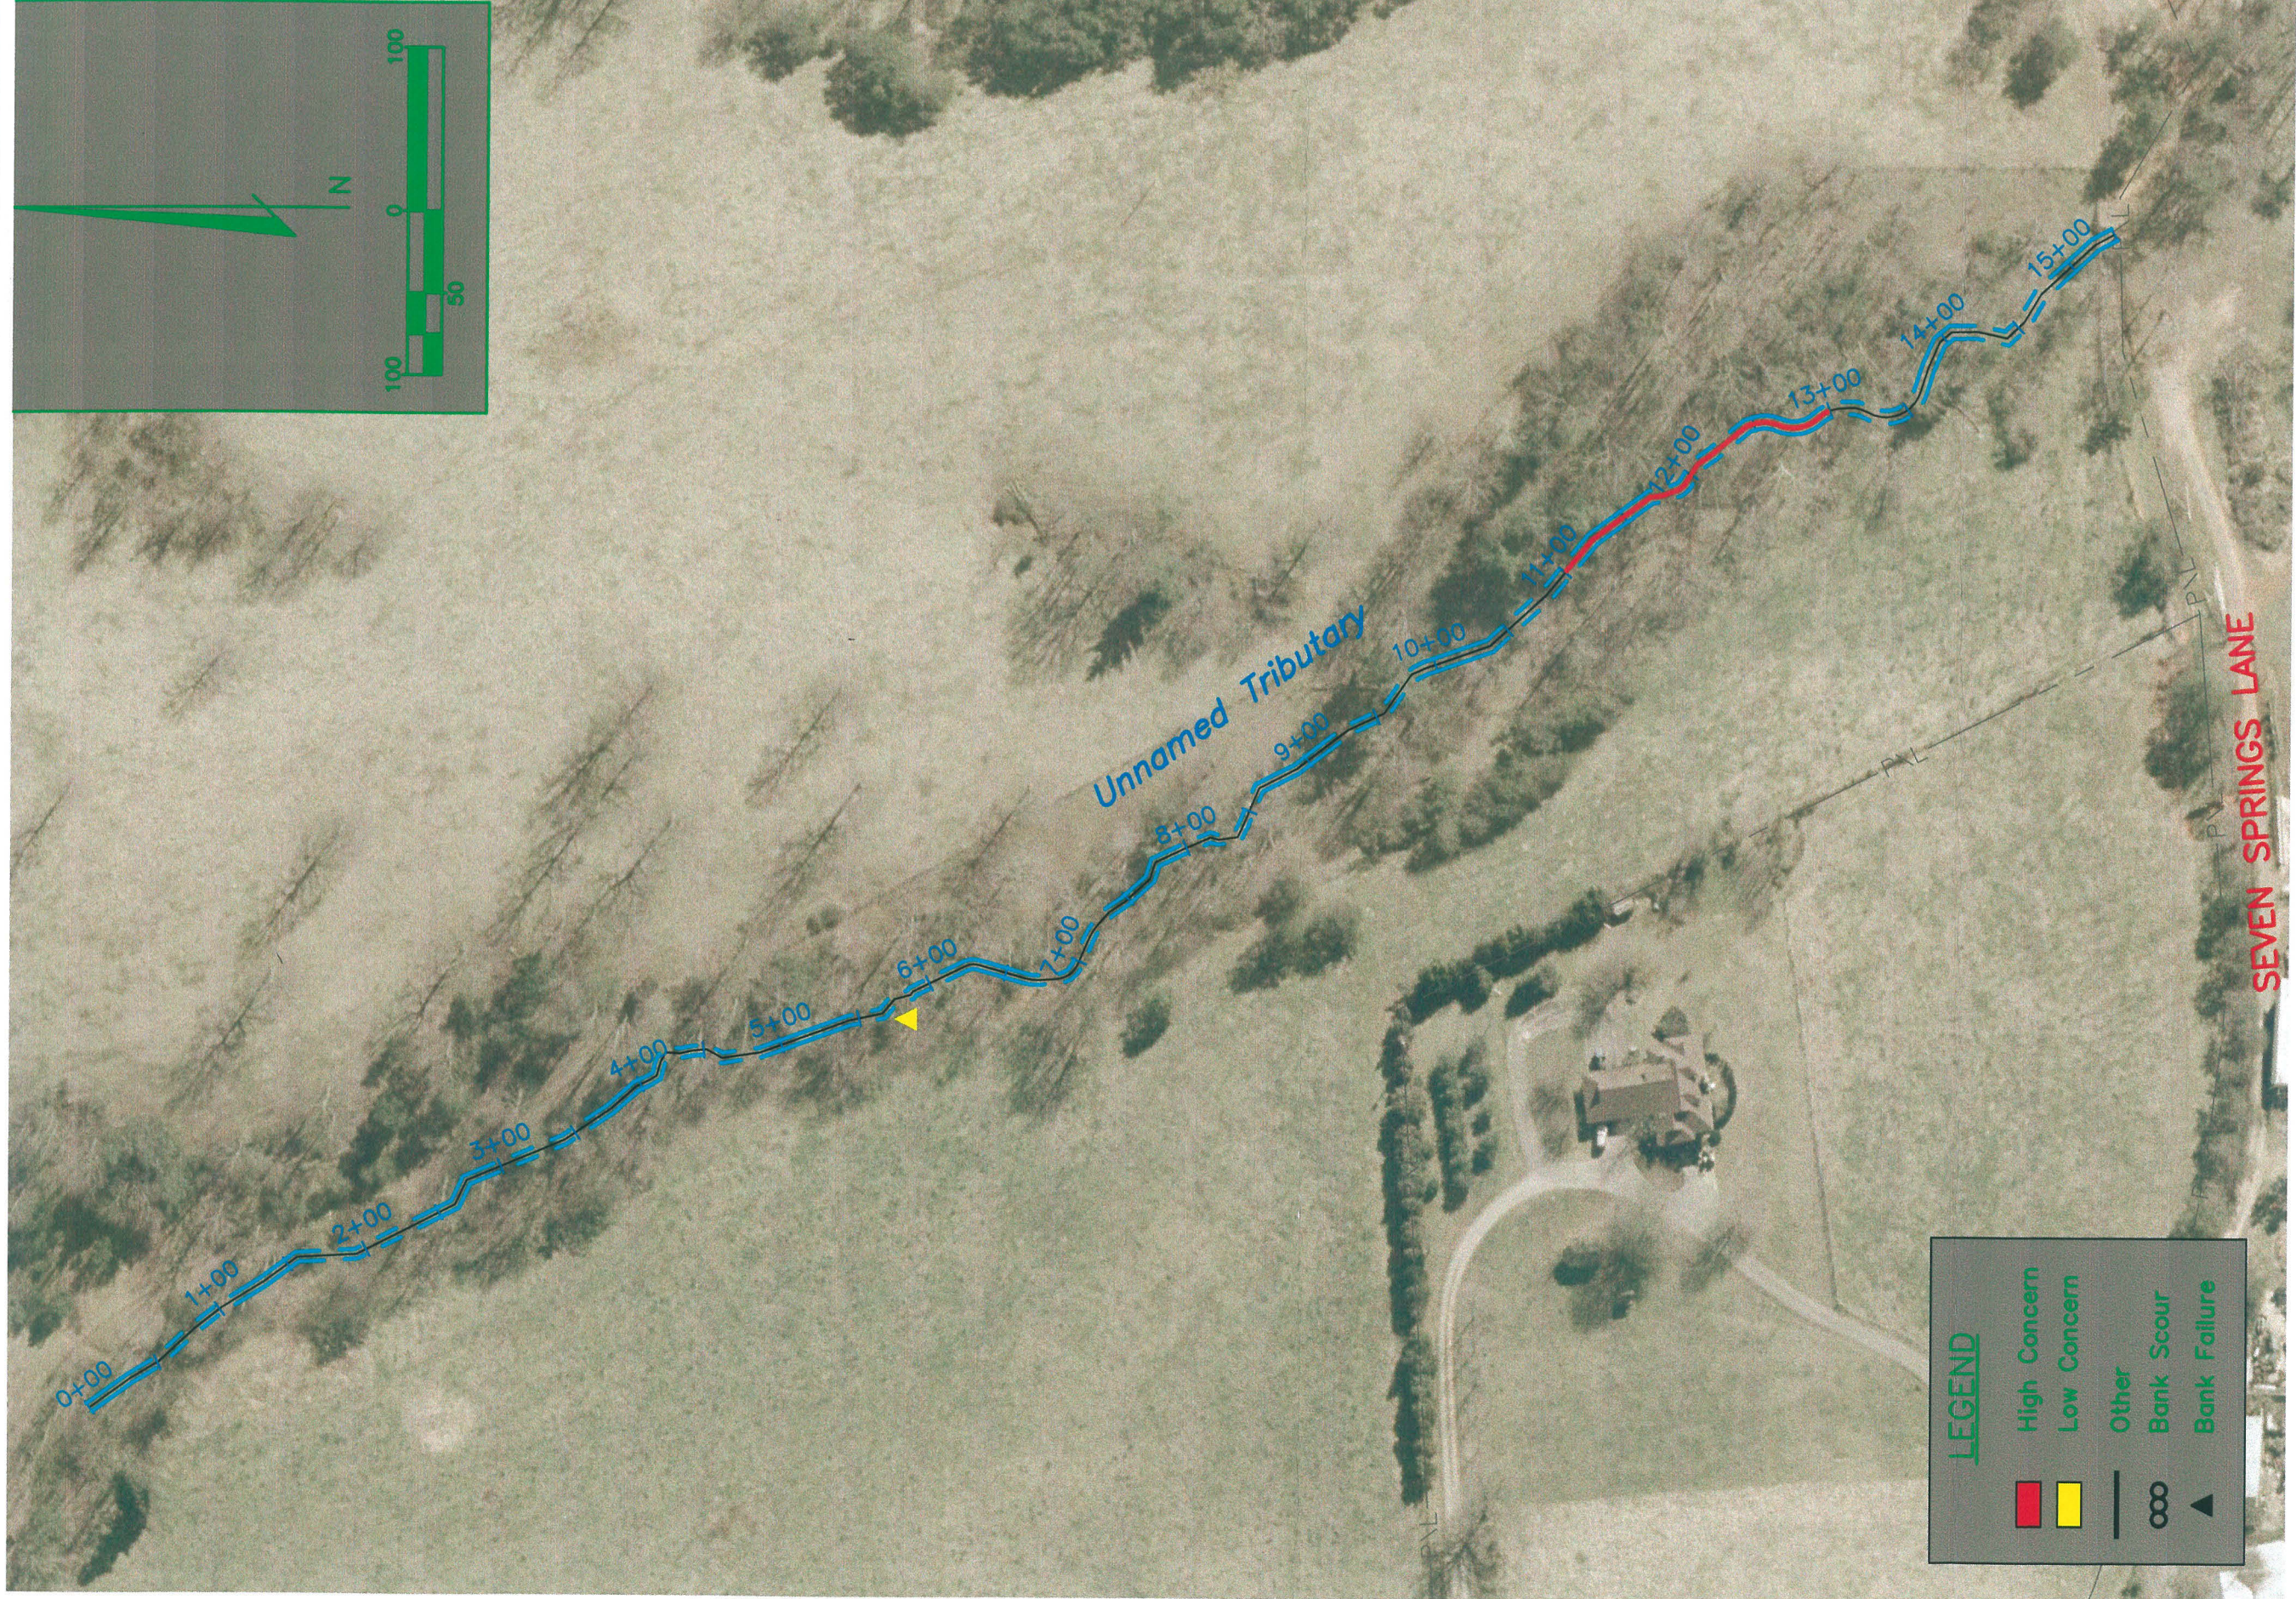
Table IX. Stream Problem Areas Silver Creek Stream Restoration / EEP Project No. D05016-1			
Feature Issue	Station Numbers	Suspected Cause	Photo Number
Stressed/failing structure	5+75 UT-A	Natural log sill - concern for long-term stability	SPA 1
Other	11+00 - 13+00 UT-A	Nearly vertical banks - need to be stabilized with matting and vegetation	SPA 2

Areas of instability were not observed along the Silver Creek Mainstem. On UT-A, a natural log sill was preserved during construction; the long-term stability of this feature was a noted concern during a site visit with the EEP. This structure will be monitored to further assess stream stability in this area. An additional area of concern exists along UT-A concerning the steep slopes of the stream banks. These banks are in need of reshaping to decrease the slopes and need revegetating to further enhance stability, as requested by EEP. Erosion control matting should be applied to protect the stream banks along this stream segment while vegetation is reestablished.
