Year 2 Monitoring Report for Stream Restoration of Silver Creek and Unnamed Tributaries

Burke County, NC
SCO # D05016-01

Submitted: December 2008

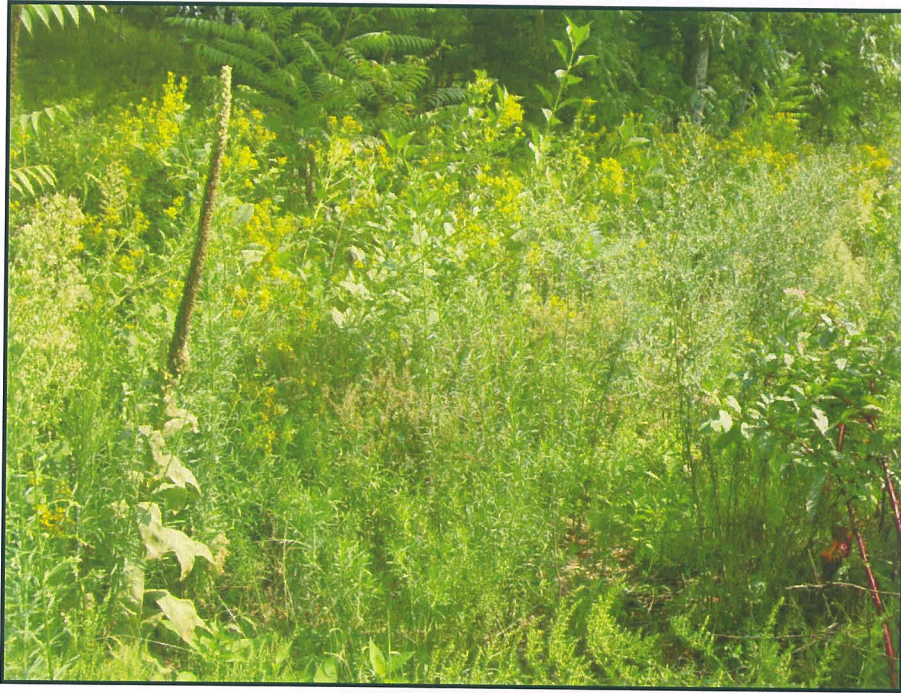
**Vegetation Plot 1 on Tributary A
Monitoring Year 2
(EMH&T, September 8, 2008)**

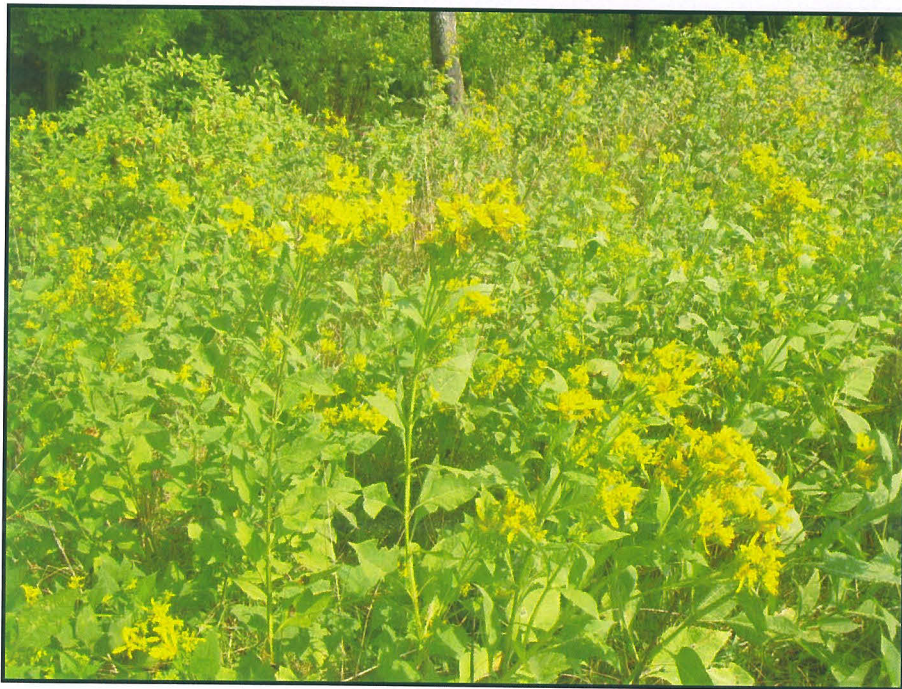
**Vegetation Plot 2 on Tributary A
Monitoring Year 2
(EMH&T, September 8, 2008)**

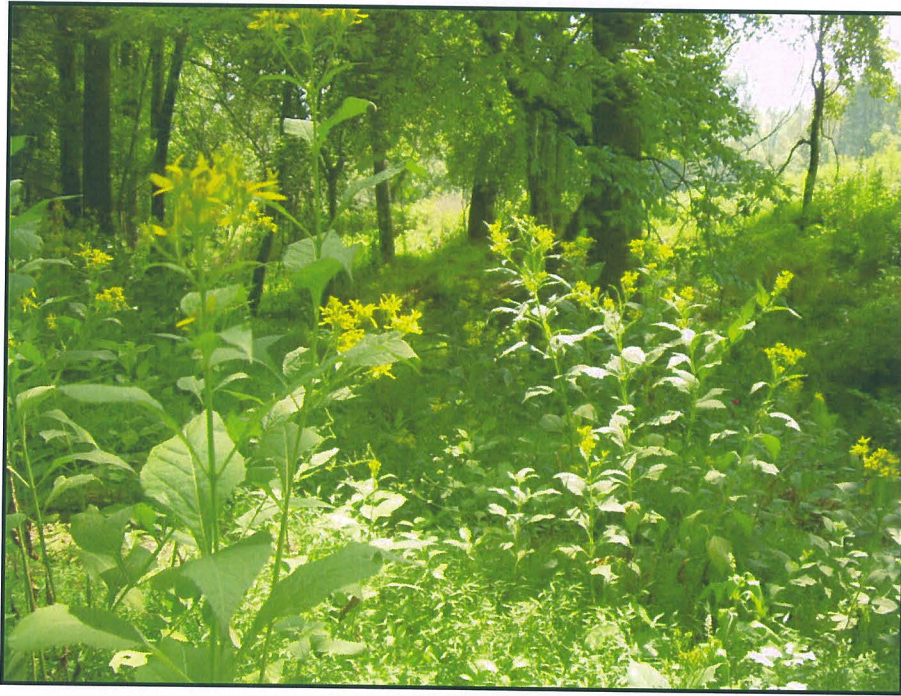
**Vegetation Plot 3 on Tributary A
Monitoring Year 2
(EMH&T, September 8, 2008)**

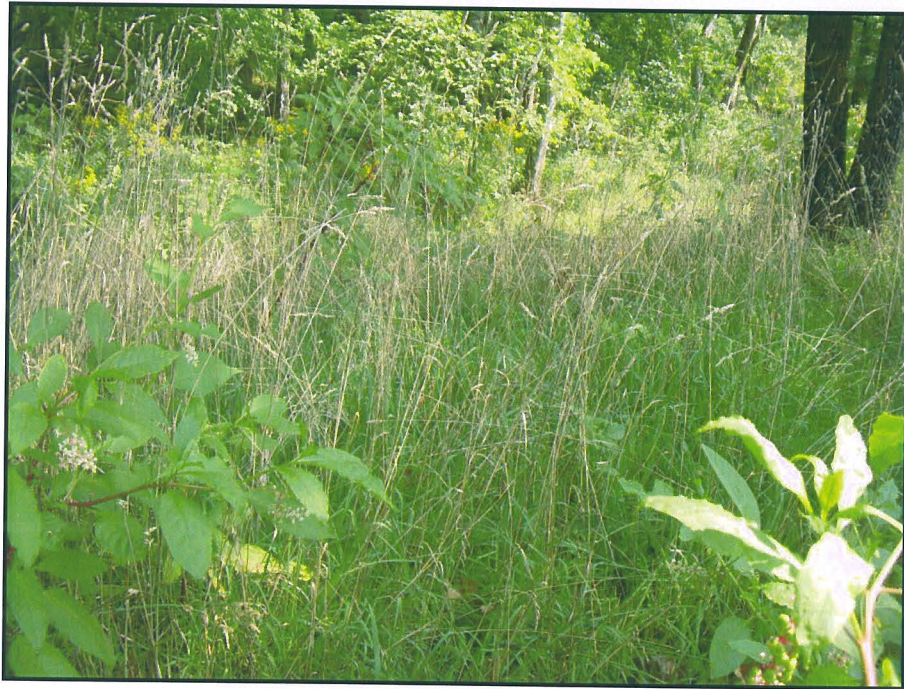
**Vegetation Plot 4 on Tributary A
Monitoring Year 2
(EMH&T, September 8, 2008)**

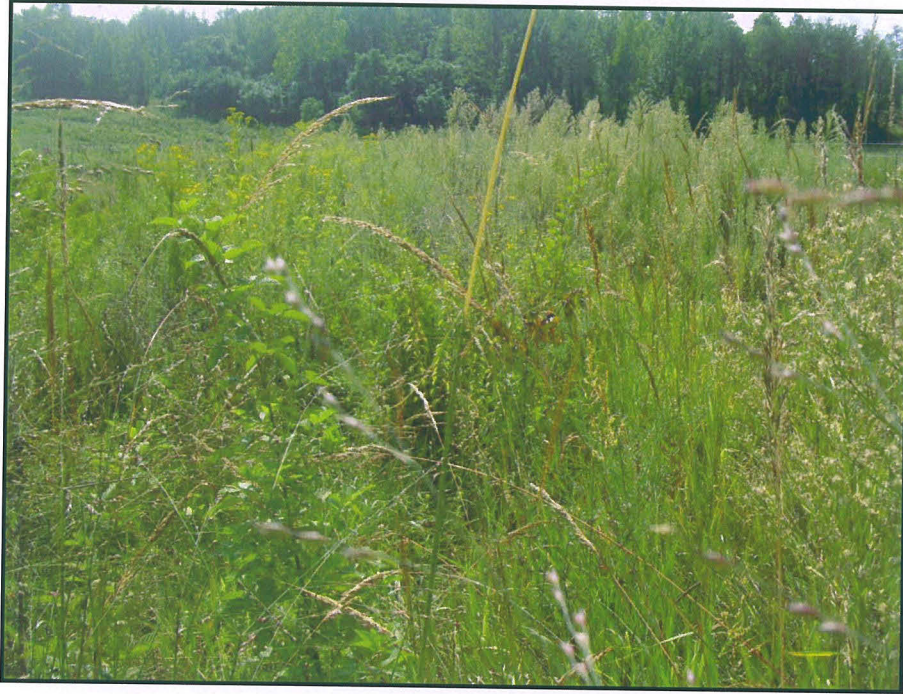
**Vegetation Plot on Tributary B
Monitoring Year 2
(EMH&T, September 8, 2008)**

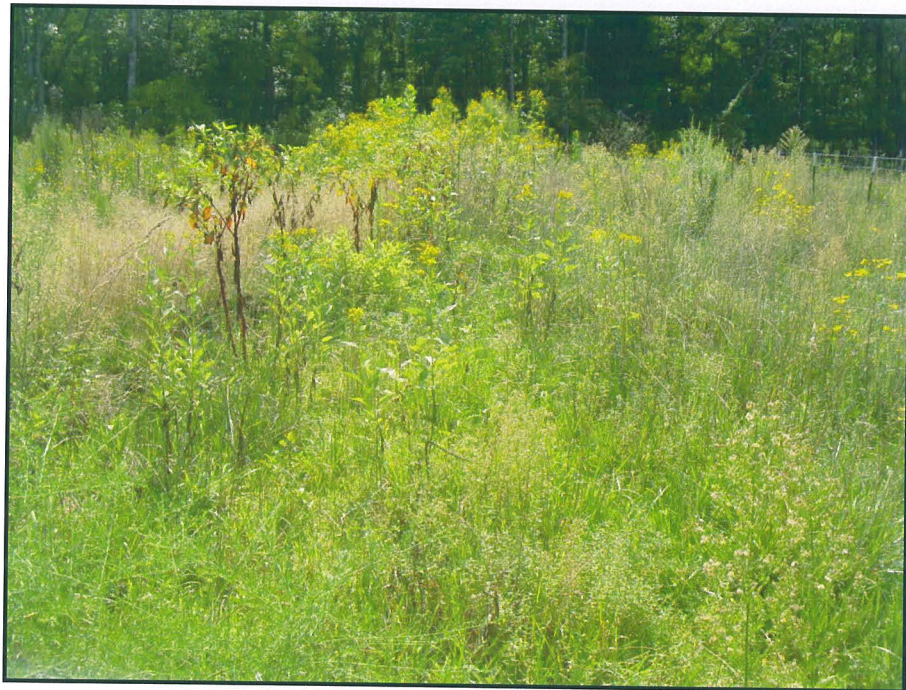
**Vegetation Plot on Tributary C
Monitoring Year 2
(EMH&T, September 8, 2008)**

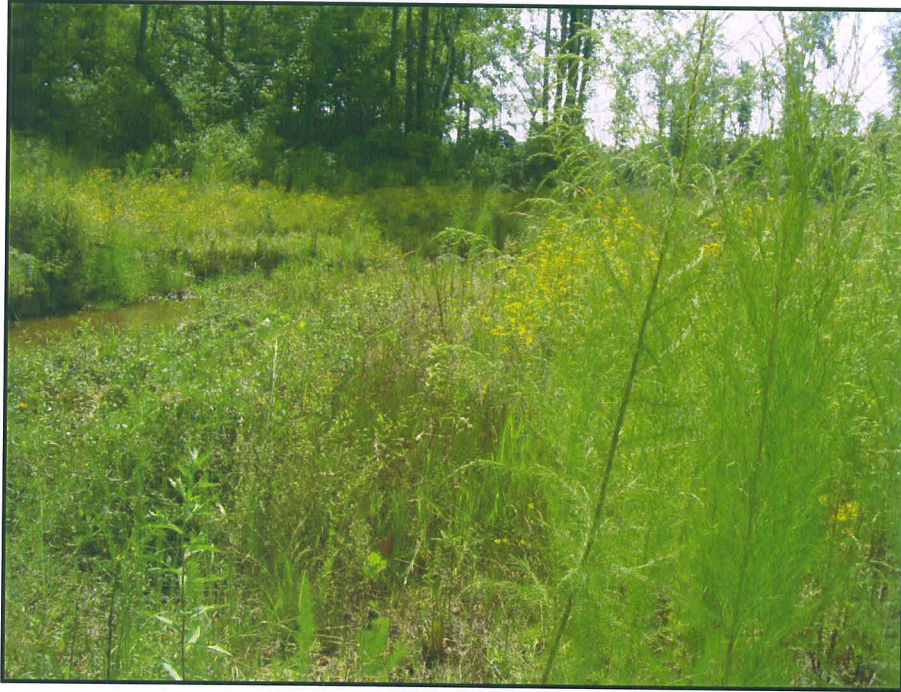
Fixed Station 1
Overview of the Silver Creek Mainstem, facing upstream near the bottom of the mainstem restored reach.
(EMH&T, September 8, 2008)

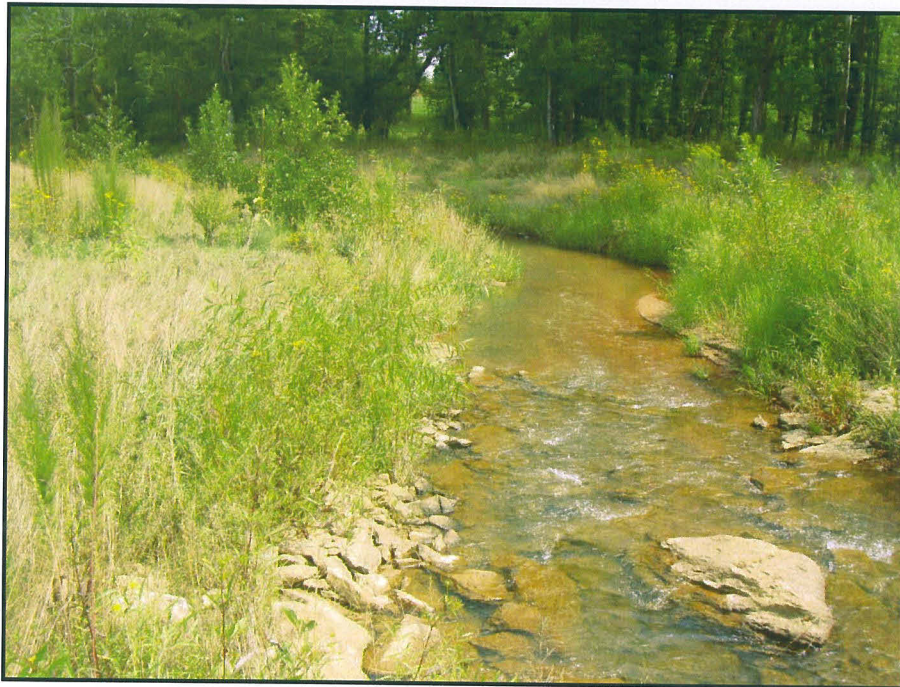
Fixed Station 2
Overview of the Silver Creek Mainstem at Riffle #3, facing downstream.
(EMH&T, September 8, 2008)

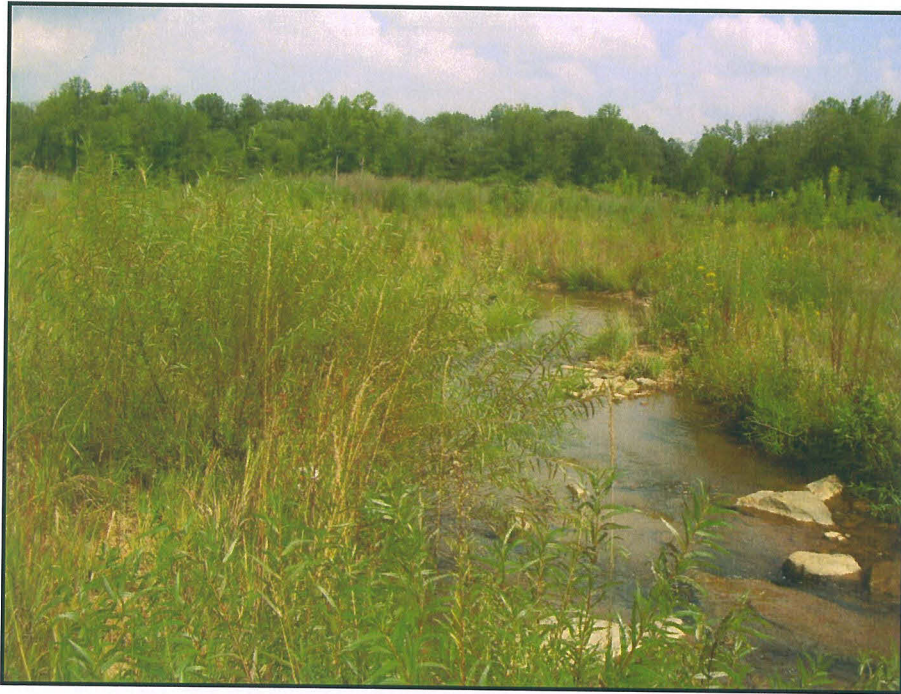
Fixed Station 3
Overview of the Silver Creek Mainstem at Riffle #1, facing downstream.
(EMH&T, September 8, 2008)

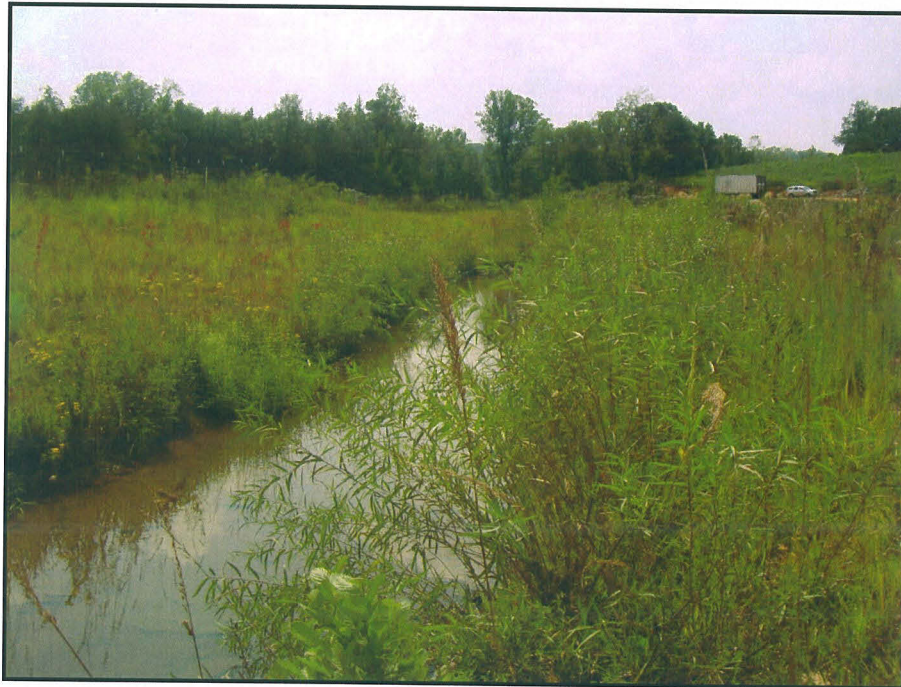
Fixed Station 4
Overview of the Silver Creek Mainstem at Riffle #1, facing upstream.
(EMH&T, September 8, 2008)

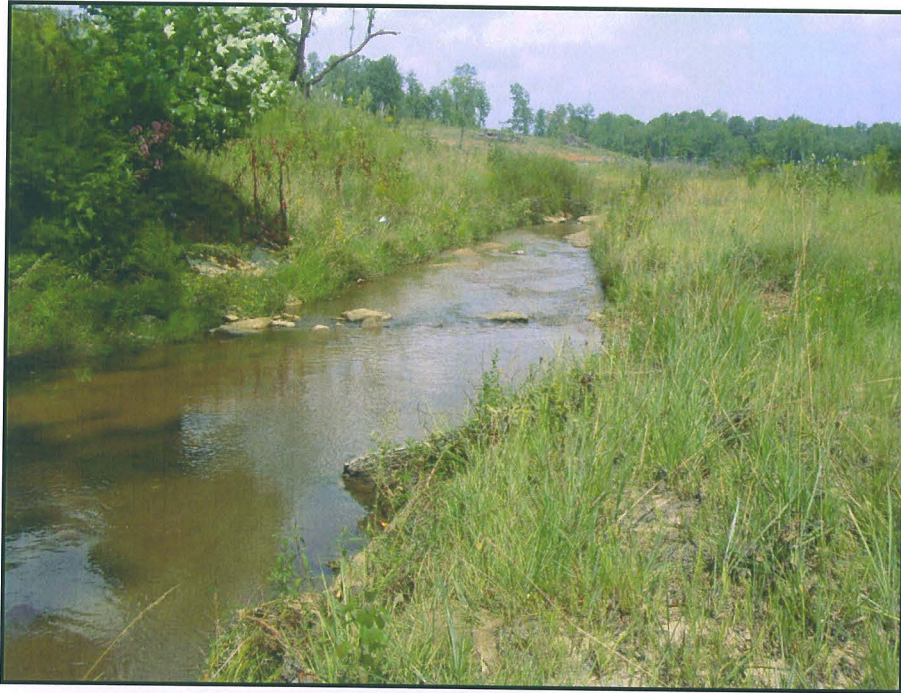
Fixed Station 5
Overview of the Silver Creek Mainstem, facing downstream near station 2+60.
(EMH&T, September 8, 2008)

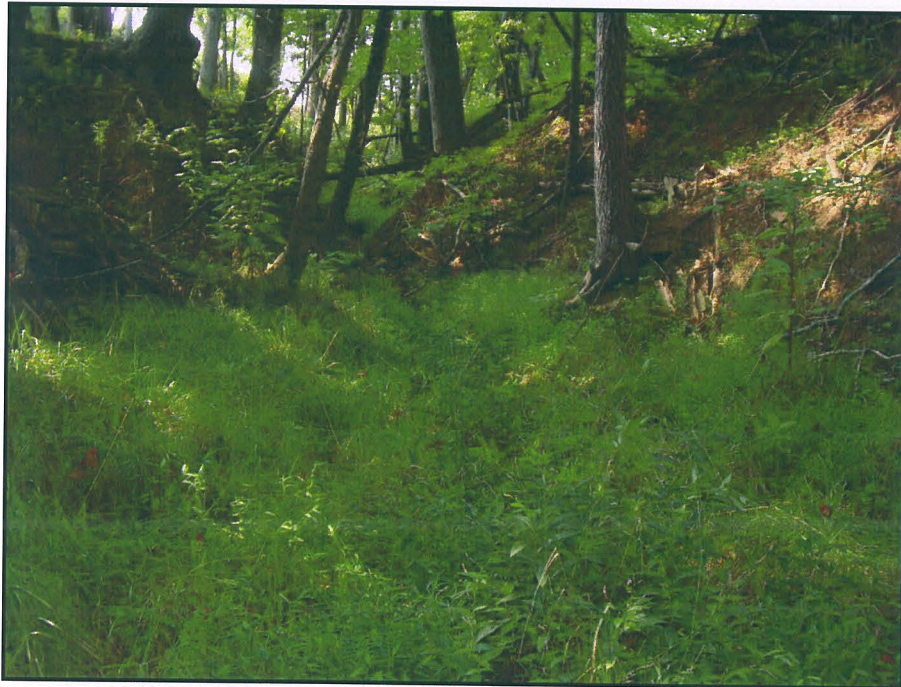
Fixed Station 6
Overview of UT-A, facing upstream near station 0+50.
(EMH&T, September 8, 2008)

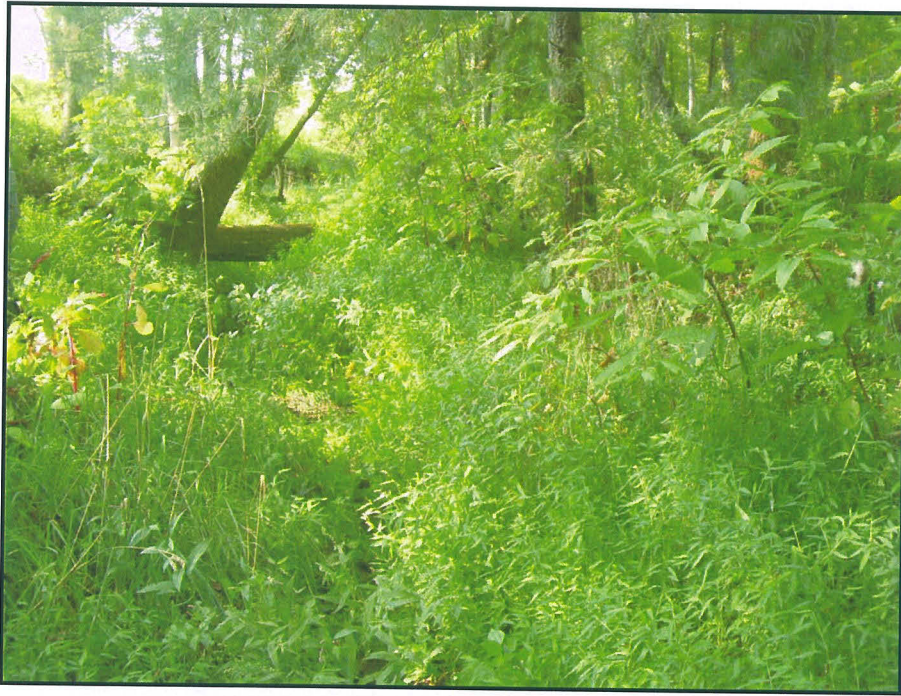
Fixed Station 7
Overview of UT-A, facing upstream near station 8+00.
(EMH&T, September 8, 2008)

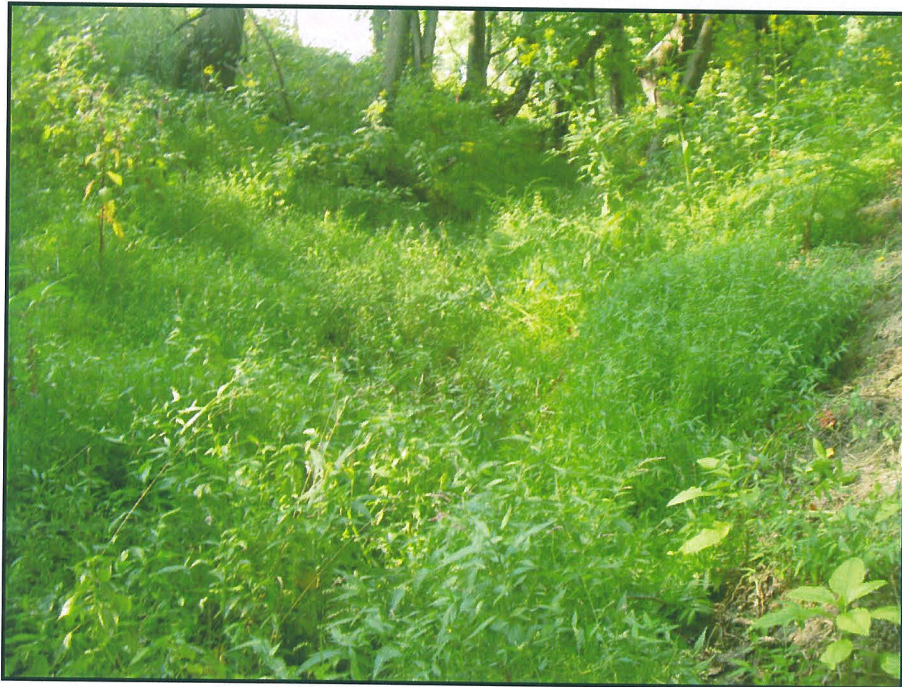
Fixed Station 8
Overview of UT-A, facing upstream near station 11+00.
(EMH&T, September 8, 2008)

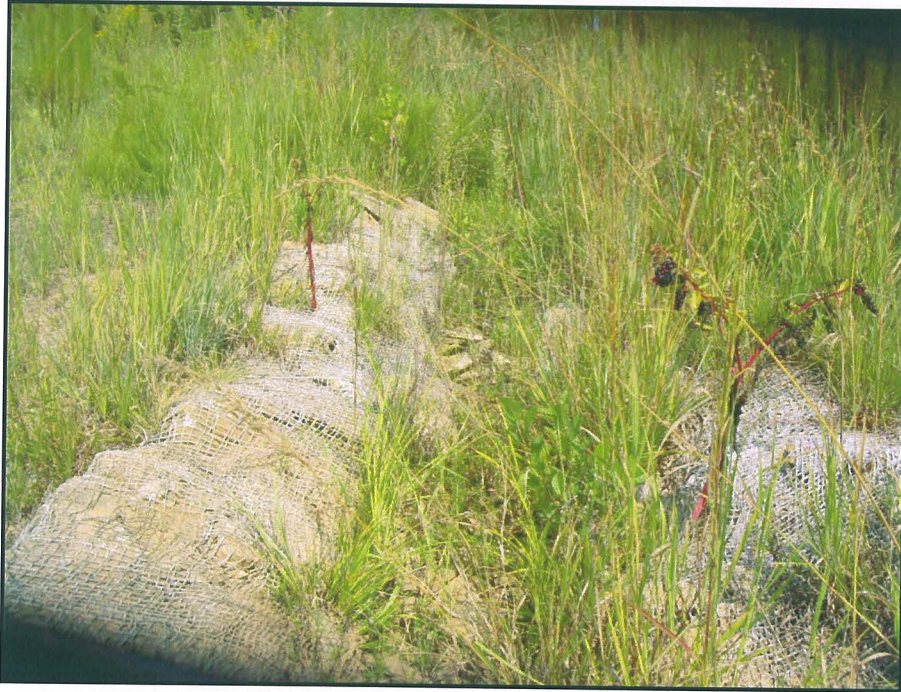
Fixed Station 9
Overview of UT-B, facing upstream from the confluence of UT-B with Silver Creek.
(EMH&T, September 8, 2008)

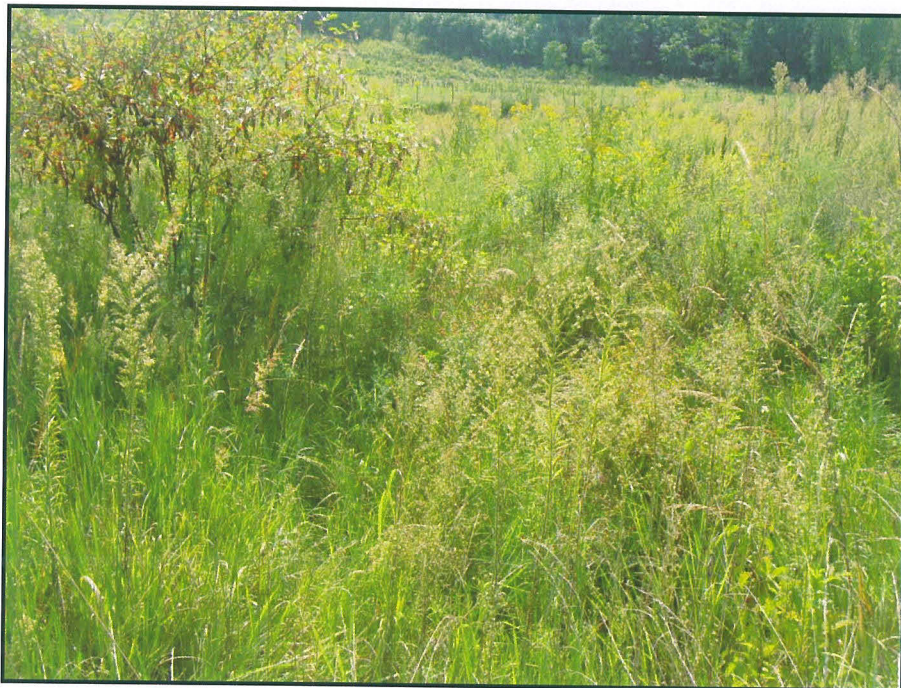
Fixed Station 10
Overview of UT-B, facing downstream towards the confluence of UT-B with Silver Creek.
(EMH&T, September 8, 2008)

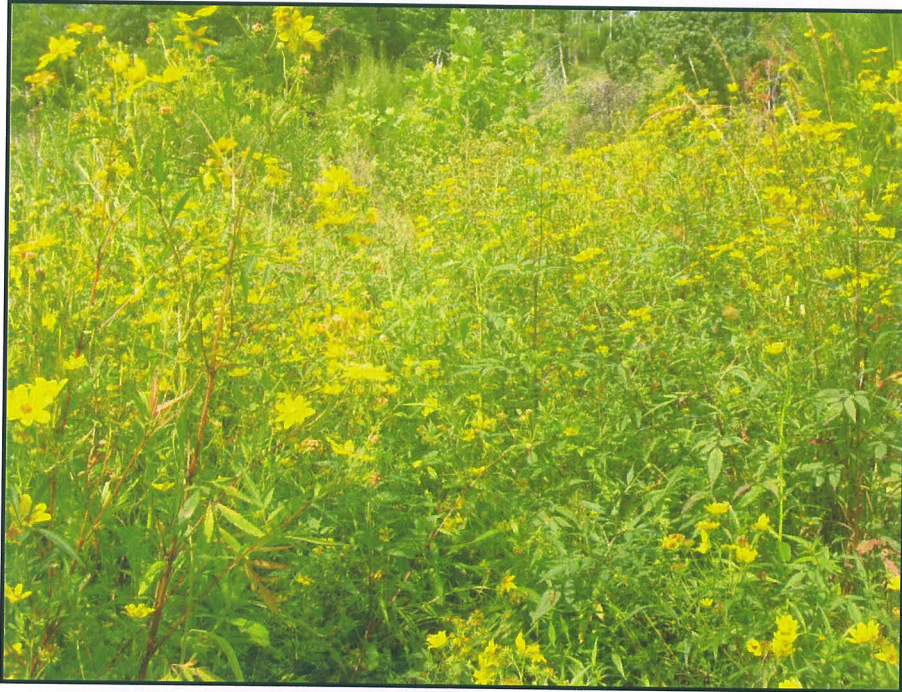
Fixed Station 11
Overview of UT-C, facing upstream from the confluence of UT-C with Silver Creek.
(EMH&T, September 8, 2008)

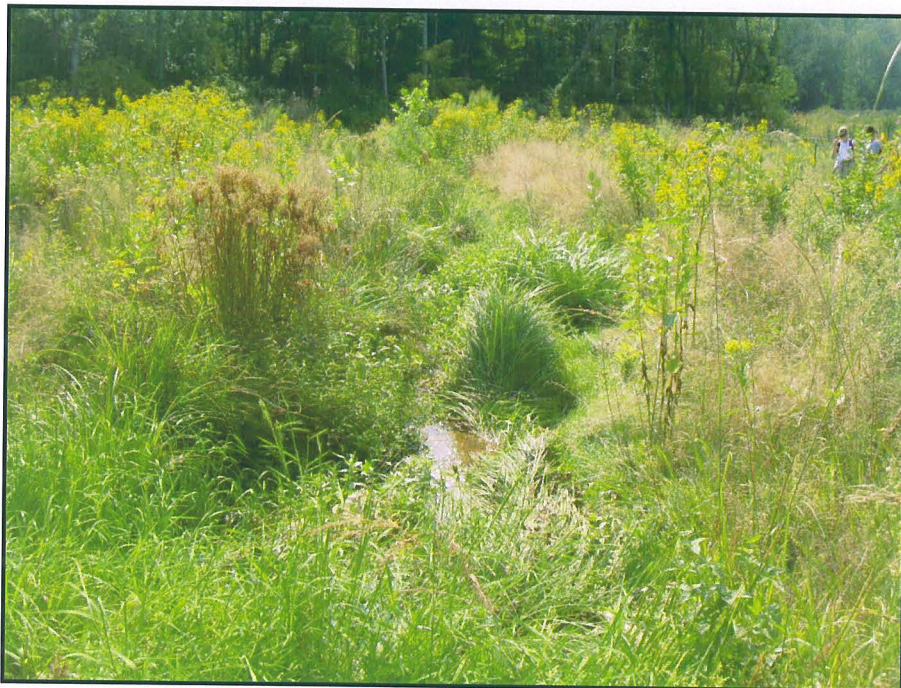
Fixed Station 12
Overview of UT-C, facing downstream towards the confluence of UT-C with Silver Creek.
(EMH&T, September 8, 2008)

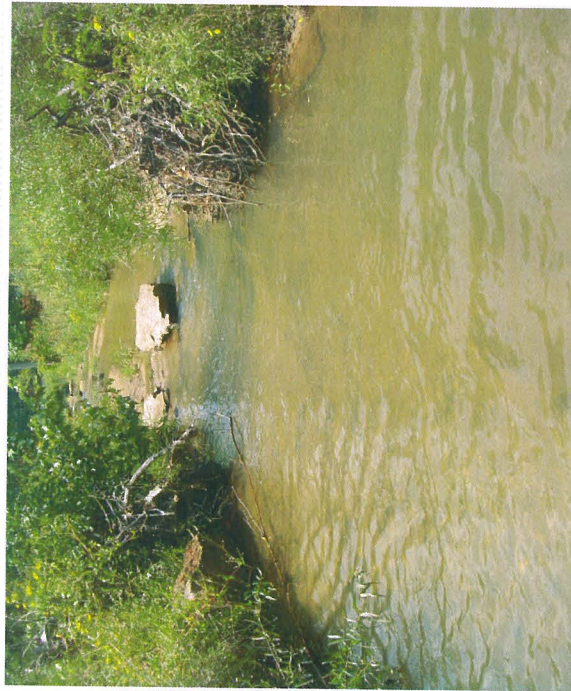
Pool at Cross Vane # 1

Pool Cross-Section 2, looking upstream
 (September 8, 2008)

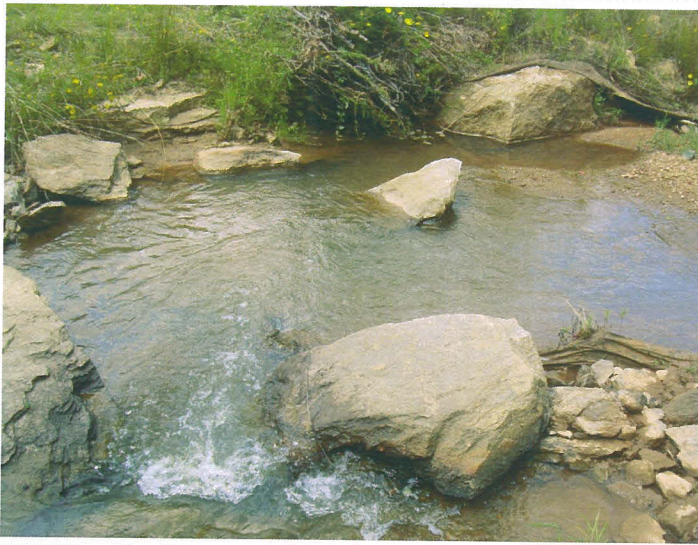
CROSS SECTION: 6
FEATURE: Pool at J-Hook # 8

Pool Cross-Section 6, from right to left across channel (September 8, 2008)

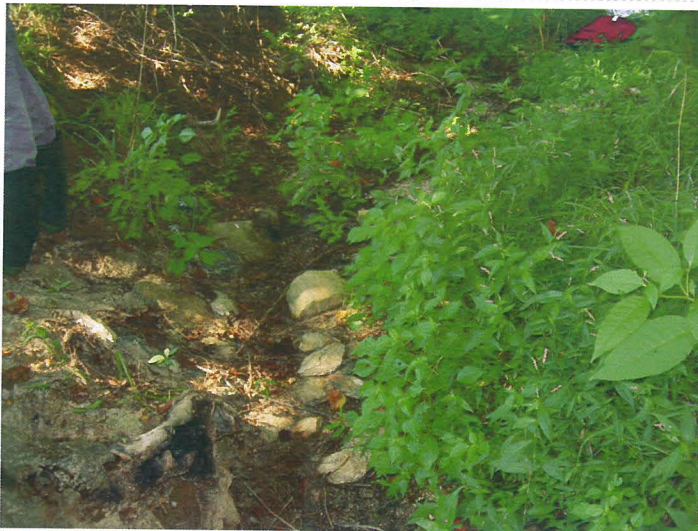
CROSS SECTION: 1
FEATURE: Riffle

UTA Cross-Section 1, looking upstream
(September 8, 2008)

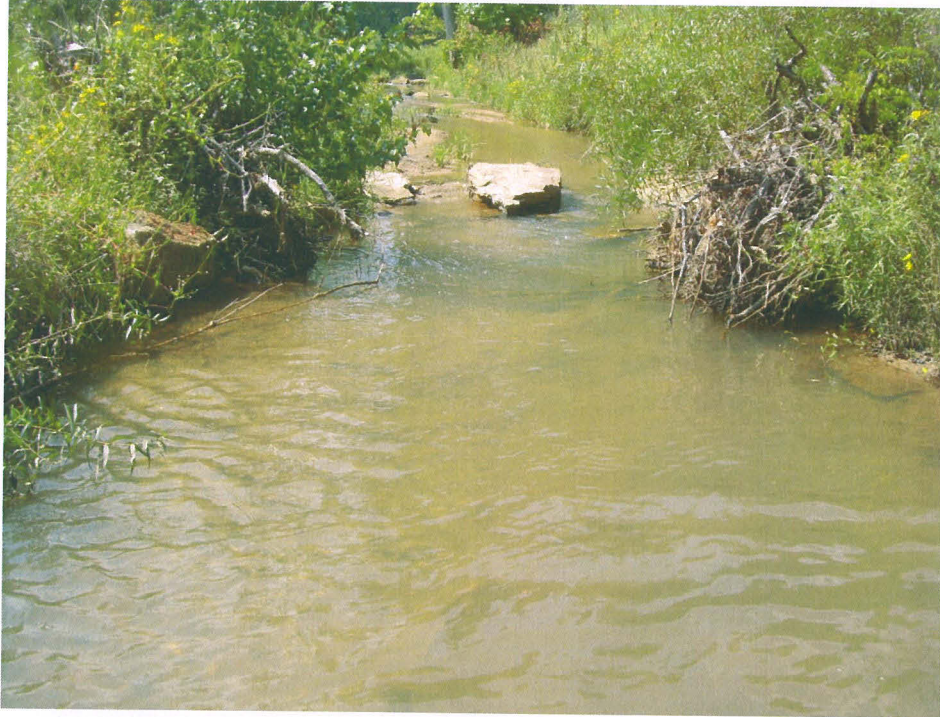
Pool Cross-Section 2, looking upstream (September 8, 2008)
