Year 3 Monitoring Report for Stream Restoration of Silver Creek and Unnamed Tributaries

Burke County, NC
SCO # D05016-01

Submitted: December 2009

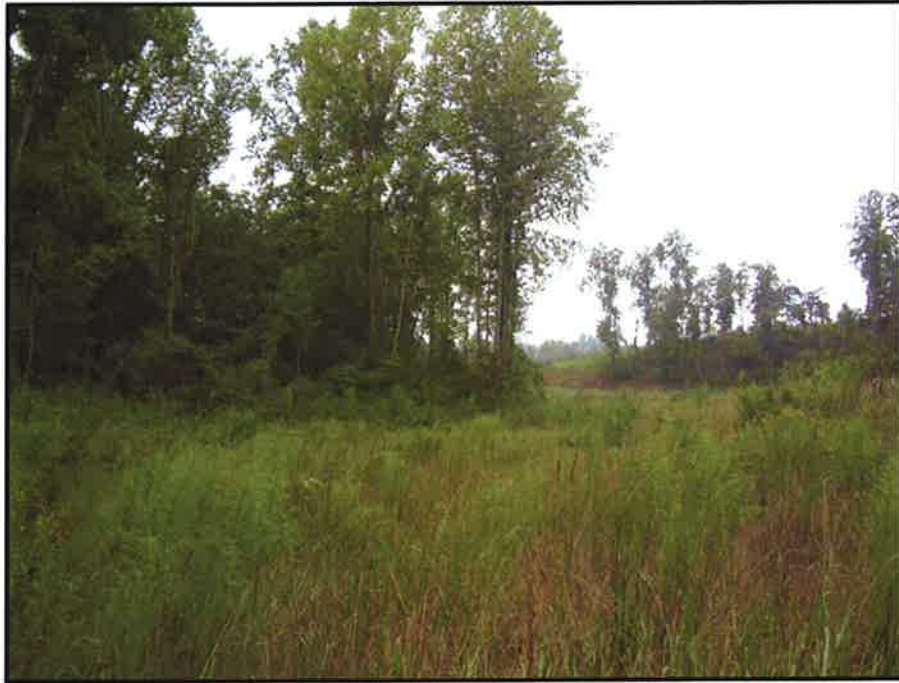
Fixed Station 1
Overview of the Silver Creek Mainstem, facing downstream from the downstream project terminus.
(EMH&T, Inc. 9/16/09)

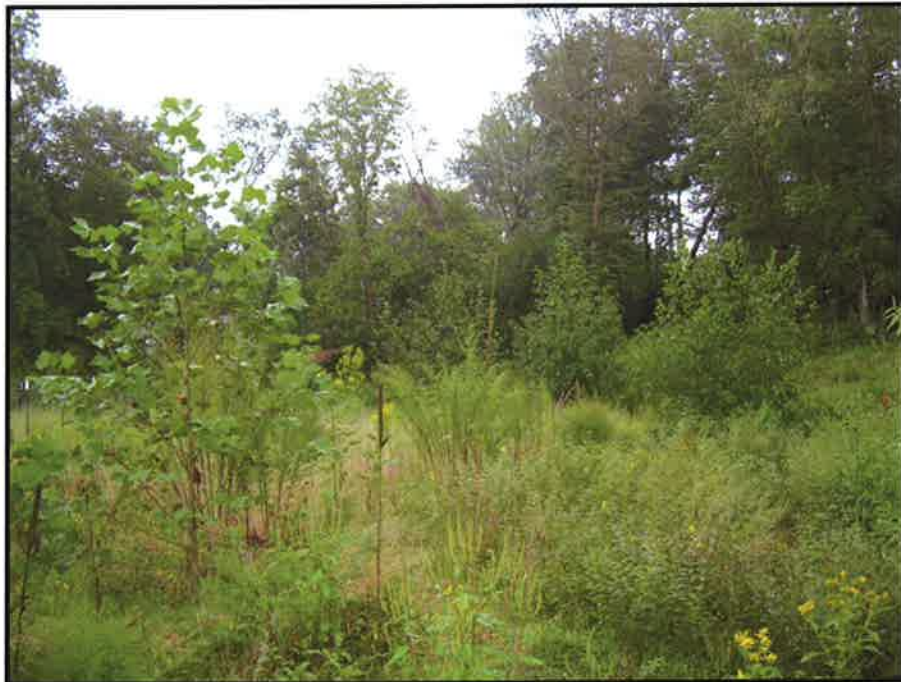
Fixed Station 2
Overview of the Silver Creek Mainstem near Riffle #3, facing downstream.
(EMH&T, Inc. 9/16/09)

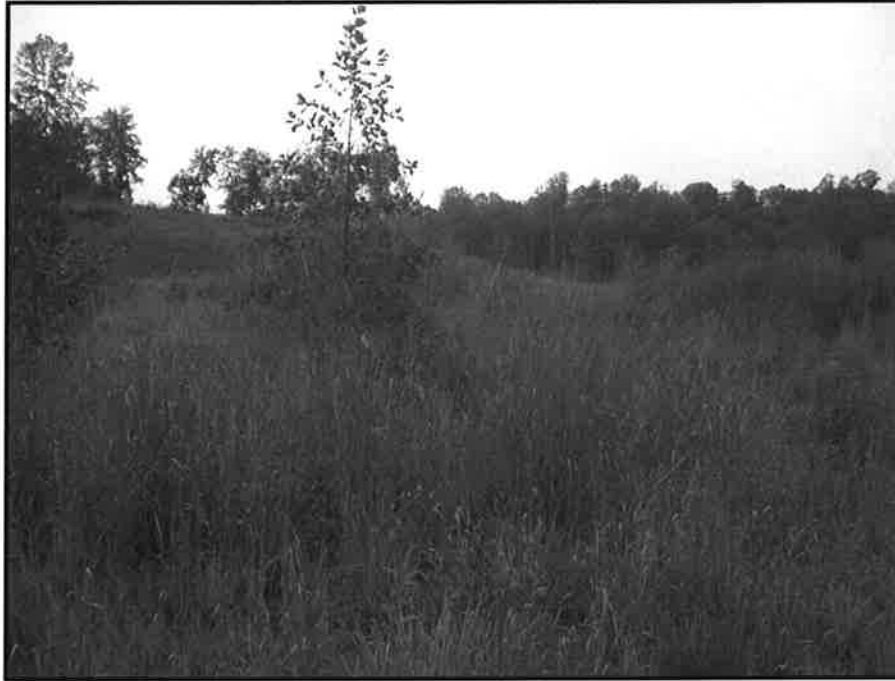
Fixed Station 3
Overview of the Silver Creek Mainstem at Riffle #1, facing downstream.
(EMH&T, Inc. 9/16/09)

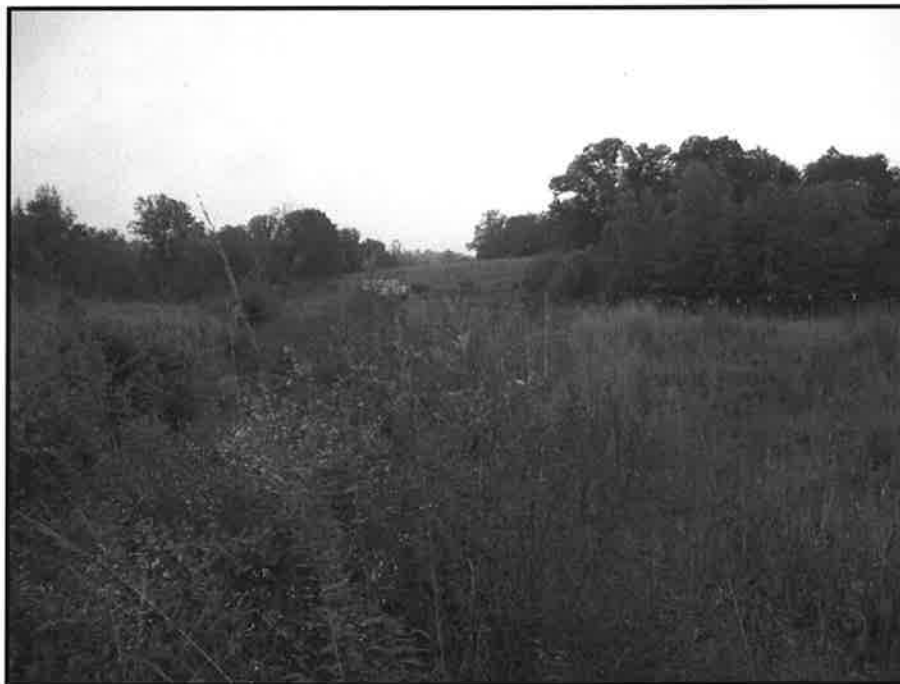
Fixed Station 4
Overview of the Silver Creek Mainstem at Riffle #1, facing upstream.
(EMH&T, Inc. 9/16/09)

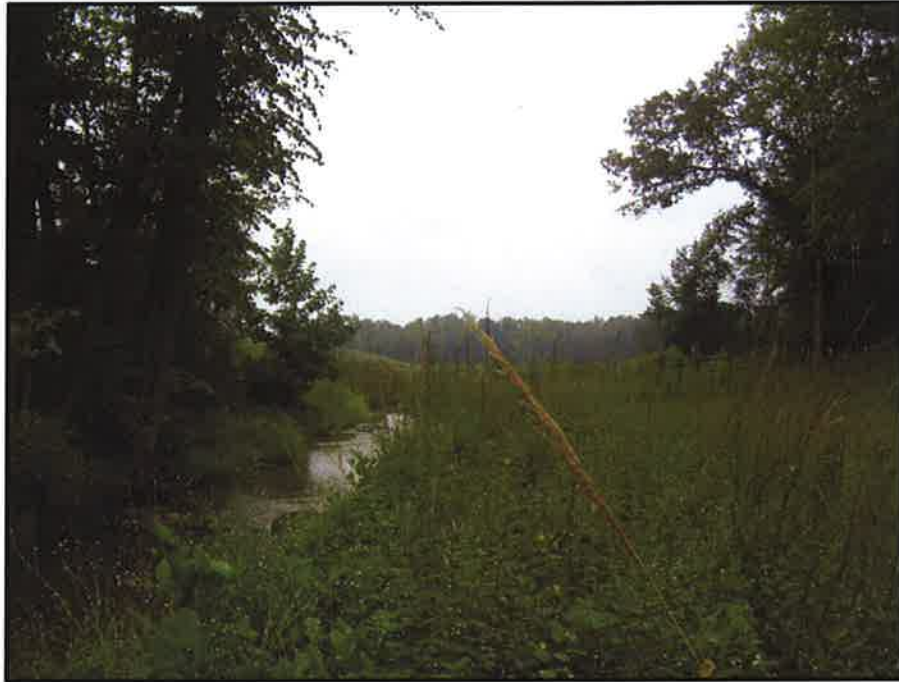
Fixed Station 5
Overview of the Silver Creek Mainstem, facing downstream near station 2+60.
(EMH&T, Inc. 9/16/09)

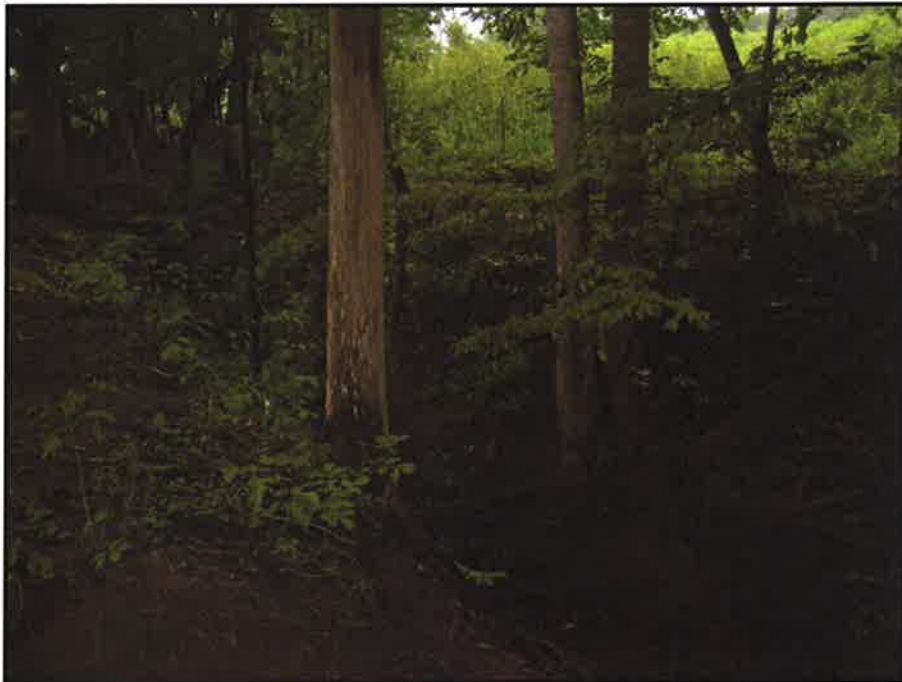
Fixed Station 6
Overview of UT-A, facing upstream near station 0+50.
(EMH&T, Inc. 9/17/09)

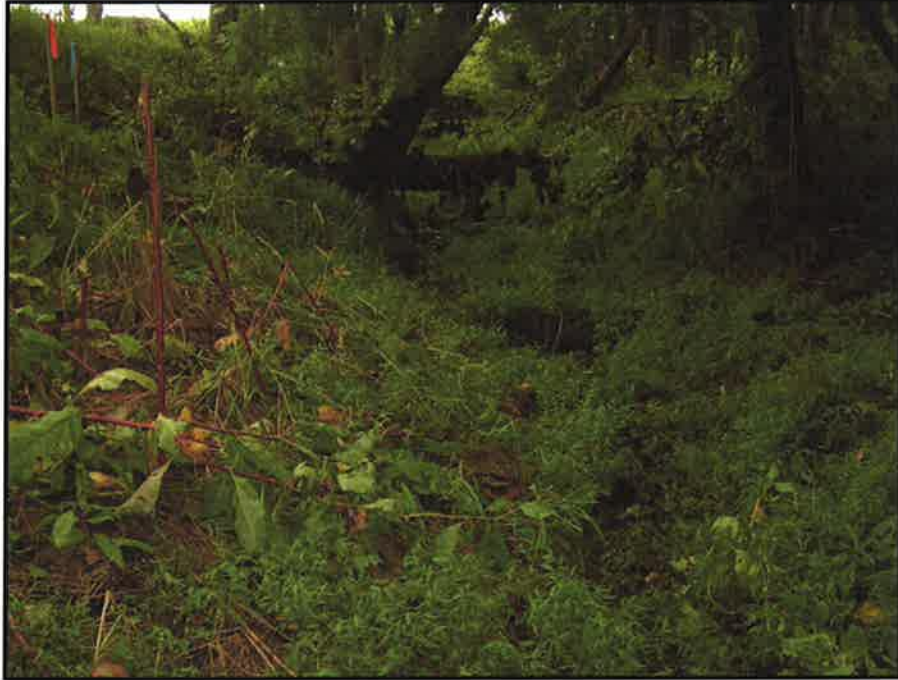
Fixed Station 7
Overview of UT-A, facing upstream near station 8+00.
(EMH&T, Inc. 9/17/09)

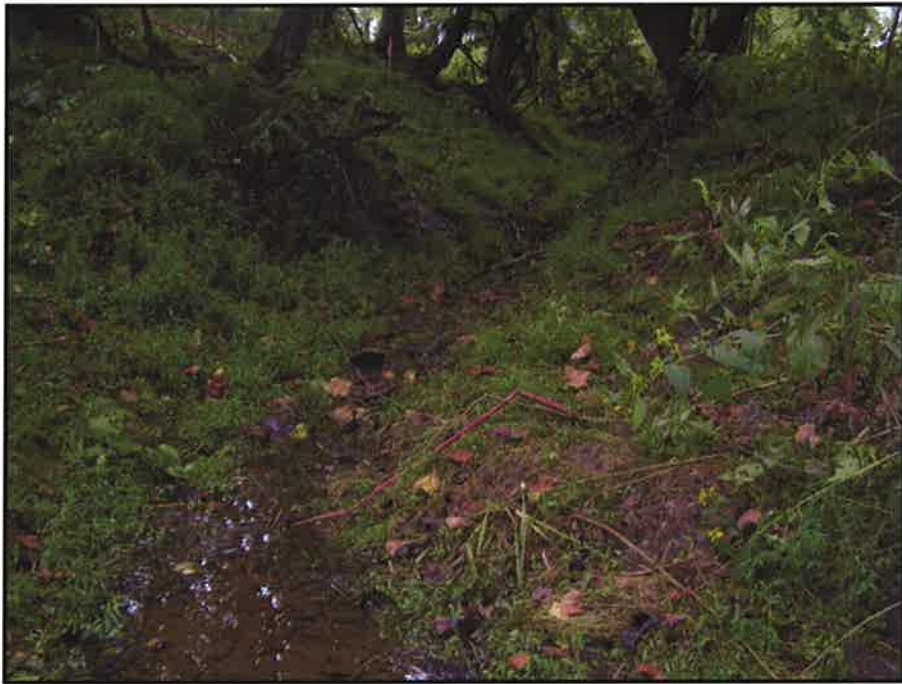
Fixed Station 8
Overview of UT-A, facing upstream near station 11+00.
(EMH&T, Inc. 9/17/09)

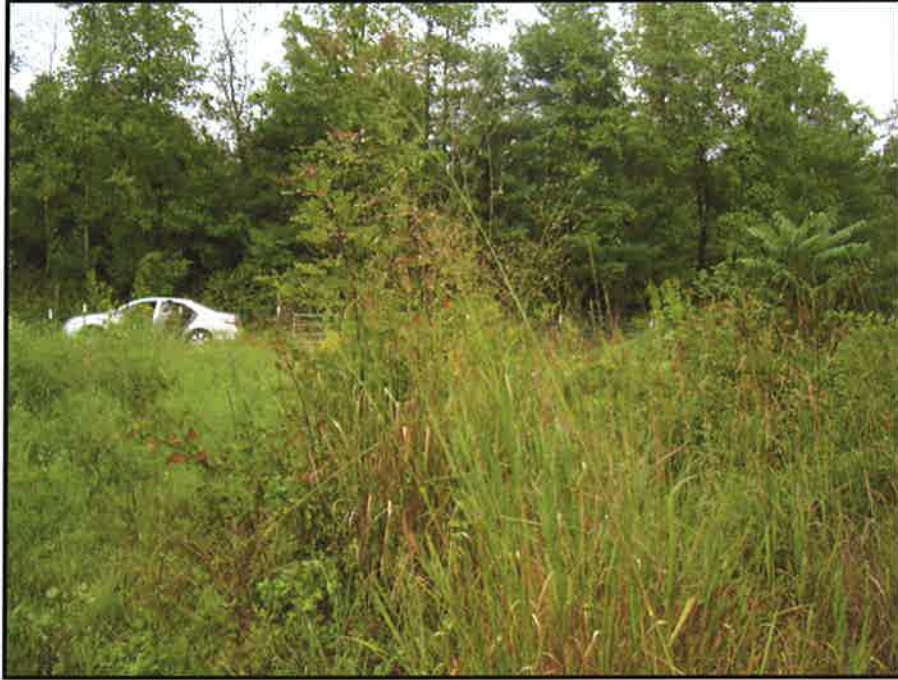
Fixed Station 9
Overview of UT-B, facing upstream from the confluence of UT-B with Silver Creek.
(EMH&T, Inc. 9/17/09)

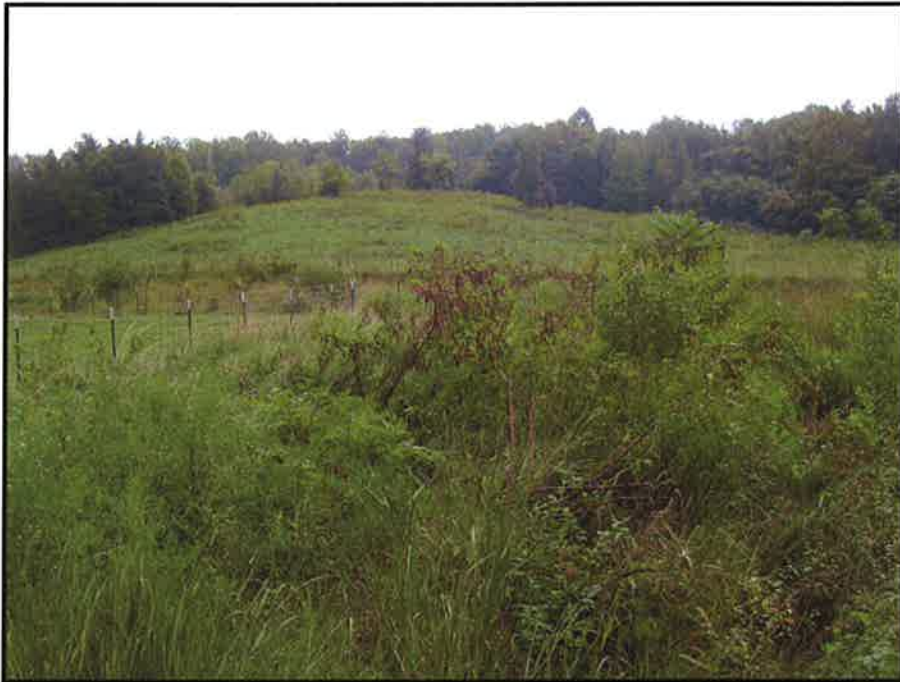
Fixed Station 10
Overview of UT-B, facing downstream towards the confluence of UT-B with Silver Creek.
(EMH&T, Inc. 9/17/09)

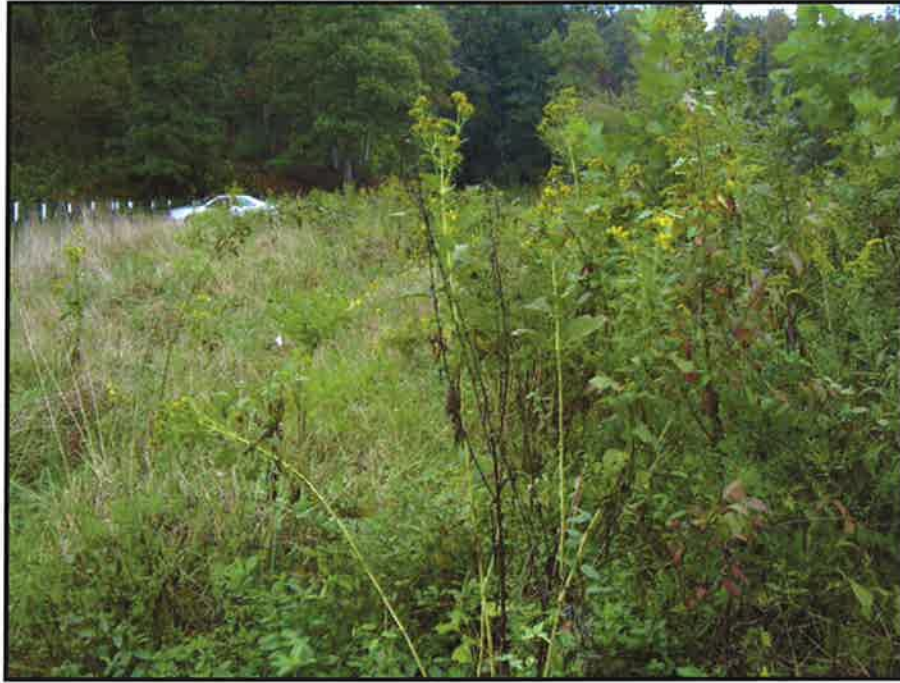
Fixed Station 11
Overview of UT-C, facing upstream from the confluence of UT-C with Silver Creek.
(EMH&T, Inc. 9/17/09)

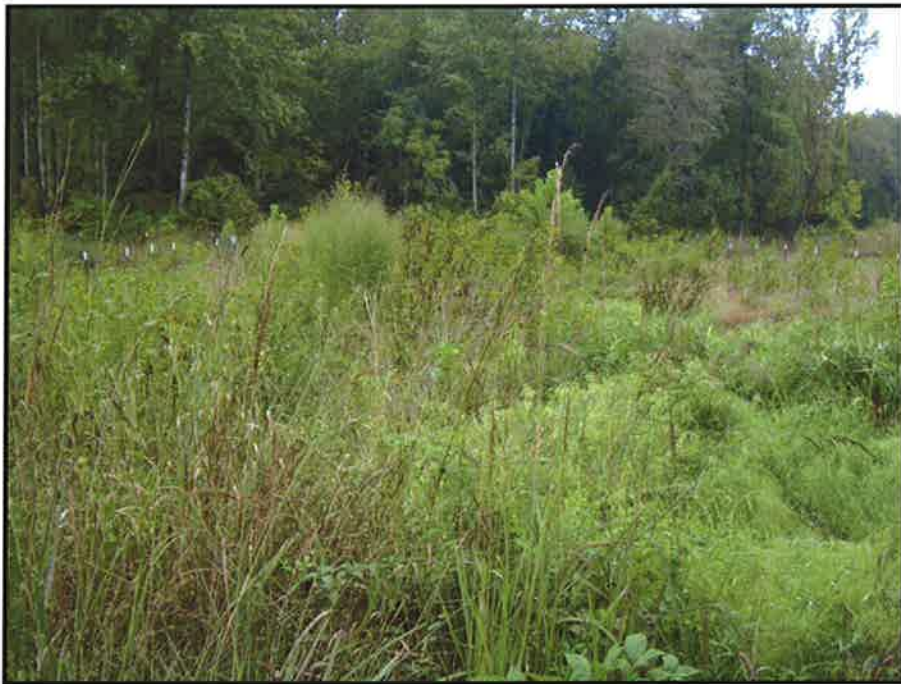
Fixed Station 12
Overview of UT-C, facing downstream towards the confluence of UT-C with Silver Creek.
(EMH&T, Inc. 9/17/09)

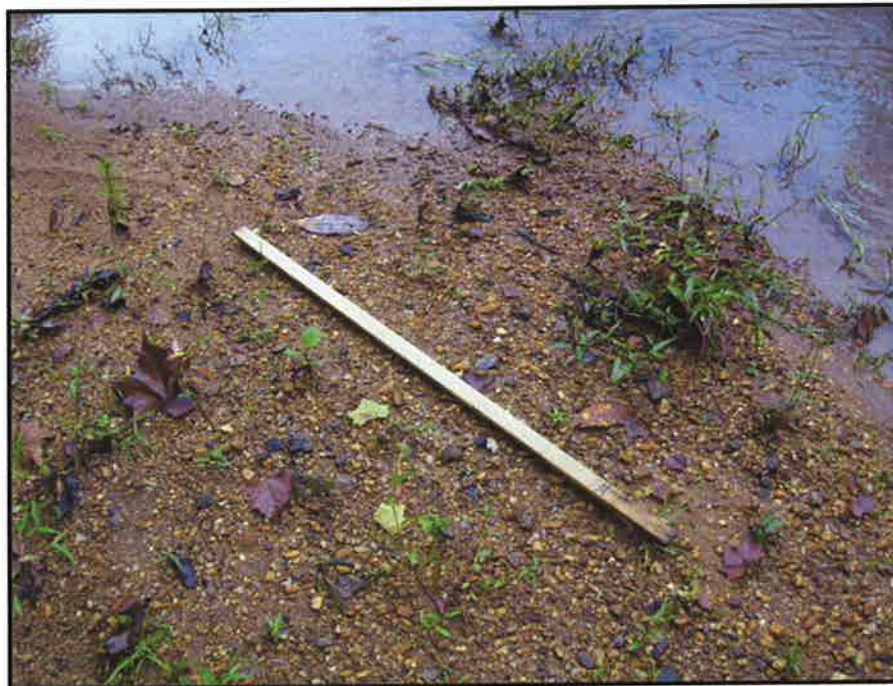
BF 2
Crest Gage on Silver Creek Mainstem.
(EMH&T, Inc. 9/21/09)
