Year 4 Monitoring Report for Stream Restoration of Silver Creek and Unnamed Tributaries

Burke County, NC
SCO # D05016-01

Submitted: February 2011

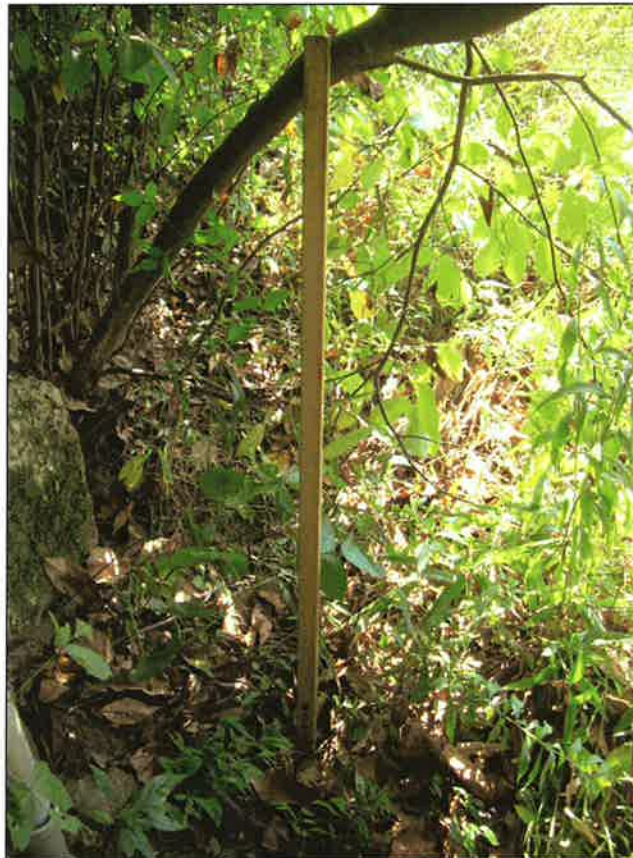
BF 2
Crest Gage on Silver Creek Mainstem.
(EMH&T, Inc. 5/12/10)
