Subject: Year 5 Monitoring Report for Stream Restoration of Silver Creek and Unnamed Tributaries
SCO# D05016-01

Year 5 Monitoring Report for Stream Restoration of Silver Creek and Unnamed Tributaries

Burke County, NC
SCO # D05016-01

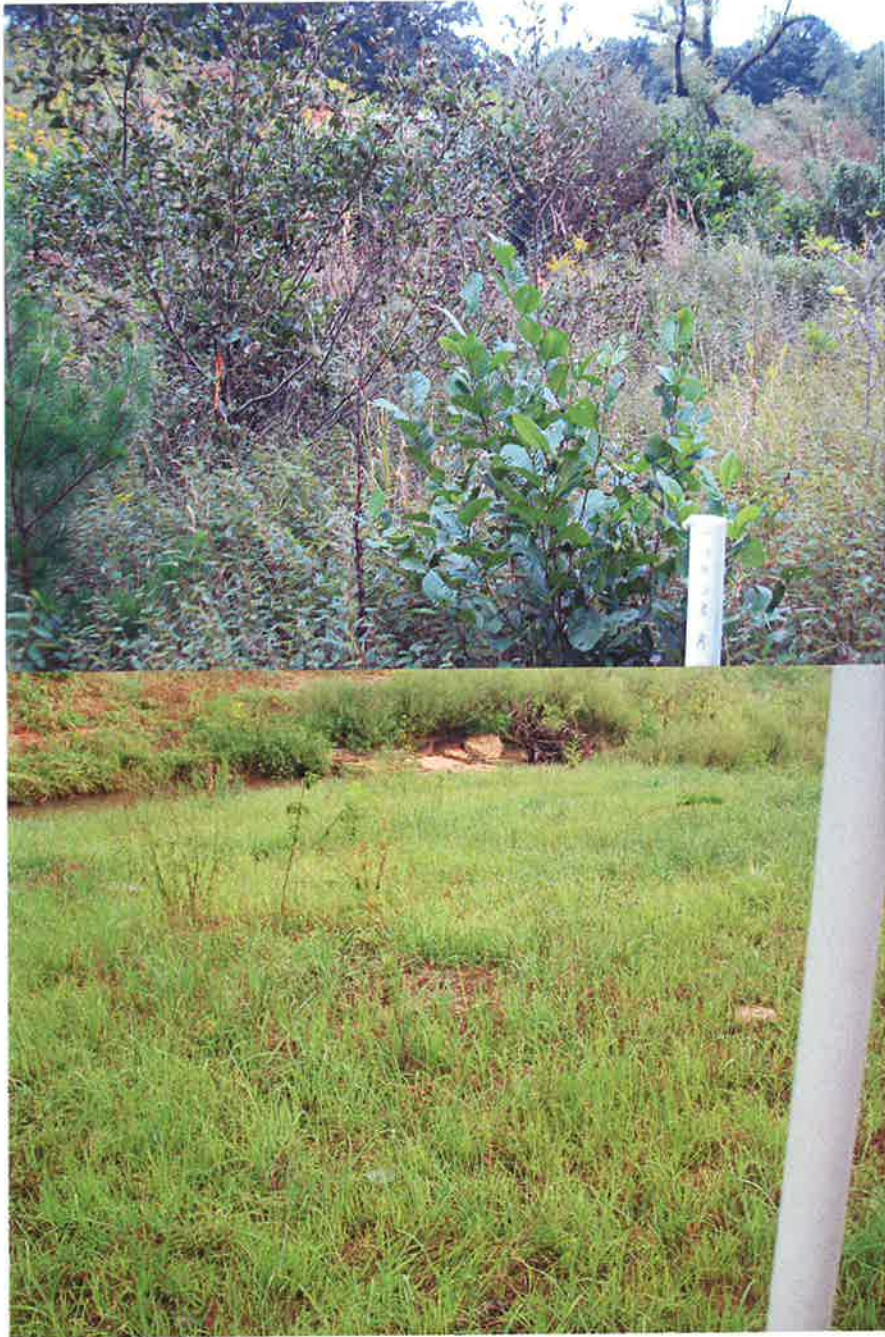
Vegetation Plot 1 on Mainstem
Year 5 – top photo (EMH&T, 9/16/11)
Year 1- bottom photo (EMH&T, 9/20/06)

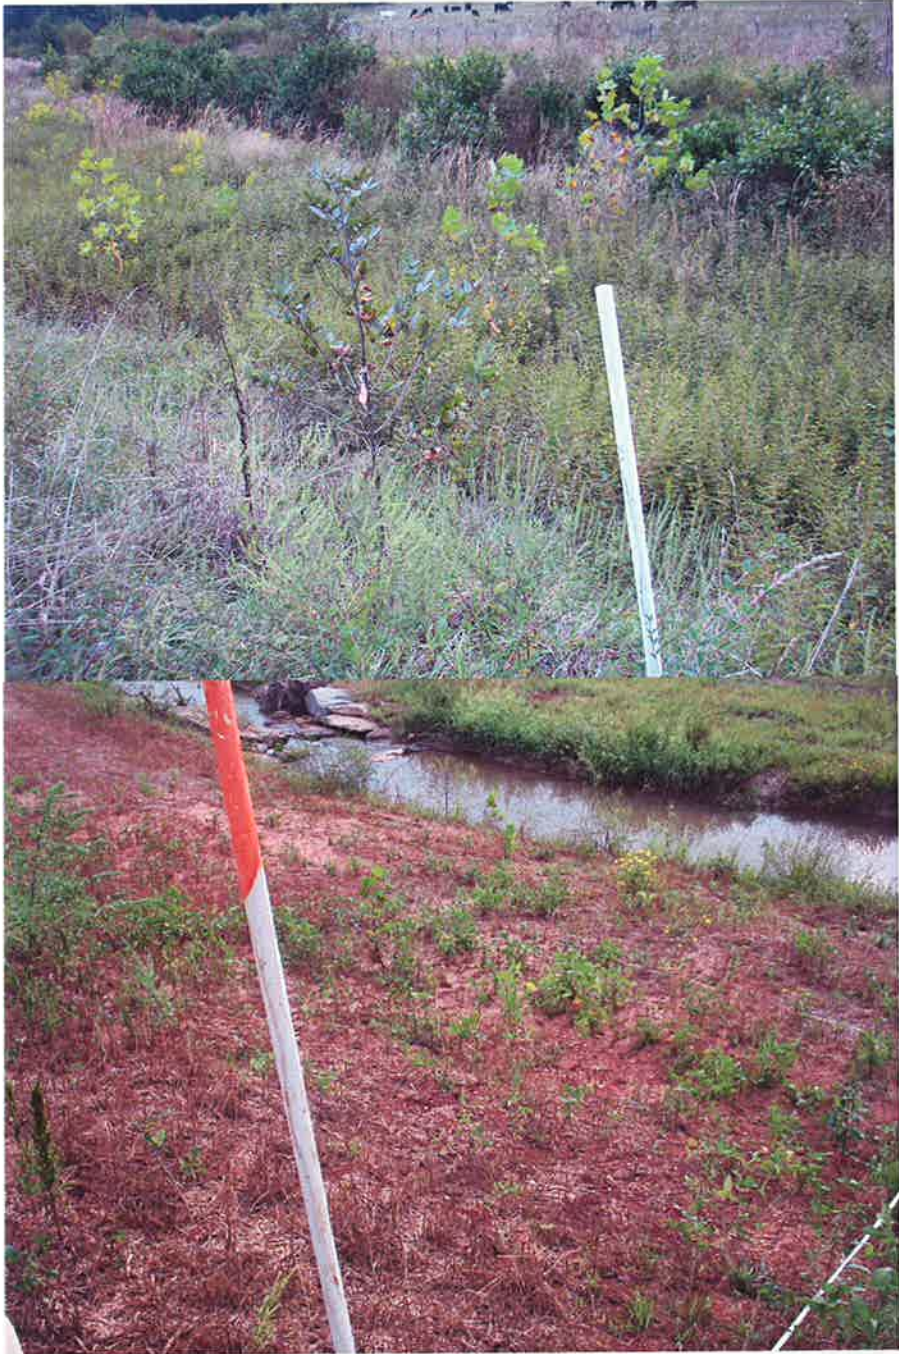
Vegetation Plot 2 on Mainstem
Year 5 – top photo (EMH&T, 9/16/11)
Year 1- bottom photo (EMH&T, 9/20/06)

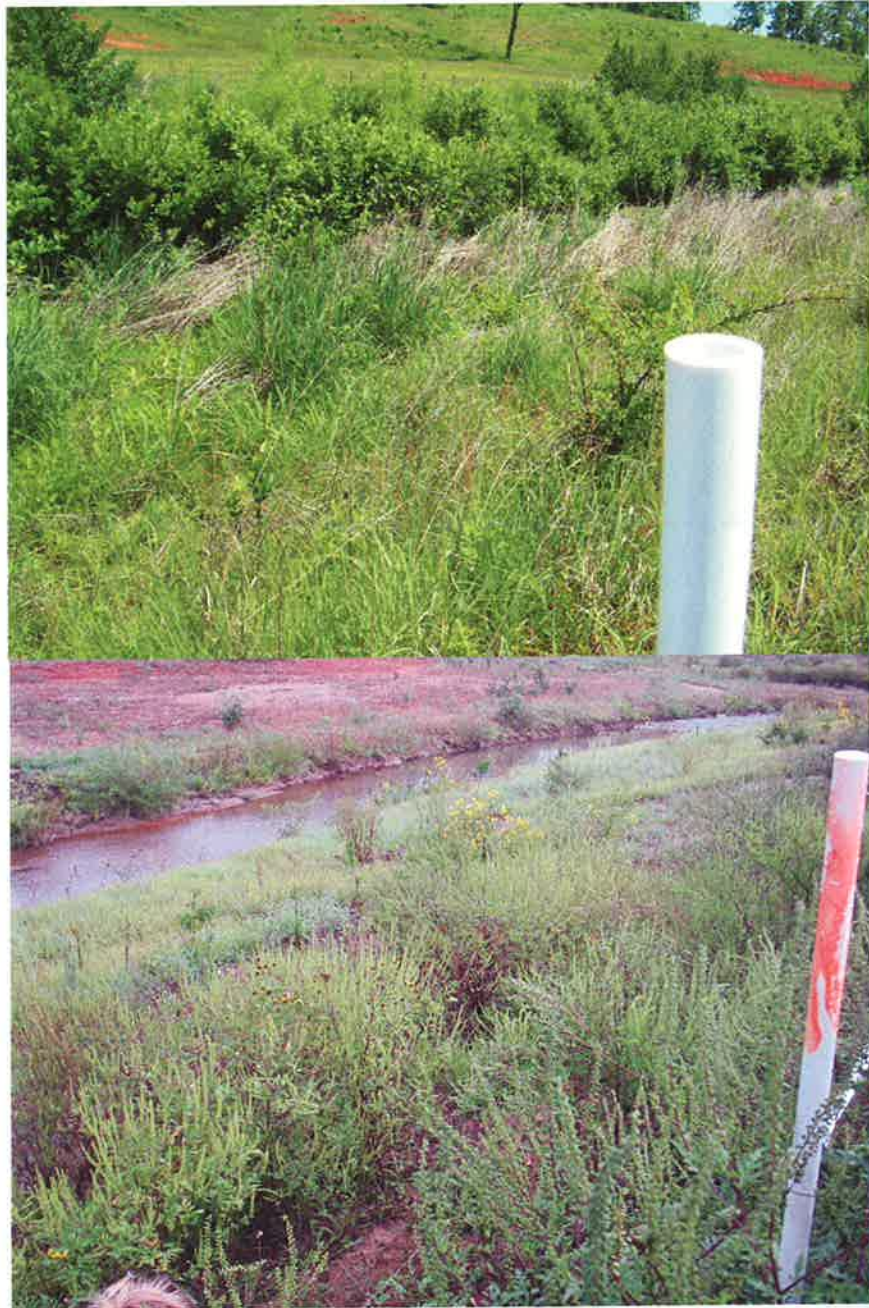
Vegetation Plot 3 on Mainstem
Year 5 – top photo (EMH&T, 9/16/11)
Year 1- bottom photo (EMH&T, 9/20/06)

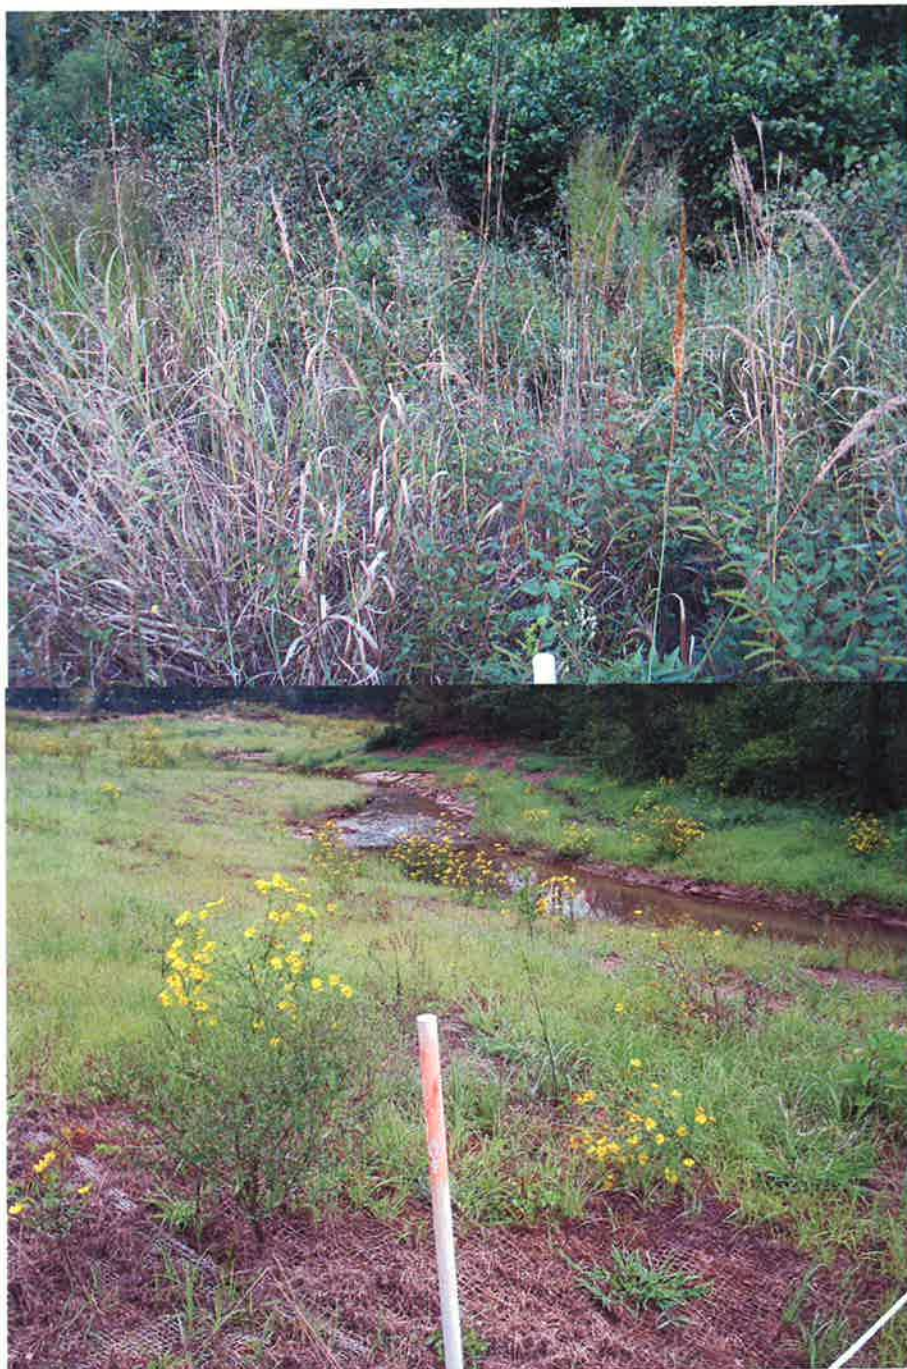
Vegetation Plot 5 on Mainstem
Year 5 – top photo (EMH&T, 9/16/11)
Year 1- bottom photo (EMH&T, 9/20/06)

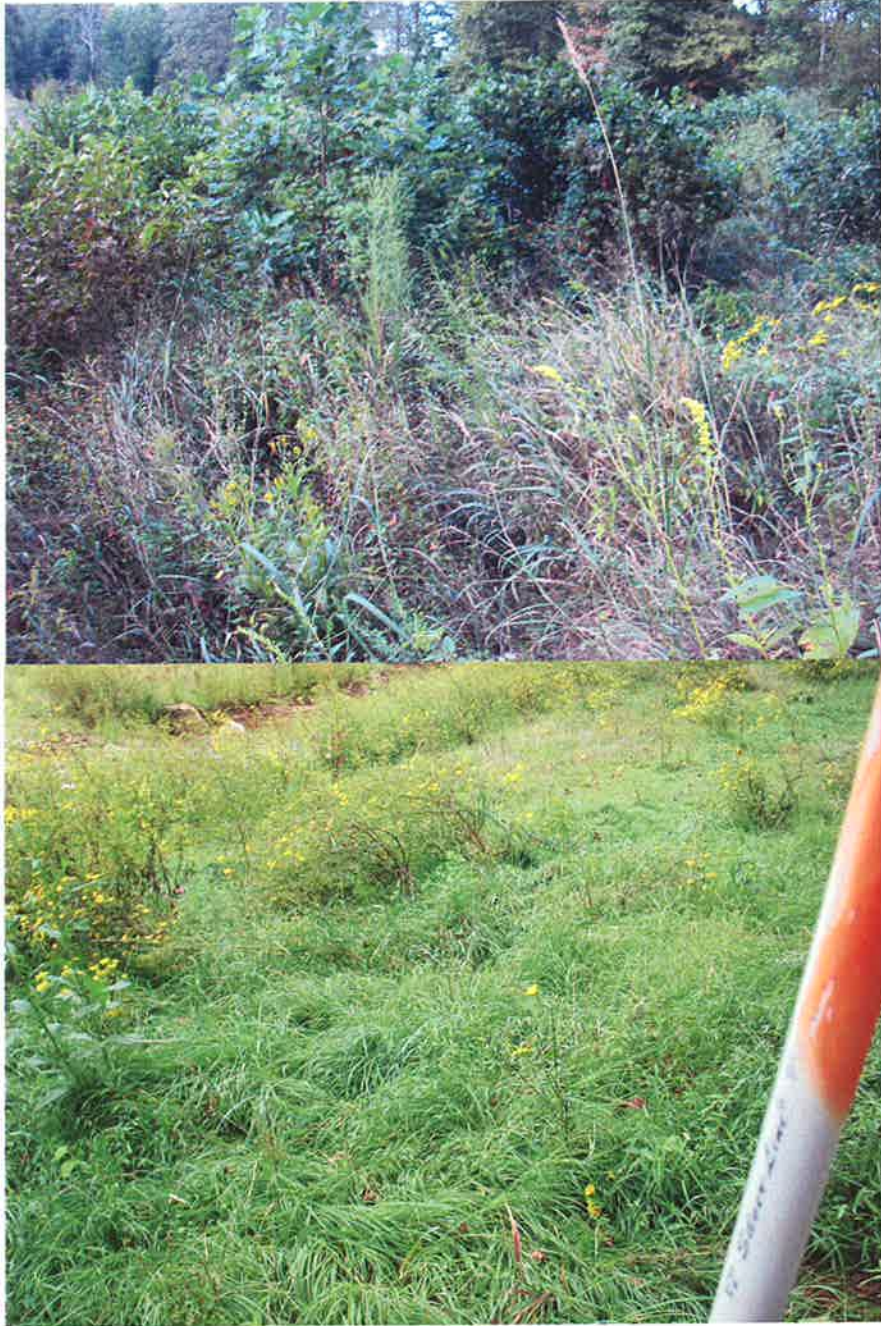
Vegetation Plot 6 on Mainstem
Year 5 – top photo (EMH&T, 9/16/11)
Year 1- bottom photo (EMH&T, 9/20/06)

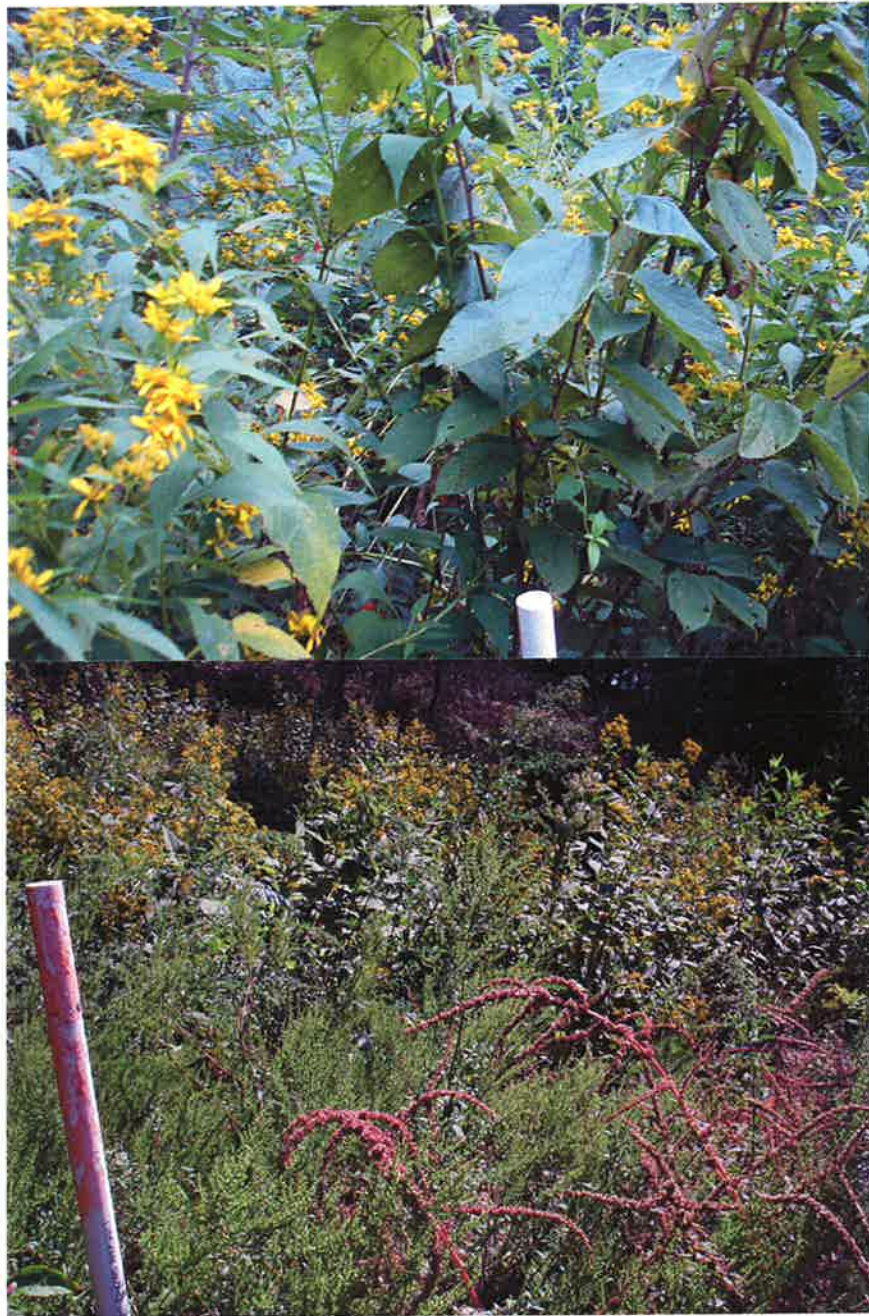
Cattle had unintentional access to UT-A through the early part of September 2009 due to a fallen tree across the protective fencing. The cattle intrusion into the riparian corridor resulted in several areas of bare ground and sparse vegetation. These areas were reseeded in the fall of 2009 using a seed mix appropriate for shady, partial canopied woodland areas. As is observed in the fixed station photos in Appendix B, ground cover has significantly increased in Years 4 and 5. The increase in vegetation cover has further stabilized the banks along UT-A.

Vegetation Plot 1 on Tributary A
Year 5 – top photo (EMH&T, 9/16/11)
Year 1- bottom photo (EMH&T, 9/20/06)

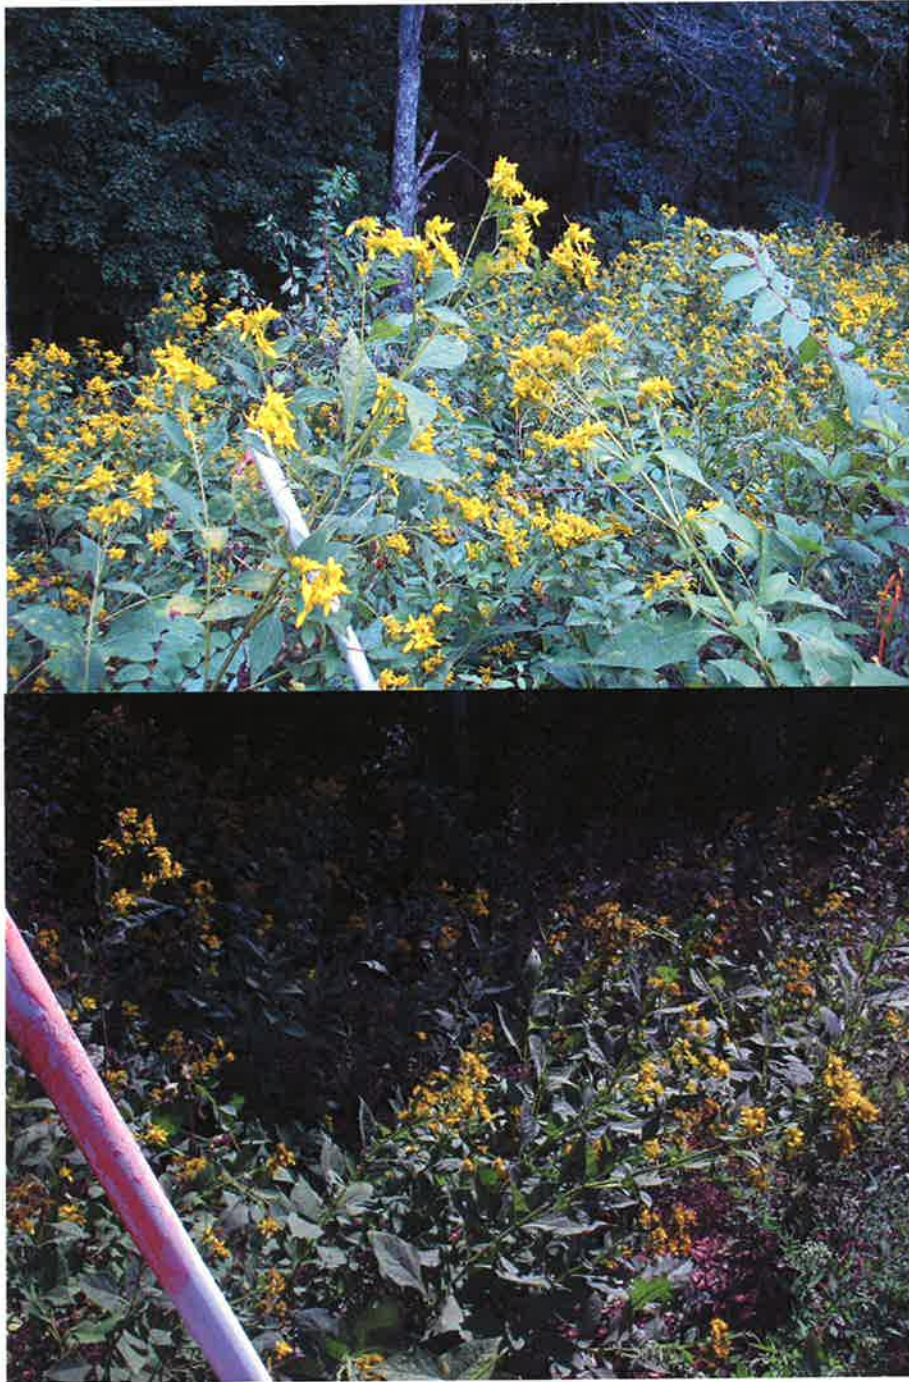
Vegetation Plot 2 on Tributary A
Year 5 – top photo (EMH&T, 9/16/11)
Year 1- bottom photo (EMH&T, 9/20/06)

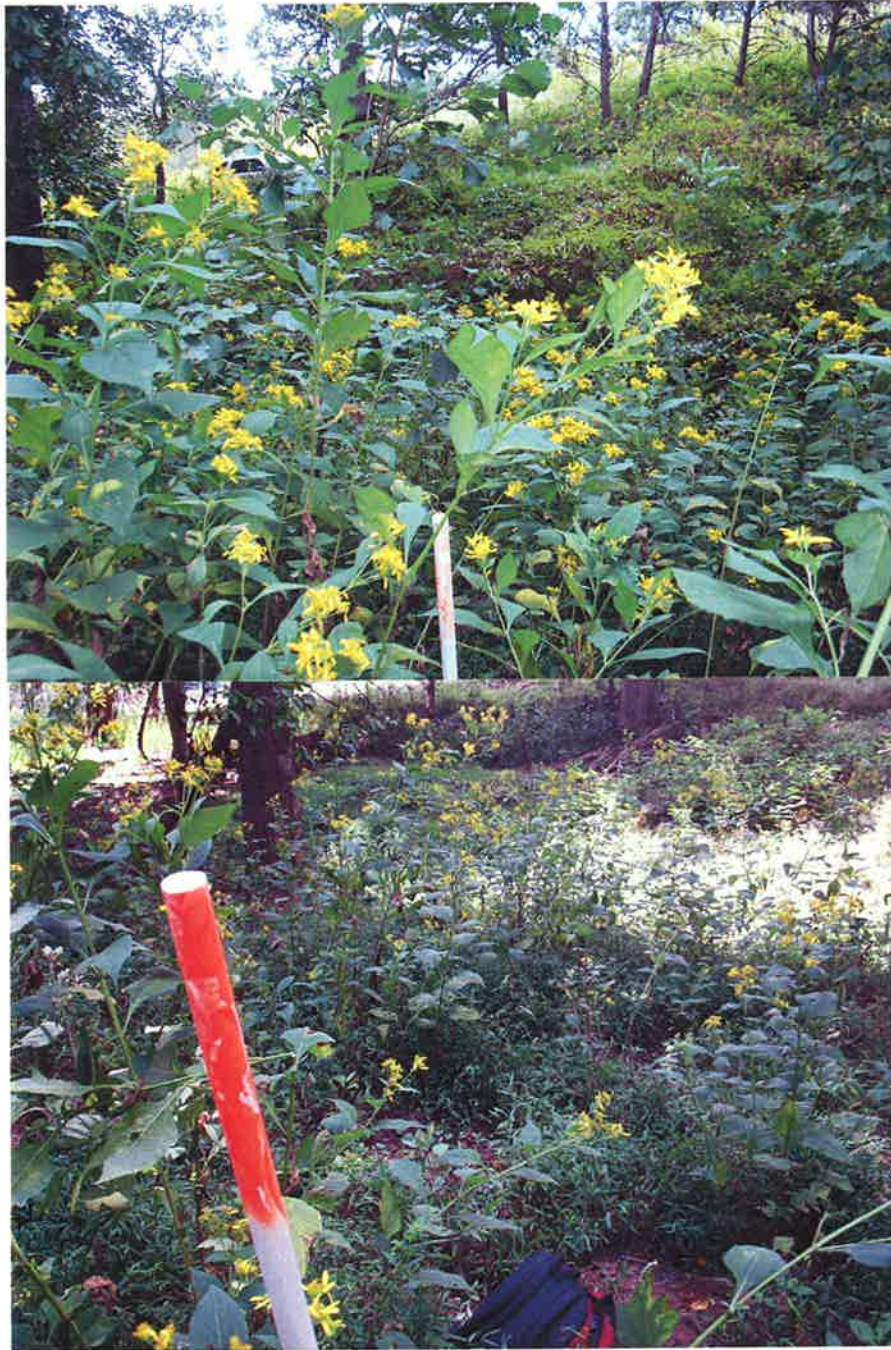
Vegetation Plot 3 on Tributary A
Year 5 – top photo (EMH&T, 9/16/11)
Year 1- bottom photo (EMH&T, 9/20/06)

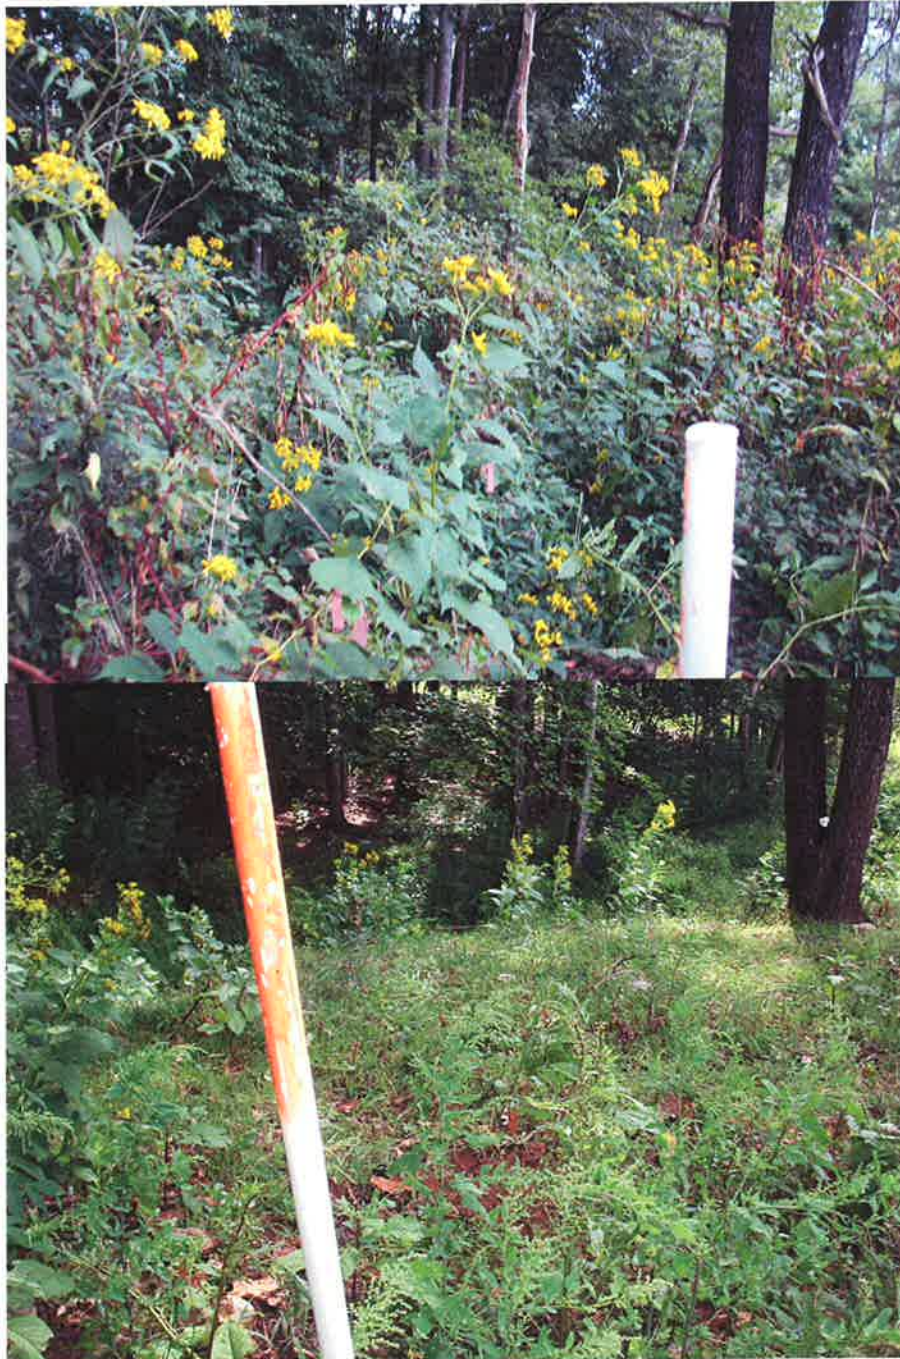
Vegetation Plot 4 on Tributary A
Year 5 – top photo (EMH&T, 9/16/11)
Year 1- bottom photo (EMH&T, 9/20/06)

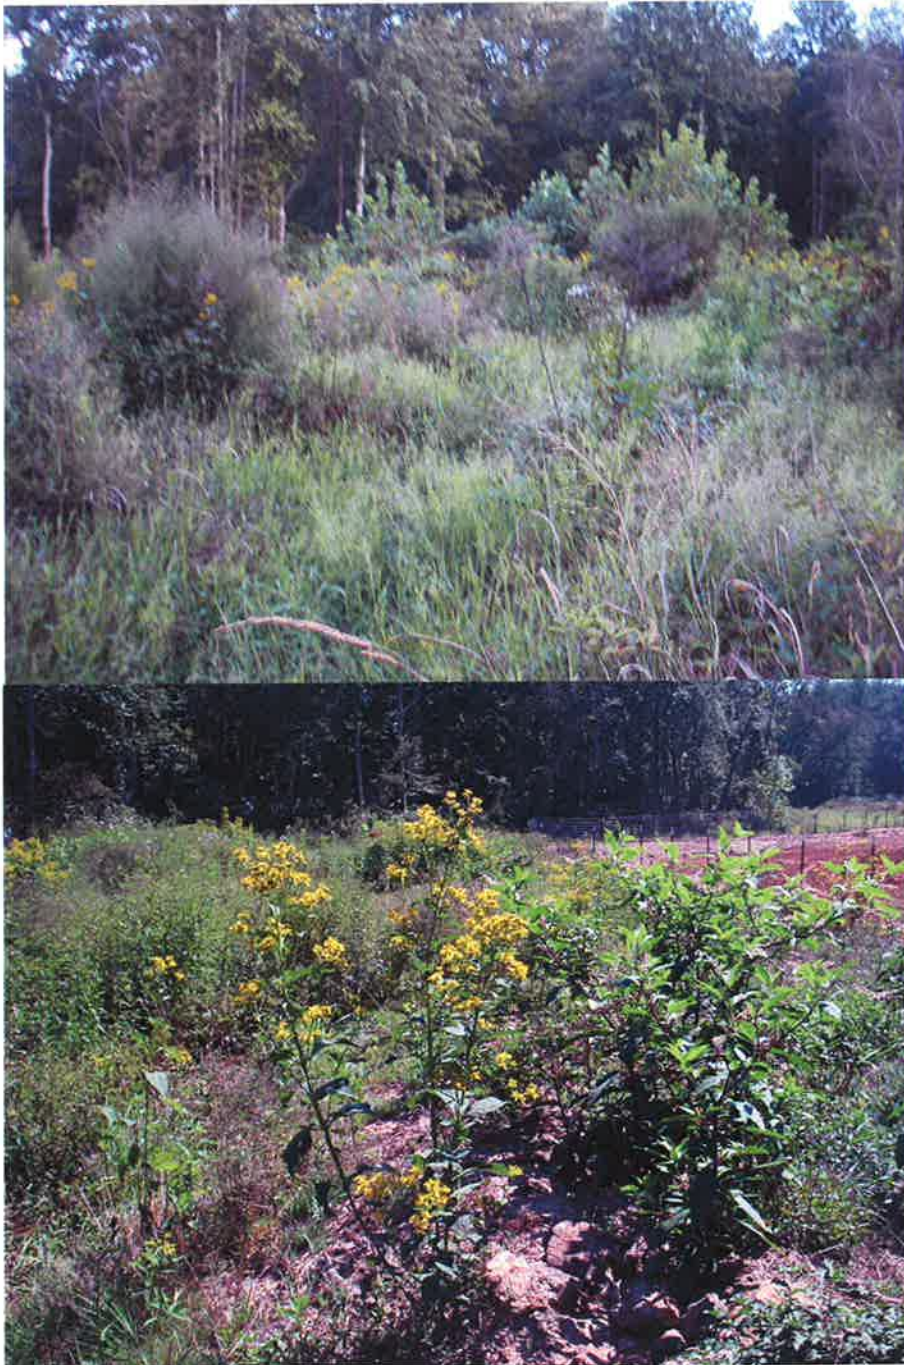
Vegetation Plot on Tributary C
Year 5 – top photo (EMH&T, 9/16/11)
Year 1- bottom photo (EMH&T, 9/20/06)

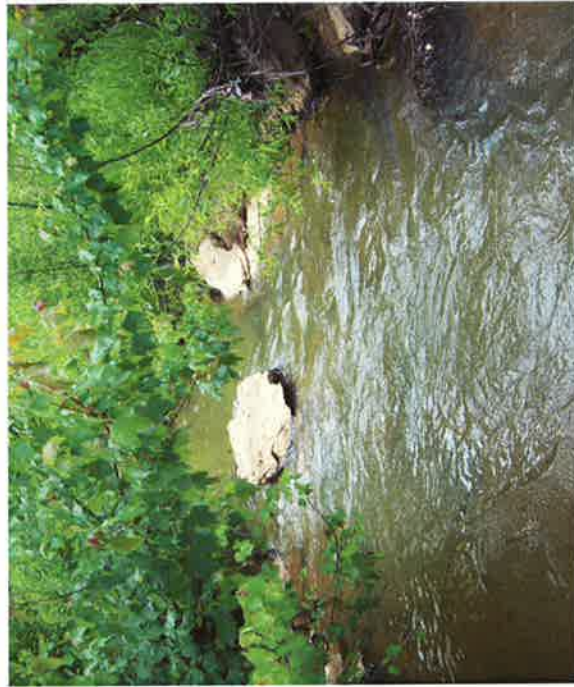
Pool Cross-Section 2, looking upstream

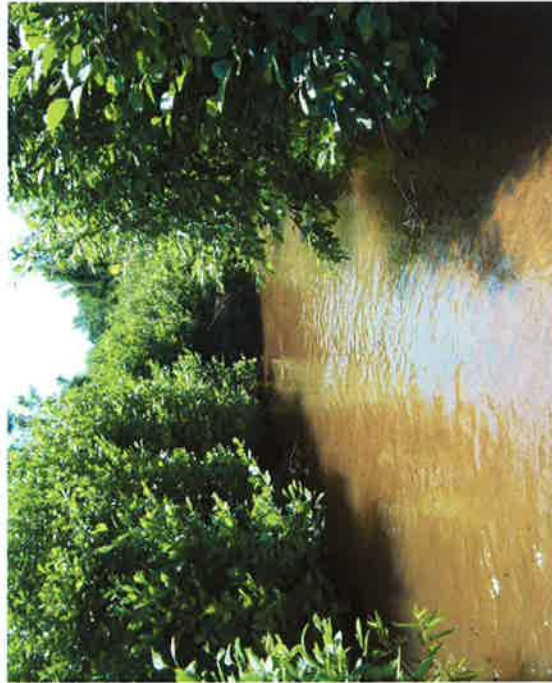
Pool Cross-Section 3, looking downstream

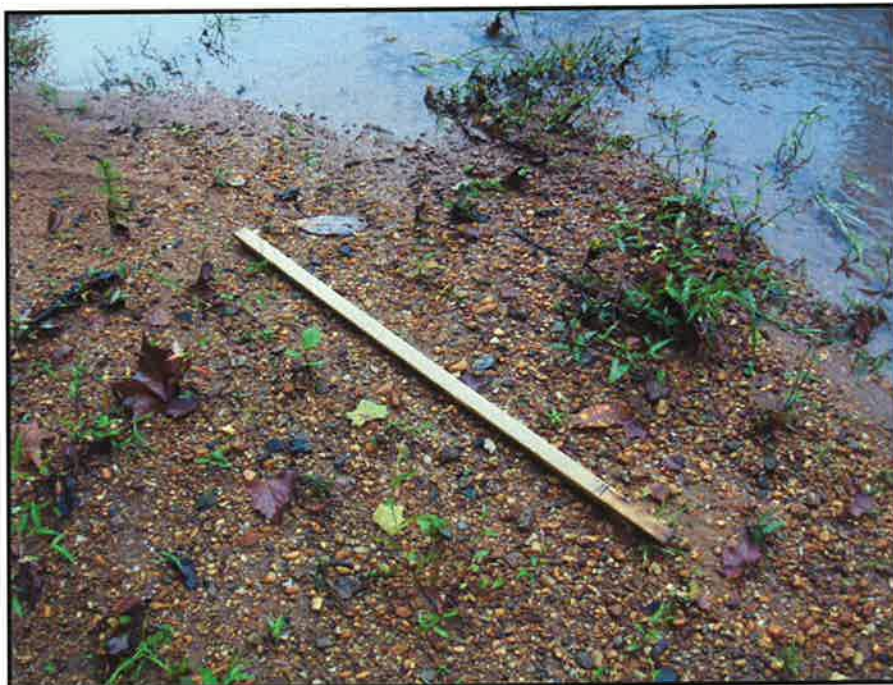
BF 2
Crest Gage on Silver Creek Mainstem (Year 3).
(EMH&T, 9/21/09)

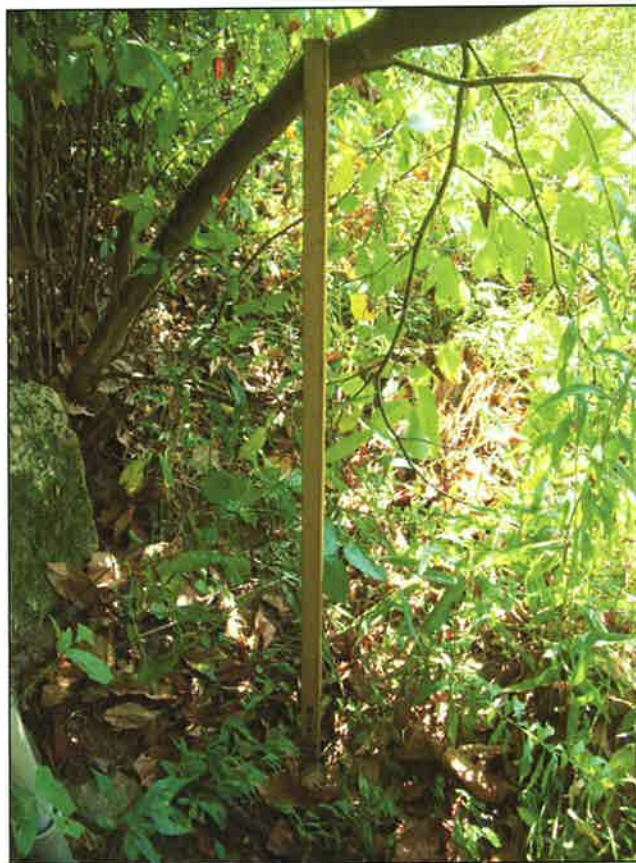
BF 4
Crest Gage on Silver Creek Mainstem (Year 4).
(EMH&T, 5/12/10)

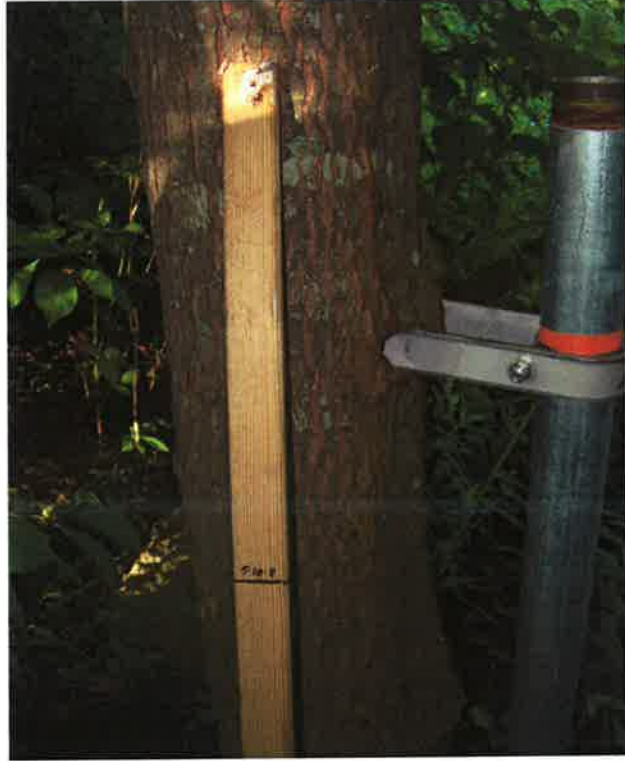
BF 5
Crest Gage on Silver Creek Mainstem (Year 5).
(EMH&T, 5/20/11)
