Sink Hole Creek Mitigation Project

Year 5 Monitoring Report

Mitchell County, North Carolina

Date Submitted: November, 2015

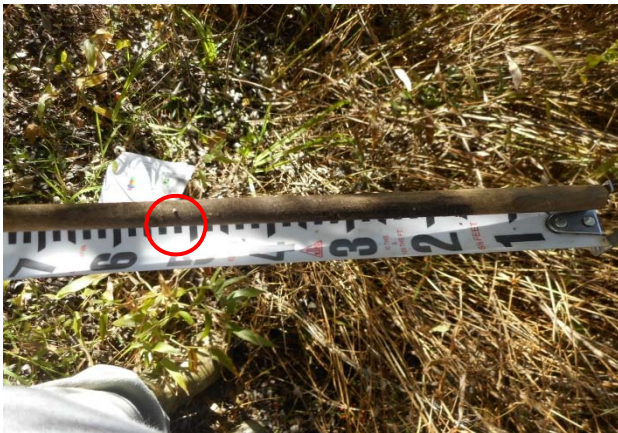
Photo1. Silver Creek crest gauge staff showing cork deposition in red circle at .52 ft above the bottom of the staff, which is at the bankfull elevation.

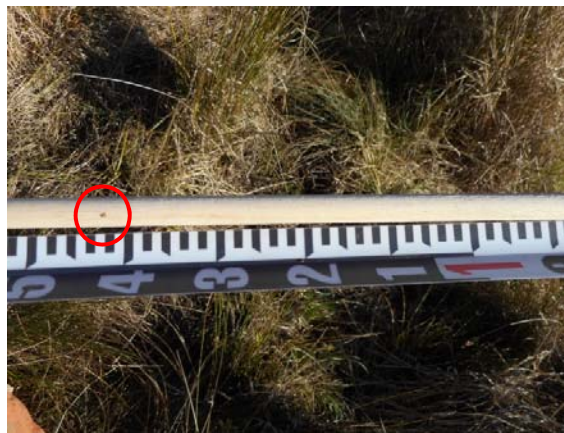
Photo 2. UT2 crest gauge staff showing cork deposition in red circle at 1.42 ft above the bottom of the staff, which is at the bankfull elevation.
