# **FINAL (MYO) BASELINE MONITORING REPORT** **SIX RUNS STREAM AND WETLAND MITIGATION PROJECT**

Sampson County, North Carolina  
Cape Fear River Basin  
HUC 03030006

NCDMS Project #100170  
DMS Contract #0303-01  
RFP: 16-20190303 (Issued 12/20/2019)  
USACE Action ID: SAW-2020-01964 | DWR Project #20201798 v1

**August 2023**

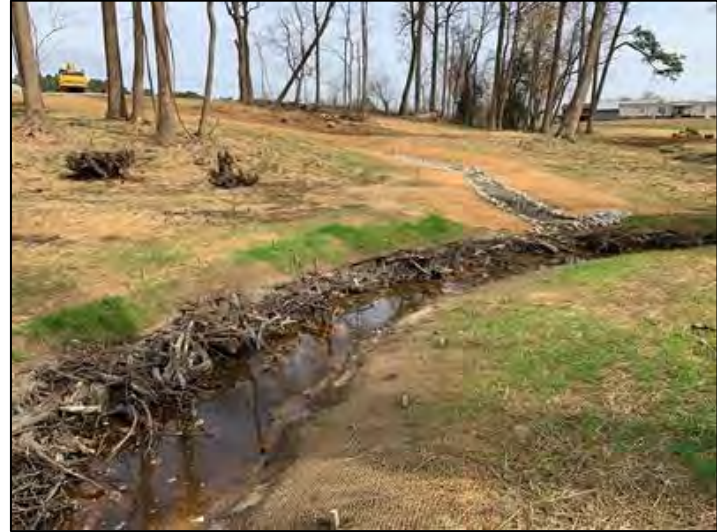
Brush toe and spillway (03/01/2023)

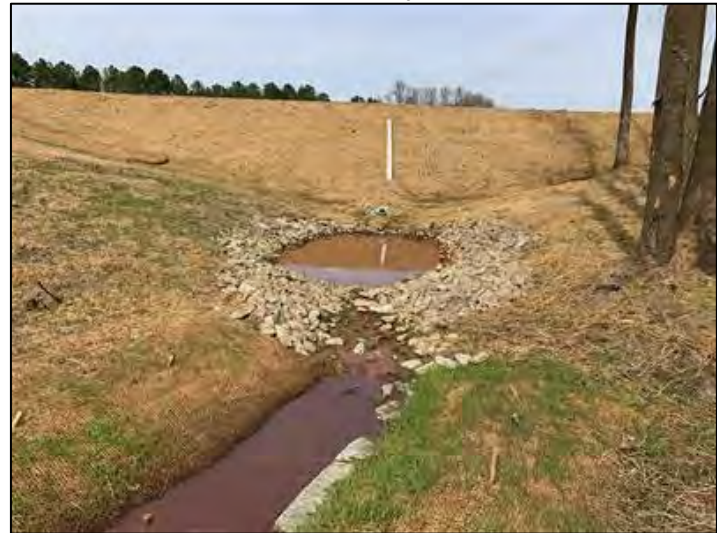
Siphon to stream (03/23/2023)

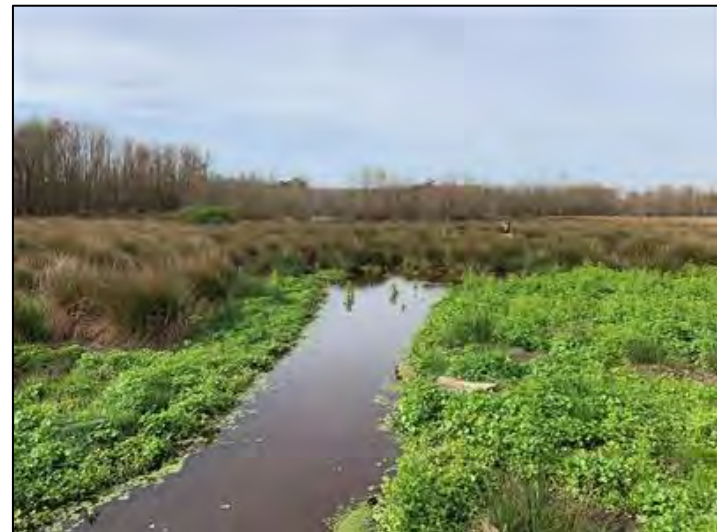
BB-C restoration terminus (downstream) (03/01/2023)

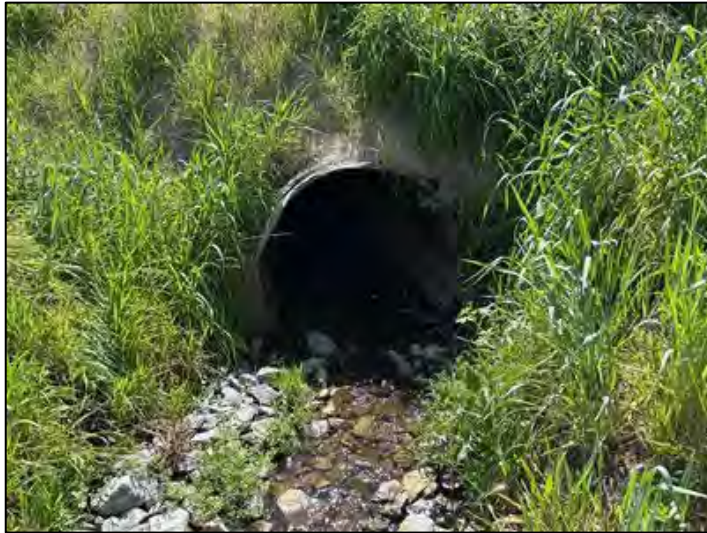
BB-B - E Darden Rd. Culvert Entrance - (03/23/2023)

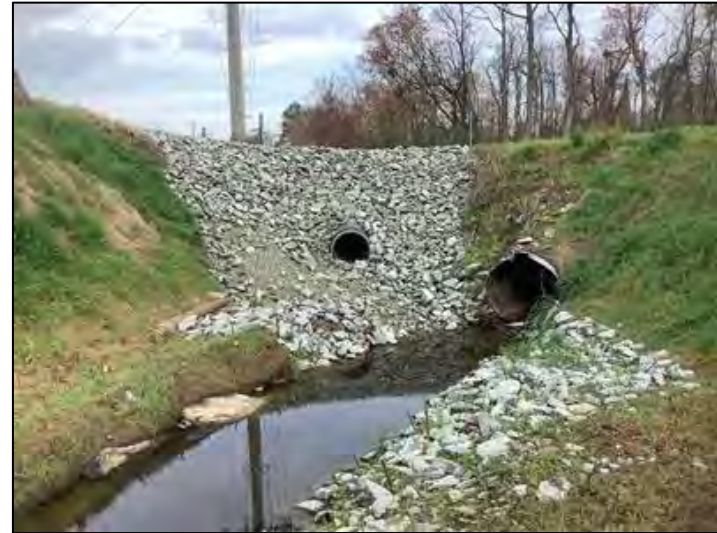
BB-C - E Darden Rd. Culvert Exit (03/30/2023)

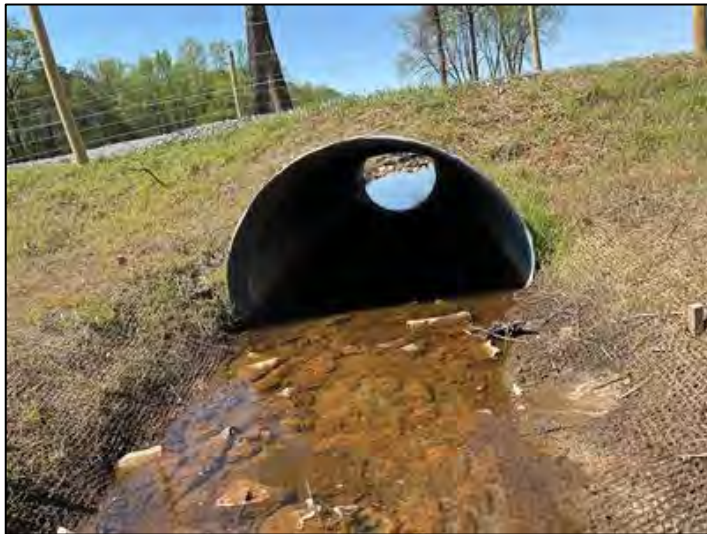
BB-C - Farm Culvert Entrance - (03/30/2023)

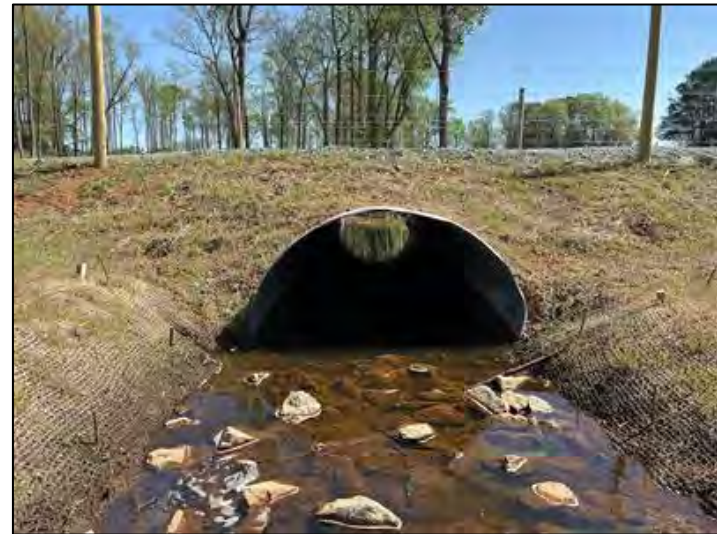
BB-C - Farm Culvert Exit - (03/30/2023)

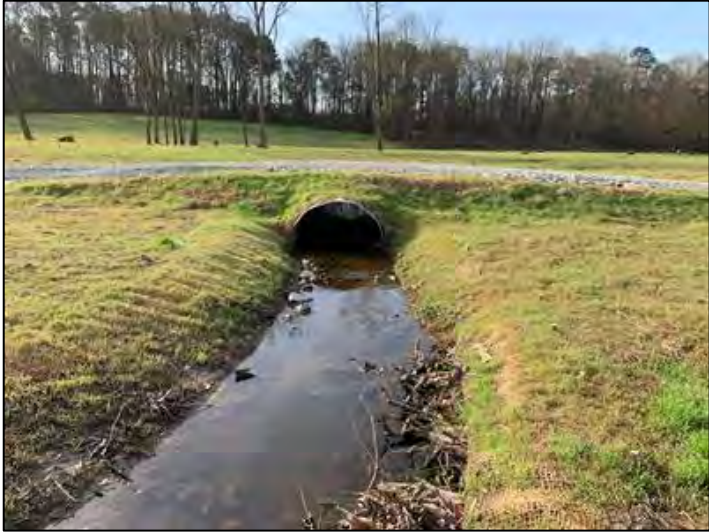
DE4-B – Farm Culvert Entrance - (03/1/2023)

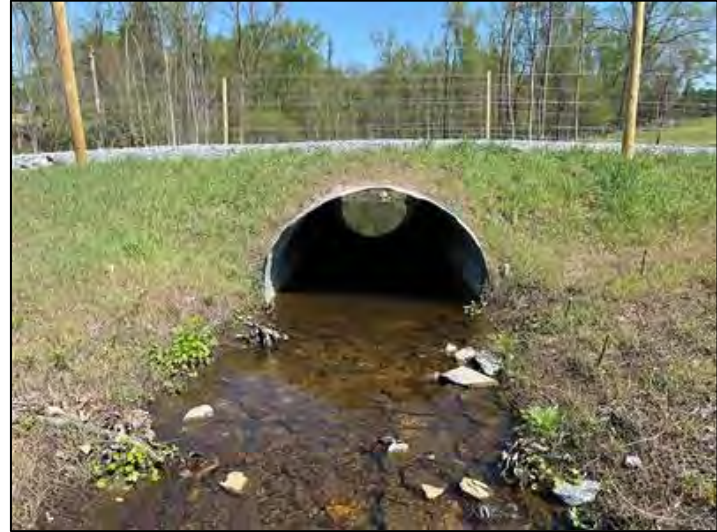
DE4-B – Farm Culvert Exit - (03/30/2023)

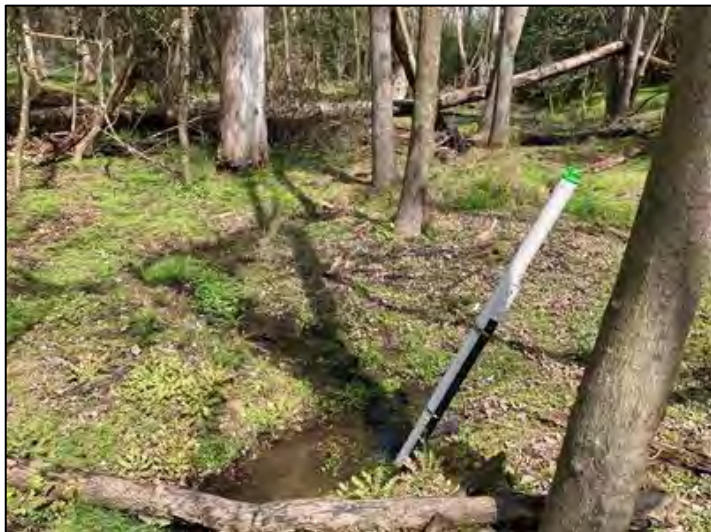
Flow Gauge MT2 (Looking Upstream) (03/28/2023)

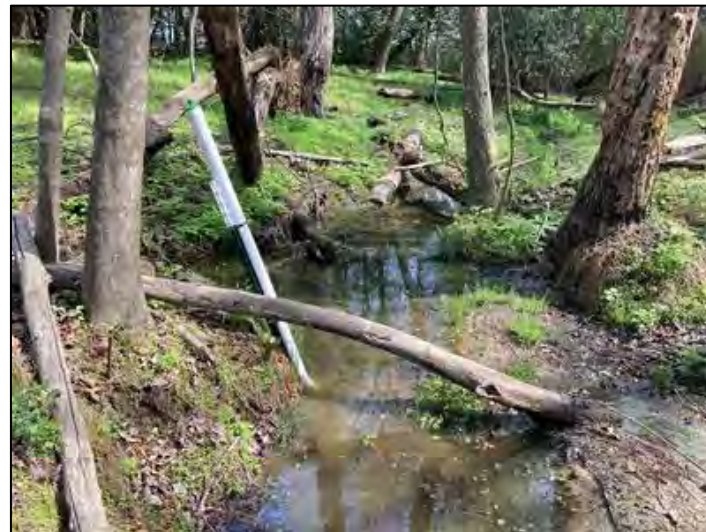
Flow Gauge BB-A (Looking Upstream) (03/28/2023)

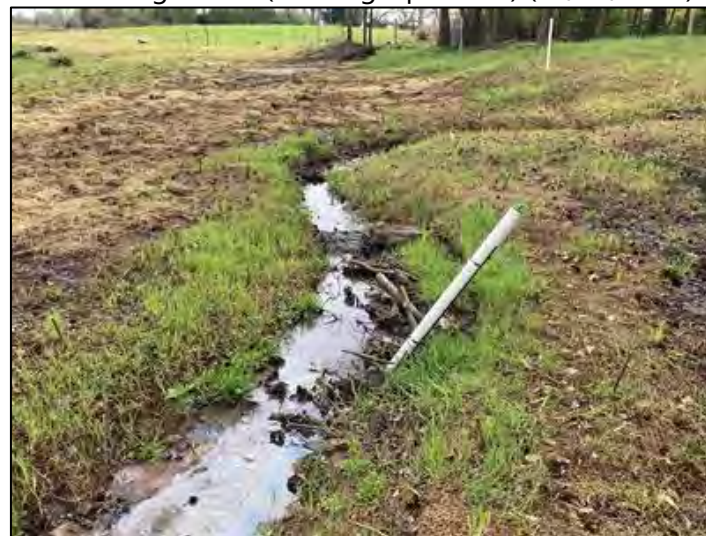
Flow Gauge DE7 (Looking Upstream) (03/28/2023)

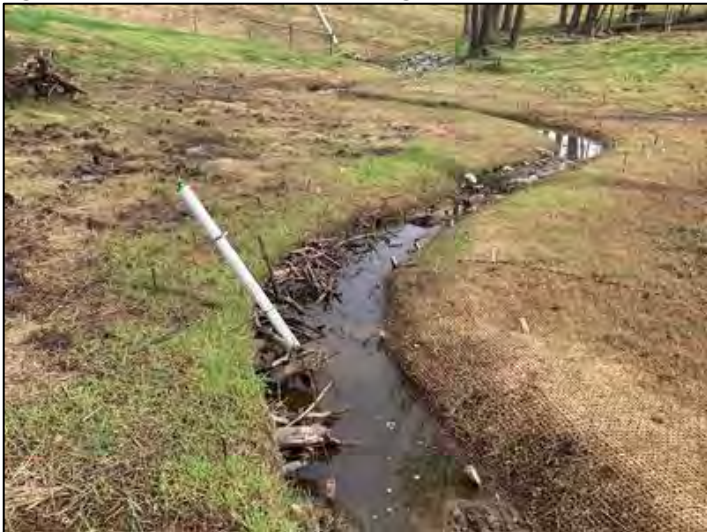
Flow Gauge DE8 (Looking Upstream) (03/28/2023)

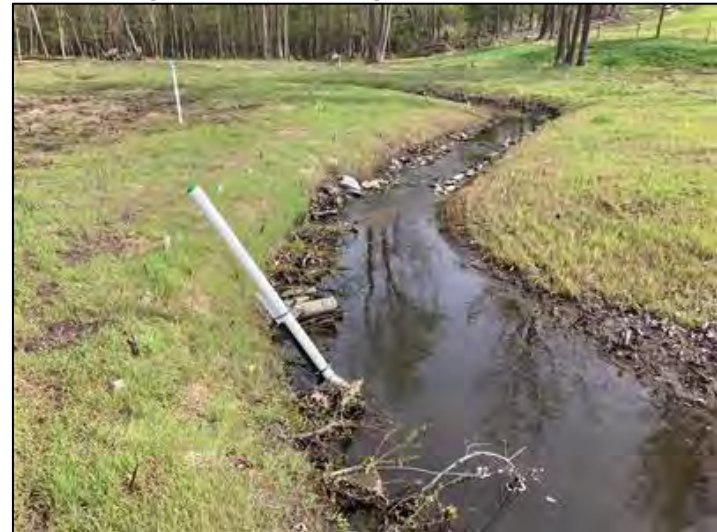
Stage Recorder DE4-B (Looking Upstream) (03/28/2023)

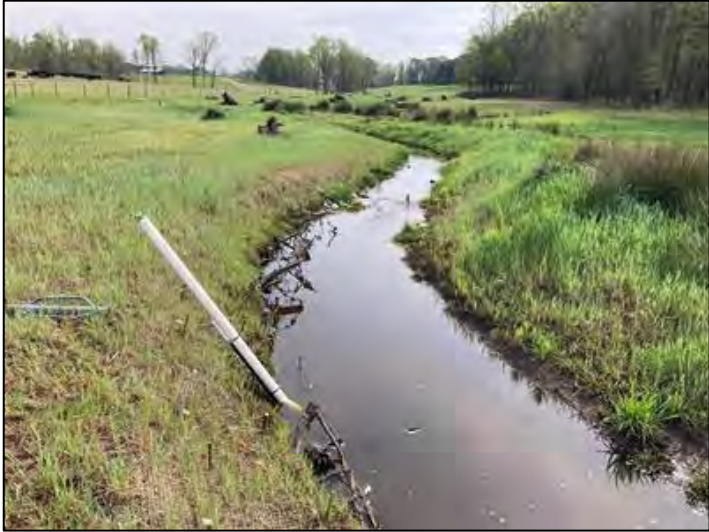
Stage Recorder BB-C\_DS (Looking Upstream) (03/28/2023)
