FINAL
MONITORING REPORT (MY1)

SLINGSHOT MITIGATION SITE
Rockingham County, North Carolina

DMS Project ID No. 100058
Full Delivery Contract No. 7525
USACE Action ID No.SAW-2018-01170
DWR #20180795 RFP No. 16-007330

Data Collection: May - November 2020
Submission: January 2021

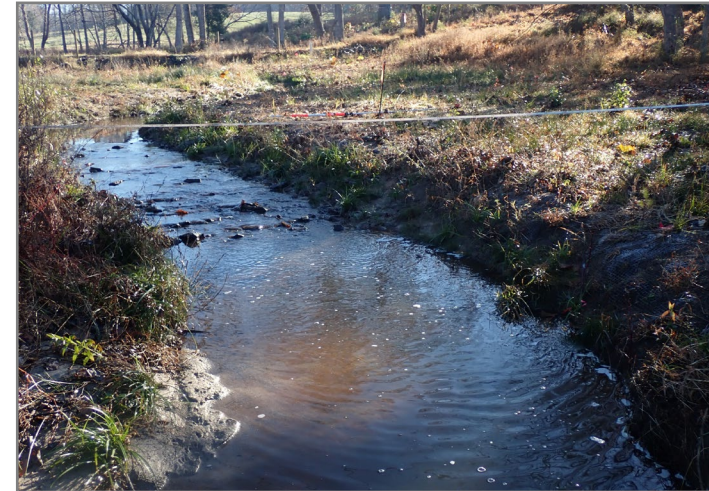
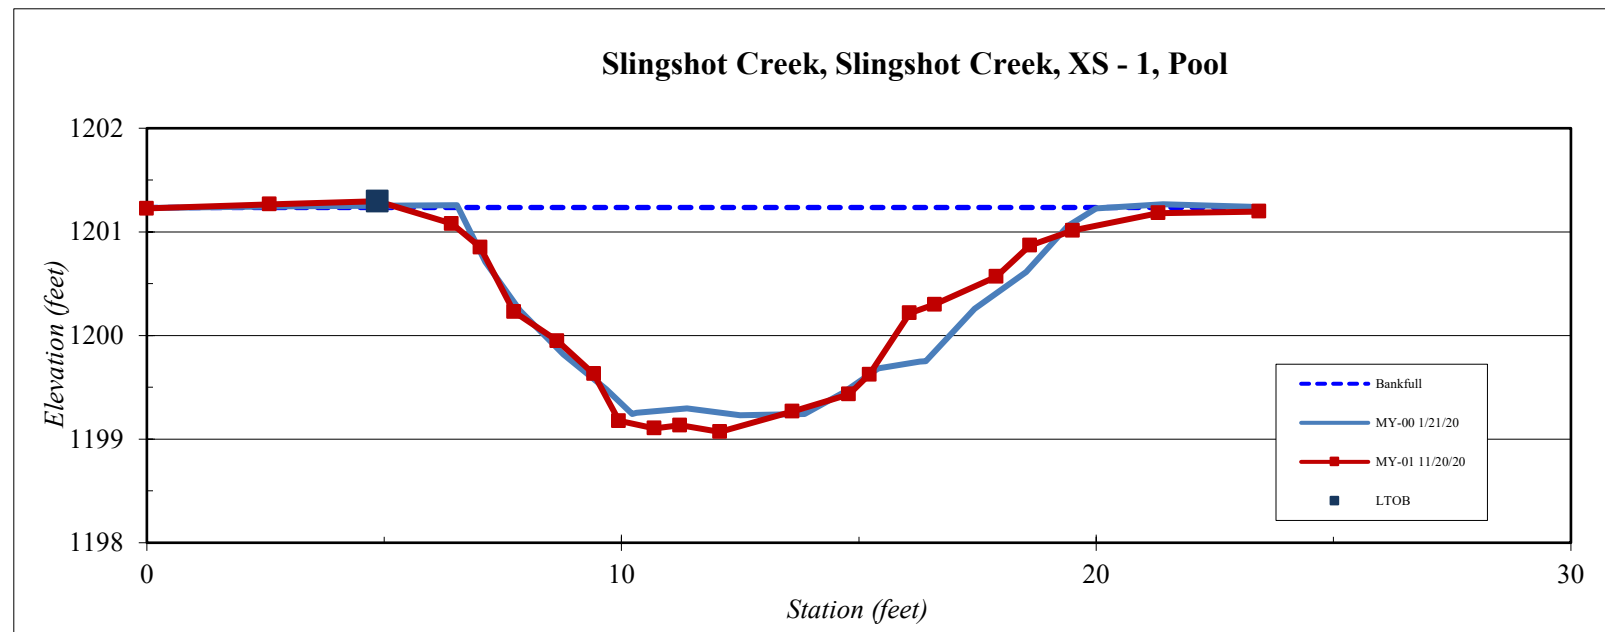
SUMMARY DATA	
Bankfull Elevation:	1201.2
Bankfull Cross-Sectional Area:	18.2
Bankfull Width:	18.8
Flood Prone Area Elevation:	NA
Flood Prone Width:	NA
Max Depth at Bankfull:	2.2
Low Bank Height:	2.2
Mean Depth at Bankfull:	1.0
W / D Ratio:	NA
Entrenchment Ratio:	NA
Bank Height Ratio:	NA

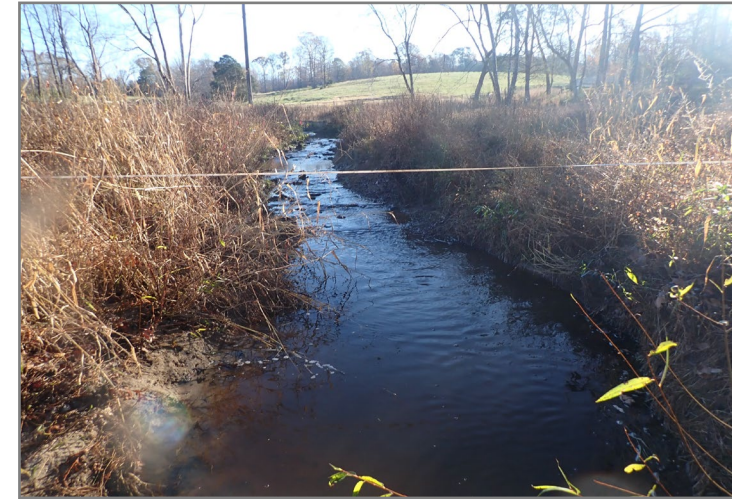
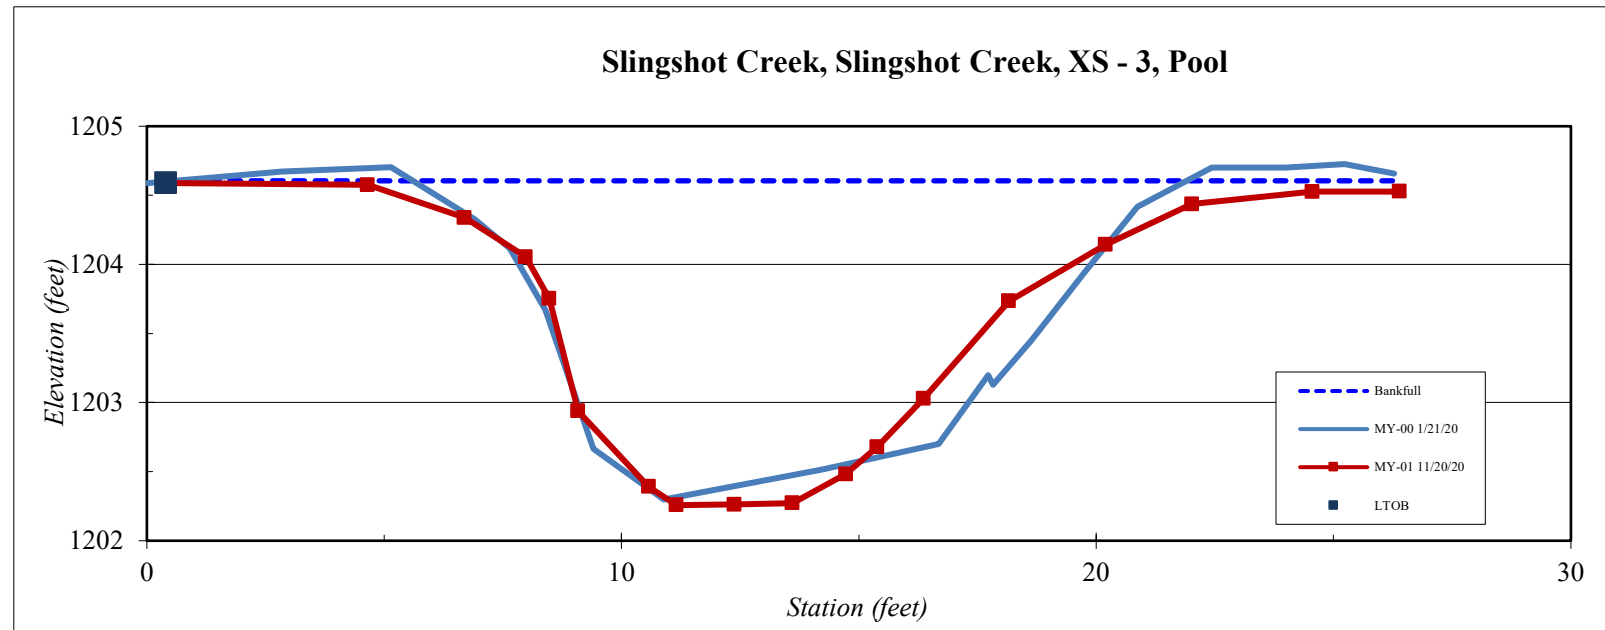
Site	Slingshot Creek
Watershed:	Cape Fear, 03030002
XS ID	Slingshot Creek, XS - 3, Pool
Feature	Pool
Date:	11/20/2020
Field Crew:	Perkinson, Keith

SUMMARY DATA	
Bankfull Elevation:	1204.6
Bankfull Cross-Sectional Area:	22.1
Bankfull Width:	26.0
Flood Prone Area Elevation:	NA
Flood Prone Width:	NA
Max Depth at Bankfull:	2.3
Low Bank Height:	2.3
Mean Depth at Bankfull:	0.8
W / D Ratio:	NA
Entrenchment Ratio:	NA
Bank Height Ratio:	NA

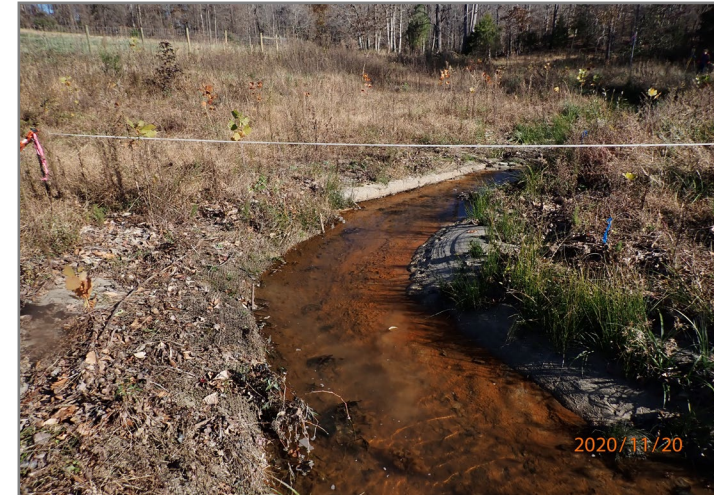
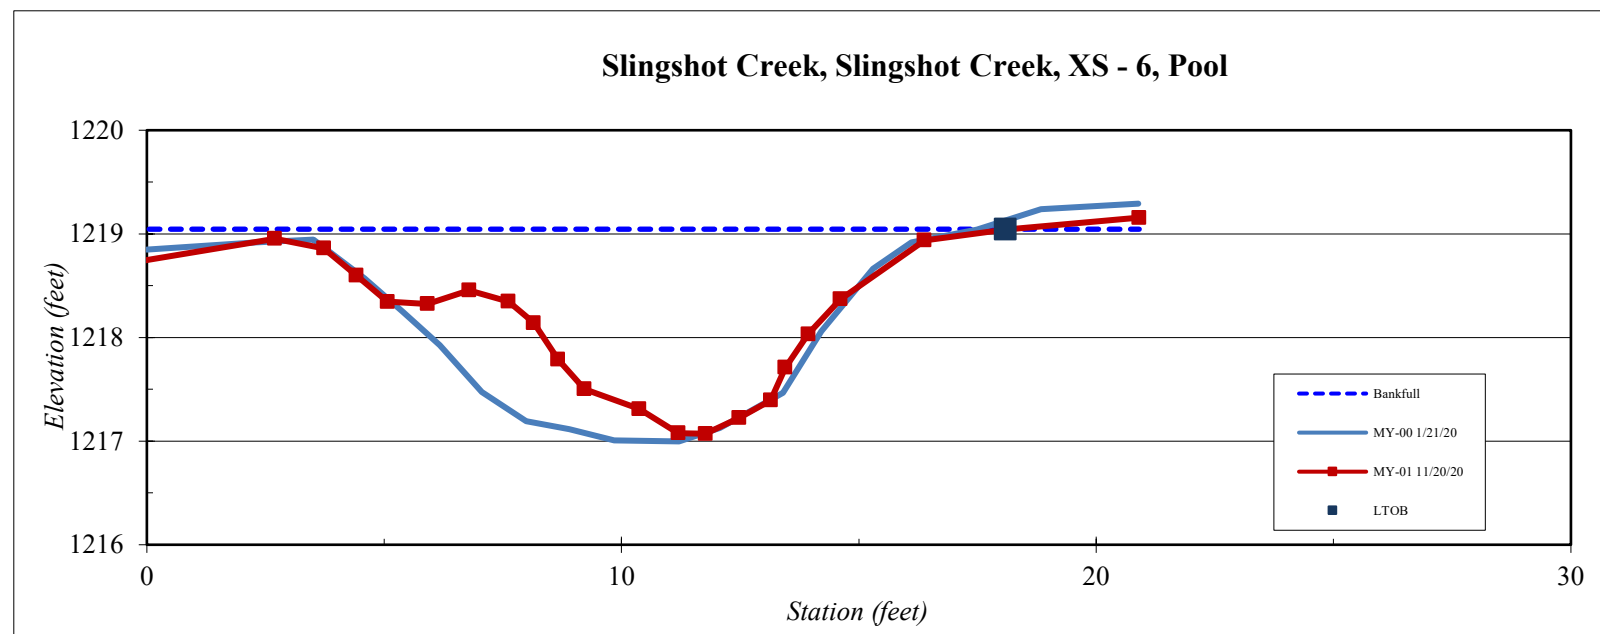
Site	Slingshot Creek
Watershed:	Cape Fear, 03030002
XS ID	Slingshot Creek, XS - 6, Pool
Feature	Pool
Date:	11/20/2020
Field Crew:	Perkinson, Keith

SUMMARY DATA	
Bankfull Elevation:	1219.0
Bankfull Cross-Sectional Area:	14.3
Bankfull Width:	18.6
Flood Prone Area Elevation:	NA
Flood Prone Width:	NA
Max Depth at Bankfull:	2.0
Low Bank Height:	2.0
Mean Depth at Bankfull:	0.8
W / D Ratio:	NA
Entrenchment Ratio:	NA
Bank Height Ratio:	NA

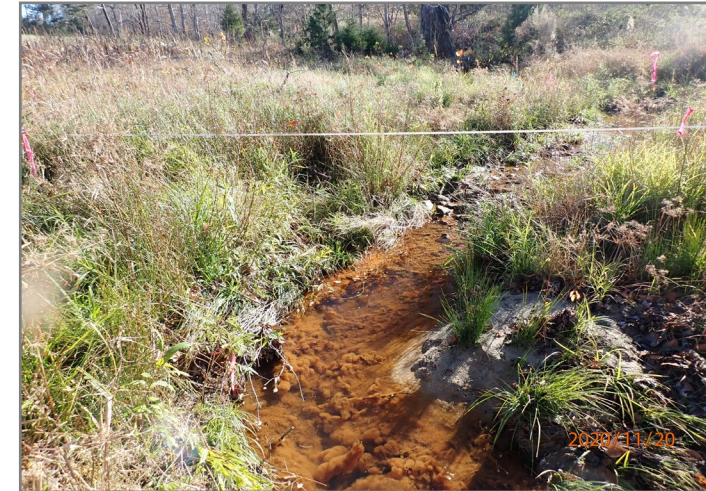
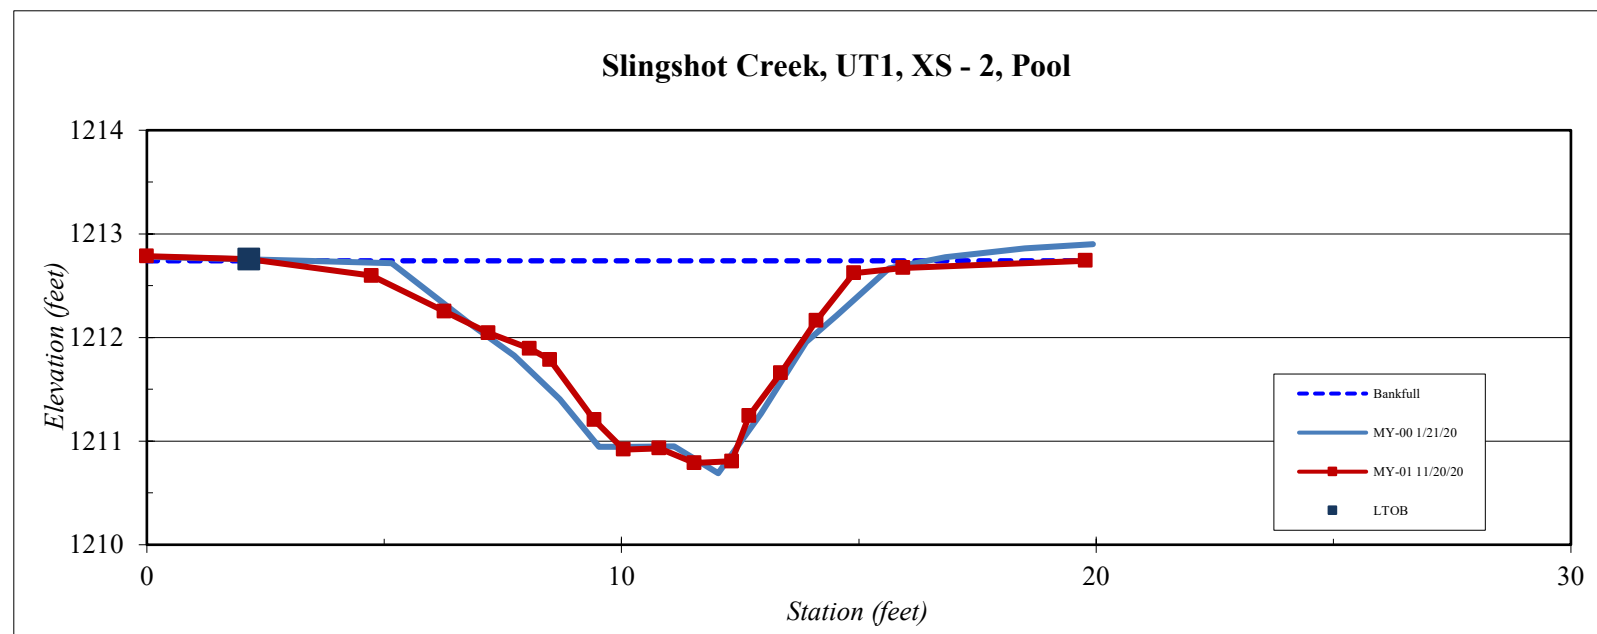
Site	Slingshot Creek
Watershed:	Cape Fear, 03030002
XS ID	UT1, XS - 2, Pool
Feature	Pool
Date:	11/20/2020
Field Crew:	Perkinson, Keith

SUMMARY DATA	
Bankfull Elevation:	1212.7
Bankfull Cross-Sectional Area:	11.4
Bankfull Width:	17.3
Flood Prone Area Elevation:	NA
Flood Prone Width:	NA
Max Depth at Bankfull:	2.0
Low Bank Height:	2.0
Mean Depth at Bankfull:	0.7
W / D Ratio:	NA
Entrenchment Ratio:	NA
Bank Height Ratio:	NA

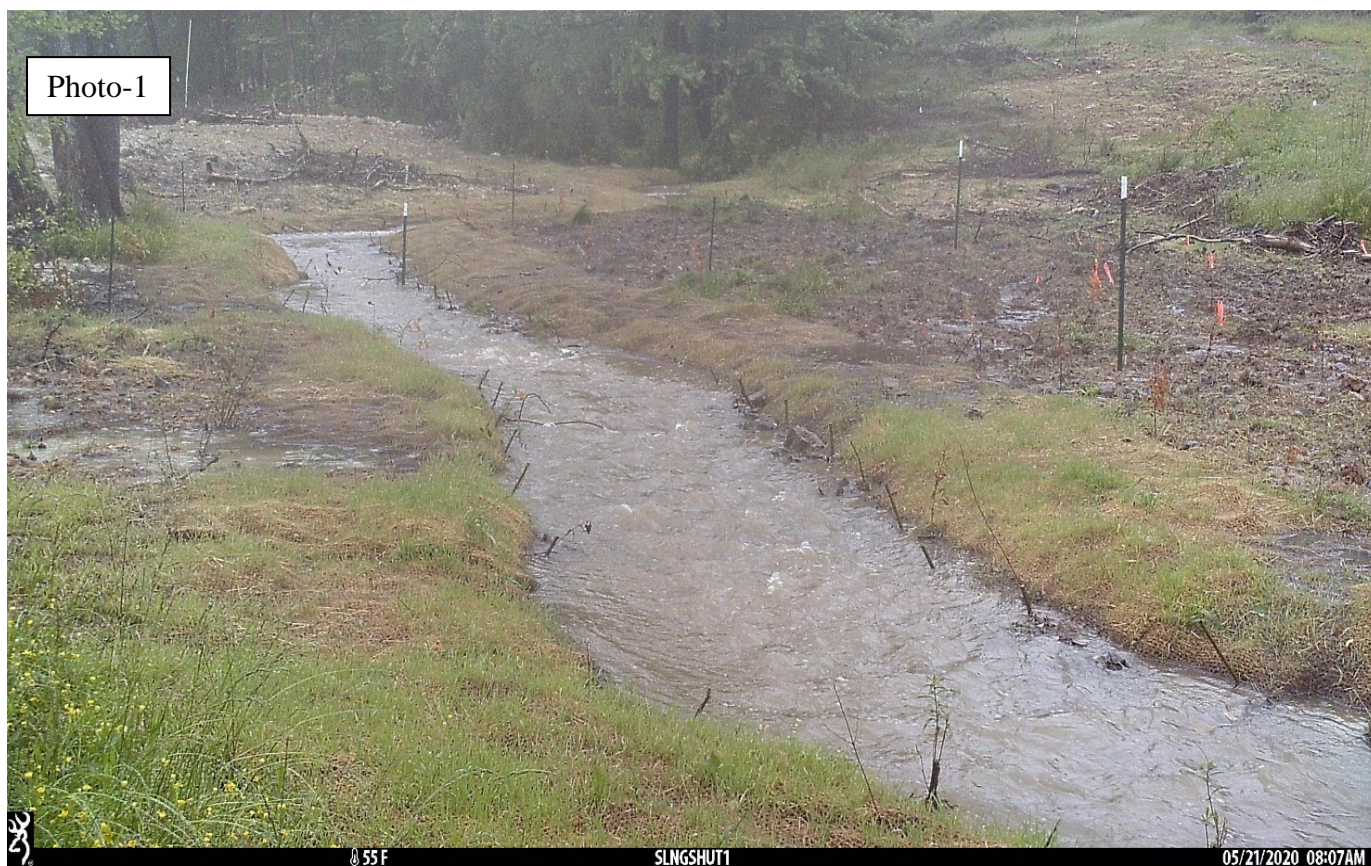
Date of Data Collection	Date of Occurrence	Method	Photo (if available)
June 3, 2020	May 21, 2020	Stream gauges and trail cameras captured a bankfull event after 5.37 inches of rain was documented between May 20th and 22nd, 2020 at an onsite rain gauge. Flow gauge recorded a stream stage of 2.15 feet.	1
November 18, 2020	November 12, 2020	Stream gauges and trail cameras captured a bankfull event after 3.1 inches of rain was documented between November 10th and 13th, 2020 at an onsite rain gauge. Flow gauge recorded a stream stage of 2.94 feet.	2, 3
