# Smith and Austin Creeks Year One Monitoring

Wake Forest, North Carolina

January 2004

# Smith and Austin Creeks Year 1 Monitoring Report Wake Forest, North Carolina

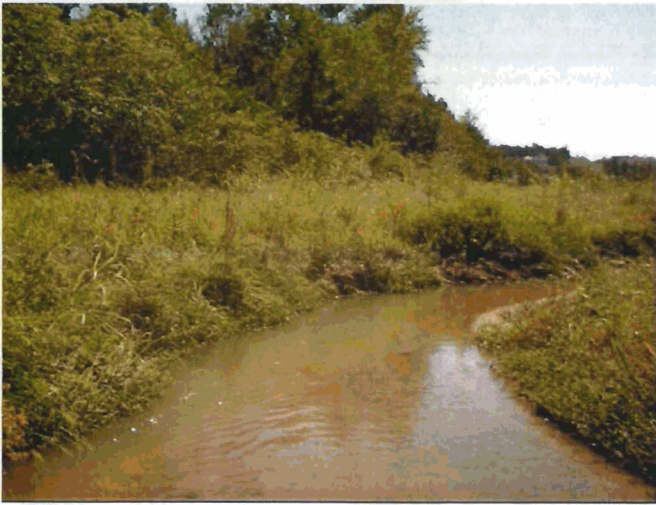
SPP51A - SR1 Live Stake Plot

Survival of live stakes was evaluated counting the two plots located in SR1 and AR3. We found 110 of the original 145 live stakes counted in SR1. 103 of the 110 live stakes found were living (6.4% mortality rate for those live stakes found). Overall the live stake plot looked like it was in good condition and did not need to be replanted (SPP 51A, 51B, and 51C in Tab 4). We could not account for 35 of the originally counted stakes. Some of them may be overshadowed by the other live stakes or the transplants above the rootwads in that meander bend. We found 89 of the original 128 stakes counted in AR3. 78 of the 89 found were living (12.4% mortality rate). Again, the plot appears to be stable and no replanting is necessary (APP 22A in Tab 4). The transplants are very thick in this bend and most of the stakes that could not be found were overgrown by transplants.

Reach	Photo Point (#)	Planted (stakes)	Year 1 (stakes)	Year 2 (stakes)	Year 3 (stakes)	Year 4 (stakes)	Year 5 (stakes)
SR1	51A, B, C	145	103 of 110 found 93.6%				
AR3	22A	128	78 of 89 found 87.6%
