**Snow Creek Stream Restoration
2006 Monitoring Report
Monitoring Year Two**

Ecosystem Enhancement Program Project Number 00344

Submitted: January 19, 2007

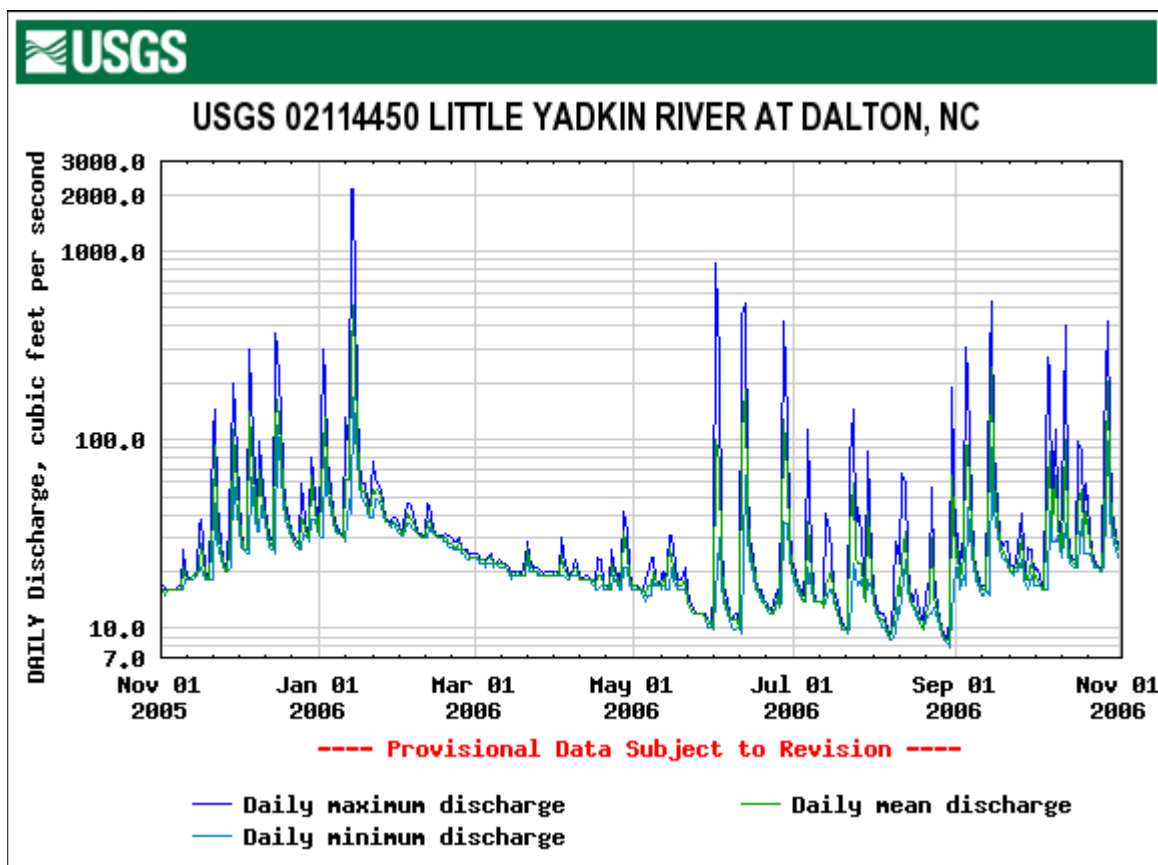
Figure 4. USGS Stream Gage Discharge Data

No crest gages are installed at this site to document bankfull events. Therefore, potential occurrence was extrapolated based on USGS stream gage discharge data for the Little Yadkin River at Dalton, NC (USGS 2006). The USGS gage plot is shown below (Figure 4). The gage is located about 25 miles from the project site and has a drainage area of 43 square miles. An estimate of the number of bankfull events in 2006 was made by comparing the stream discharges from the USGS data in cubic feet per second (cfs) against the bankfull discharge estimated from the drainage area on the Rural Piedmont Regional Curve. According to the regional curve, a bankfull event occurs on a stream with a 43-square mile drainage area when the discharge is about 1,300 cfs. This discharge was exceeded in mid January of 2006, indicating that the Little Yadkin River has had one bankfull event this year (as of November 2, 2006). Snow Creek is in proximity to the Little Yadkin River, and it is likely that the project site also experienced a bankfull event in mid January 2006.

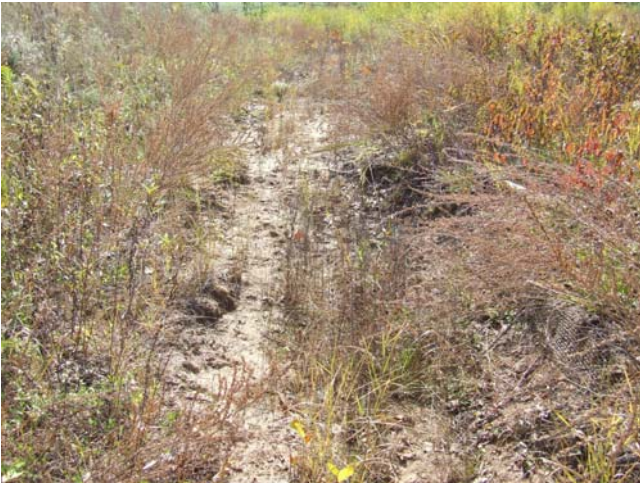
VPA1 on left bank, facing south

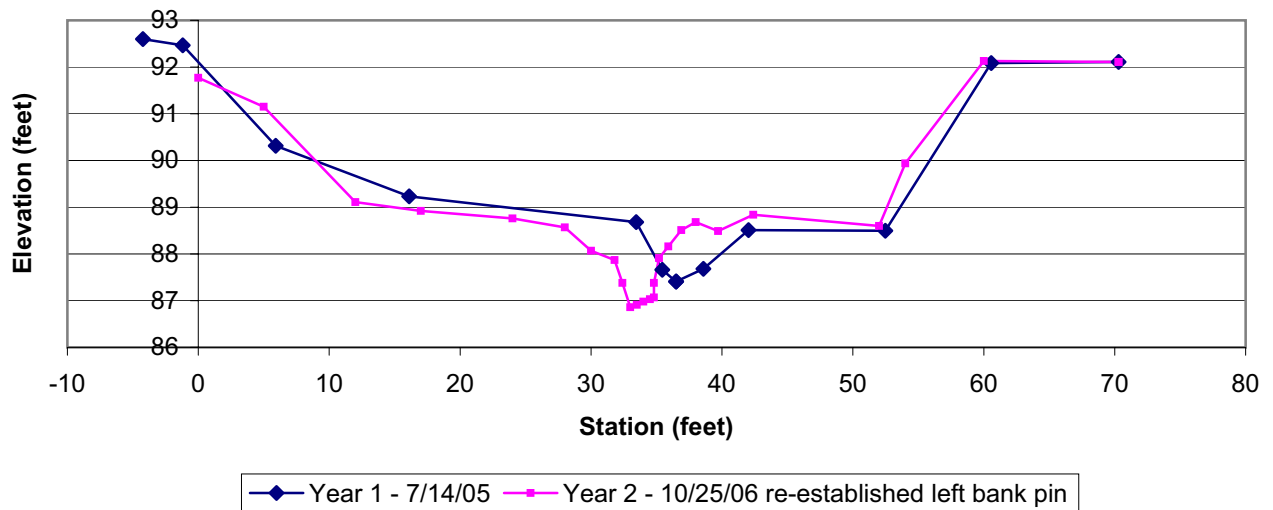
UT to Snow Creek XS 2 - Year 1 & 2 Overlay

Cross section pins were located for all plots with the exception of cross section 2 on the UT to Snow Creek, where the left bank pin was not found. URS re-established the left bank pin in the field. Data from this cross section are not comparable to the previous year's data. The re-establishment of pins effectively relocates the cross sections.

Notes: Hand manipulated for data overlay to compensate for re-established left bank pin.
