**Snow Creek Stream Restoration  
2007 Final Monitoring Report  
Monitoring Year Three**

**Ecosystem Enhancement Program Project Number 00344**

Prepared by: URS Corporation – North Carolina  
1600 Perimeter Park Drive, Suite 400  
Morrisville, NC 27560

Submitted: February 22, 2008

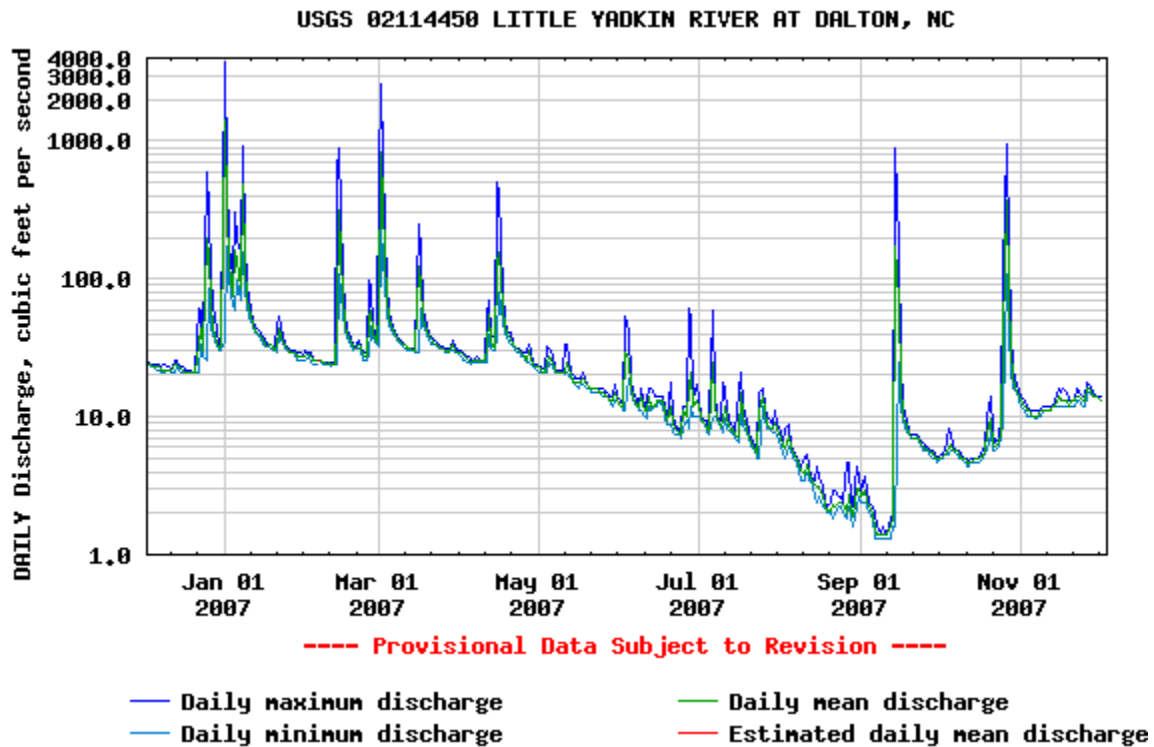
Figure 4. USGS Stream Gage Discharge Data

No crest gages are installed at this site to document bankfull events. Therefore, potential occurrence was extrapolated based on USGS stream gage discharge data for the Little Yadkin River at Dalton, NC (USGS 2007). The USGS gage plot is shown below (Figure 4). The gage is located about 25 miles from the project site and has a drainage area of 43 square miles. An estimate of the number of bankfull events in 2007 was made by comparing the stream discharges from the USGS data in cubic feet per second (cfs) against the bankfull discharge estimated from the drainage area on the Rural Piedmont Regional Curve. According to the regional curve, a bankfull event occurs on a stream with a 43-square mile drainage area when the discharge is about 1,300 cfs. This discharge was exceeded in January and March of 2007, indicating that the Little Yadkin River has had two bankfull events this year (as of November 30, 2007). Snow Creek is in proximity to the Little Yadkin River, and it is likely that the project site also experienced two bankfull events during 2007.

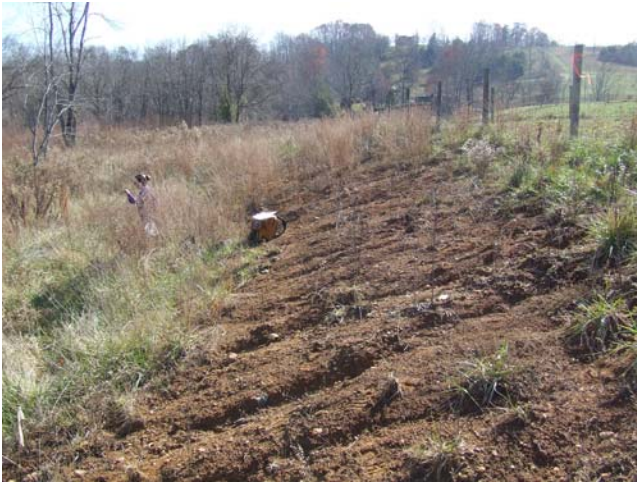
VPA2 on right bank, facing downstream

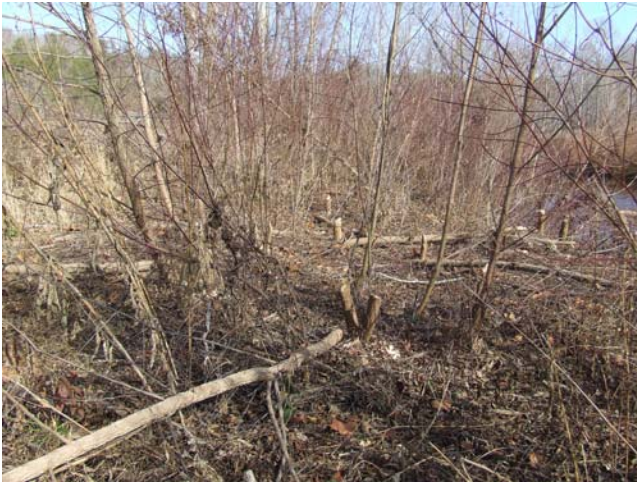
NVPA2 on left bank, facing downstream

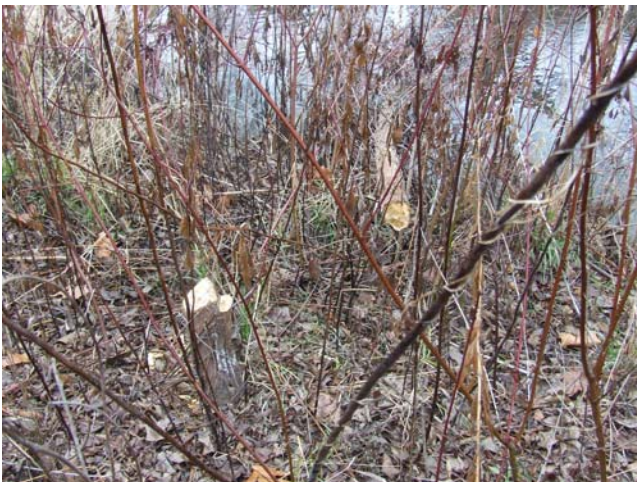
NVPA4 on left bank, facing downstream

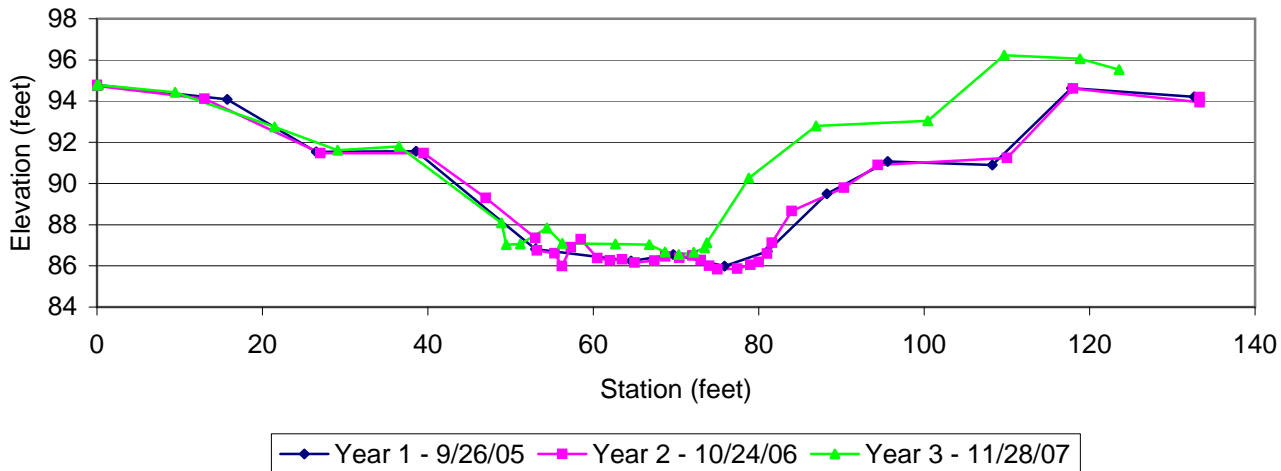
Snow Creek - XS 1, Year 1, 2, & 3 Overlay  
 Notes: Hand manipulated for data overlay.  
 2007 Right pin shot deleted due to error in recording.

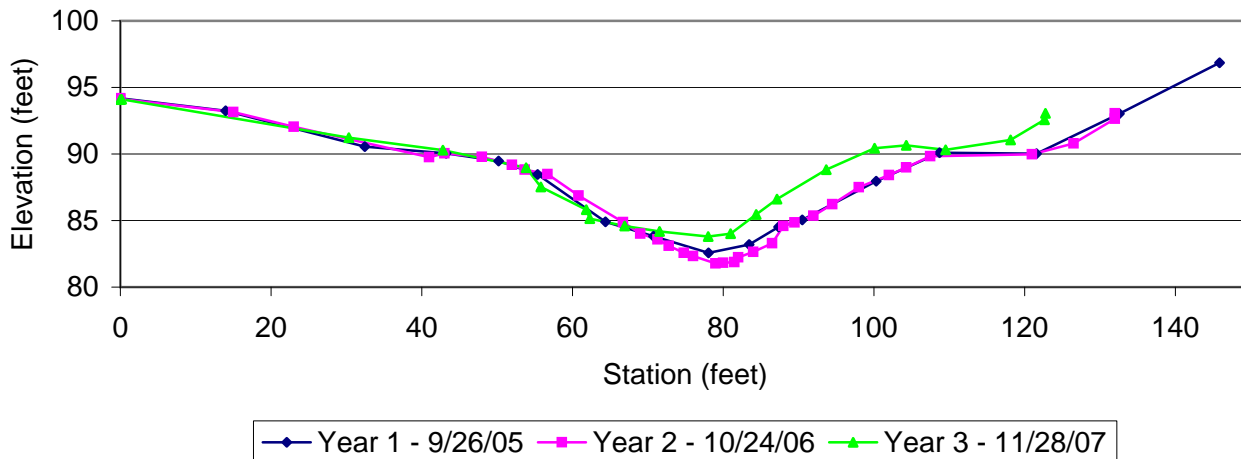
Snow Creek - XS 2, Year 1, 2 & 3 Overlay  
 Notes: Hand manipulated for data overlay  
 2006 and 2007 right pin is steel conduit (vegetation plot corner).

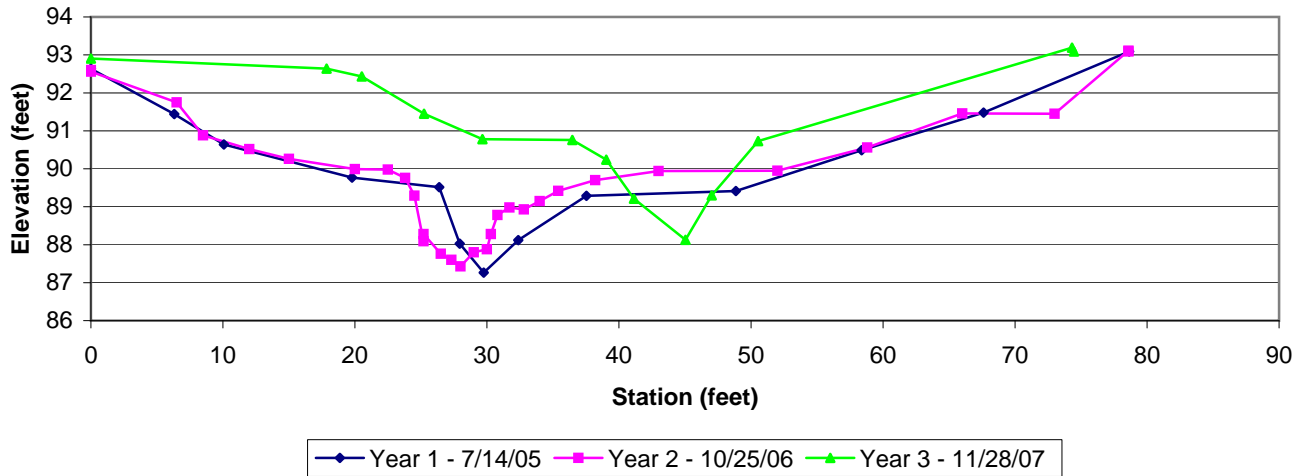
### UT to Snow Creek XS 1 - Pool - Year 1, 2 & 3 Overlay

Notes: Hand manipulated for data overlay.  
Left pin not found during 2007 survey.

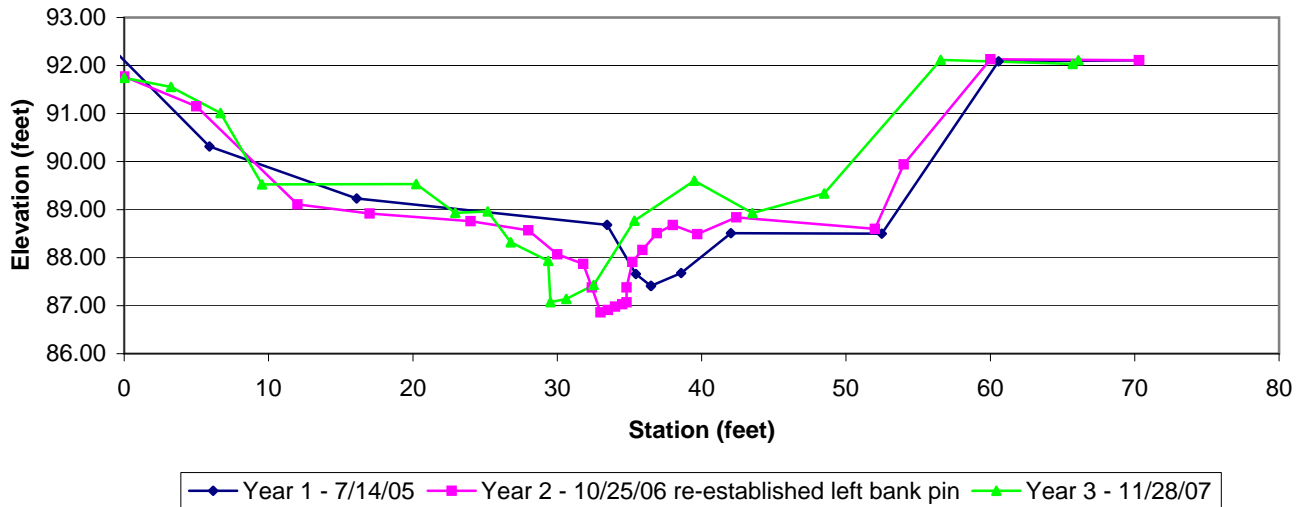
### UT to Snow Creek XS 2 - Riffle - Year 1, 2 & 3 Overlay

Notes: Hand manipulated for data overlay to compensate for re-established left bank pin.
