**Snow Creek Stream Restoration
2008 Final Monitoring Report
Monitoring Year Four**

Ecosystem Enhancement Program Project Number 00344

February 12, 2009

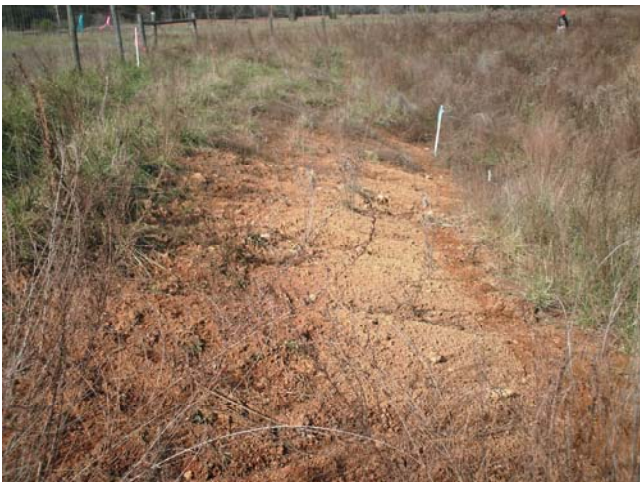
VPA5 on right bank (11/19/08)

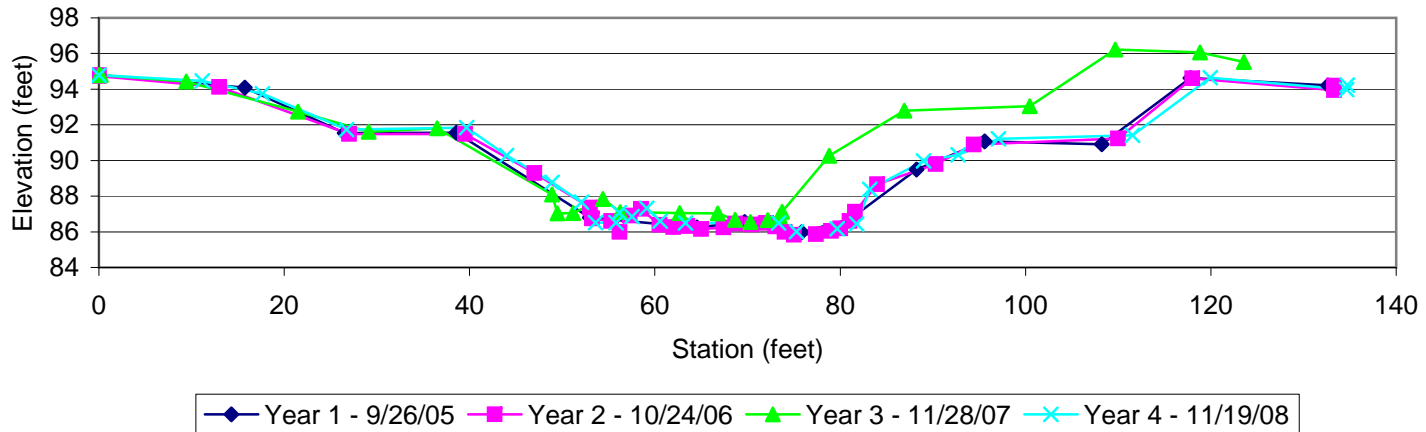
Snow Creek - XS 1, Year 1, 2, 3, & 4 Overlay
 Notes: Hand manipulated for data overlay.
 2007 Right pin shot deleted due to error in recording.
 Site experienced massive sand deposition between 2006 and 2007.
