**South Fork Mitigation Project
Catawba County, North Carolina**

Year 3 Monitoring Report

November 2007

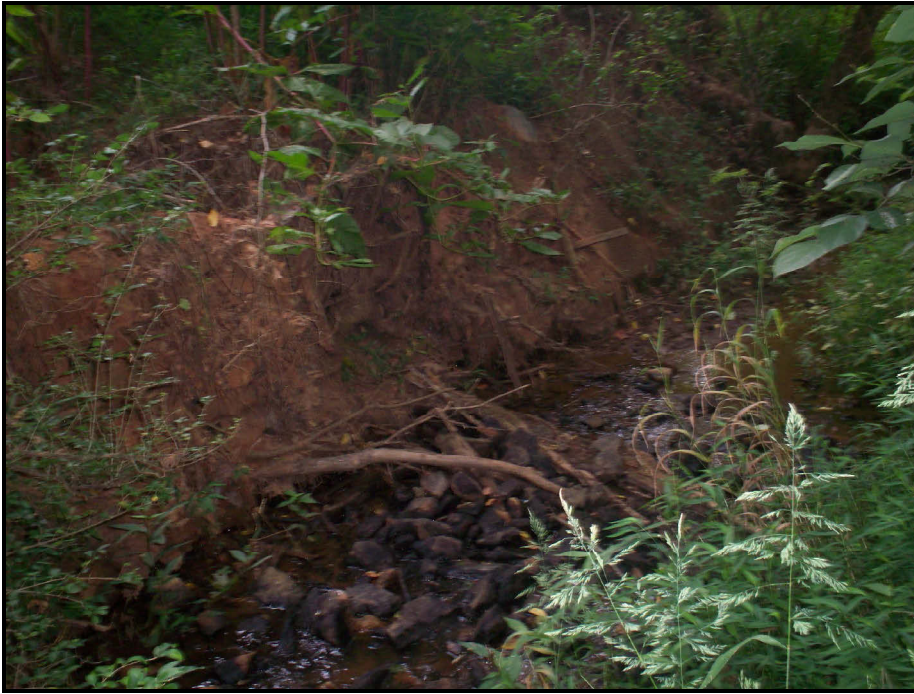
SPA 1. Erosion along left bank in UT-2A North at STA 10+50

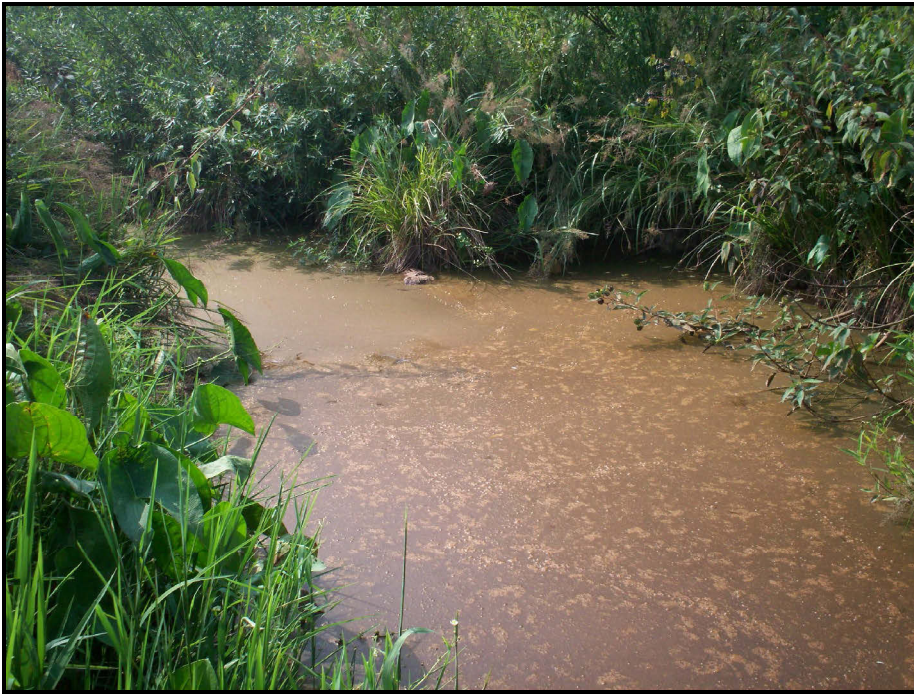
SPA 3. Stagnant flow in UT2A North at STA 25+50 resulting from excess vegetation downstream of the photo.

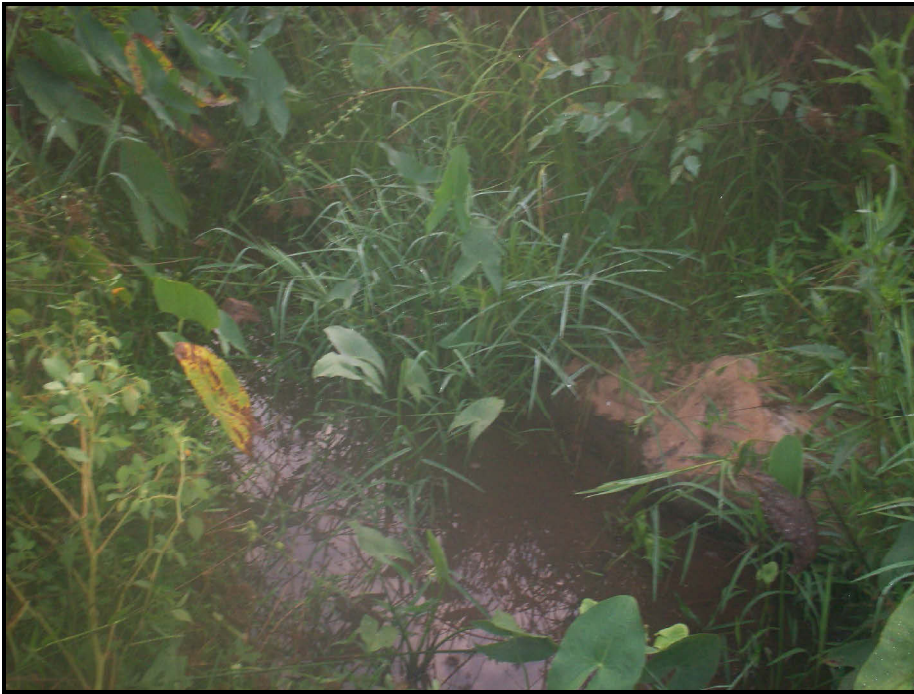
SPA 6. Vegetation filling channel in UT3 North at station 12+00 and throughout UT3.

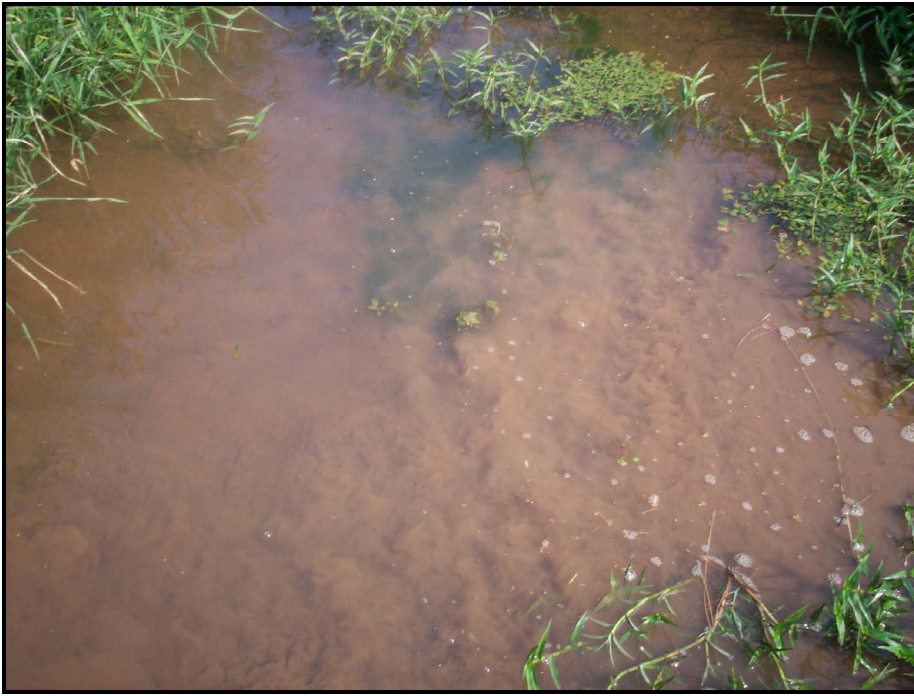
SPA 7. Buried log vane in UT1A North at STA 50+00.

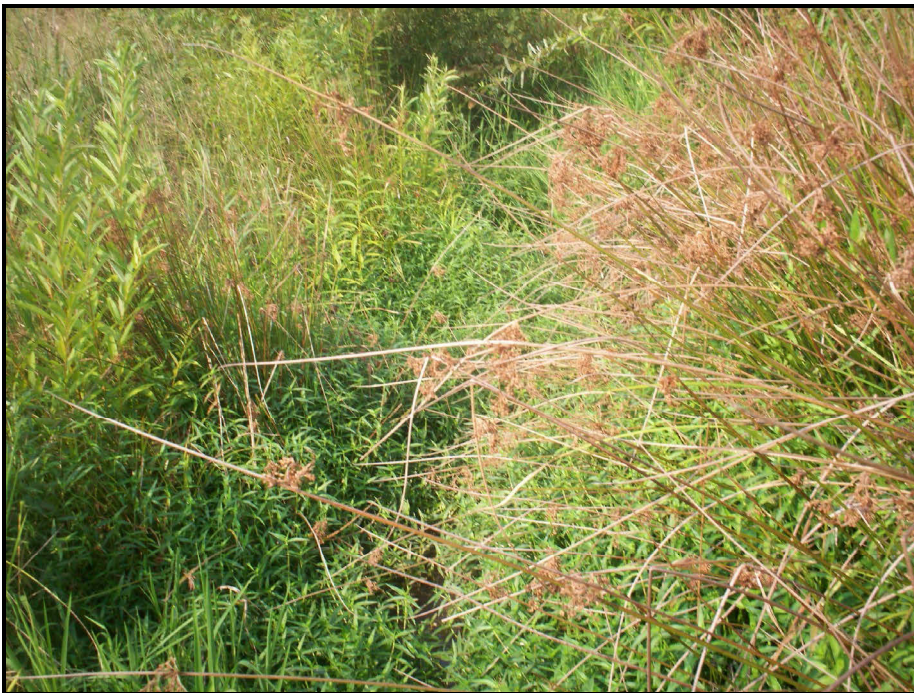
SPA 8. Vegetation growing in the channel channel at constructed riffle in UT1A North at STA 53+25.

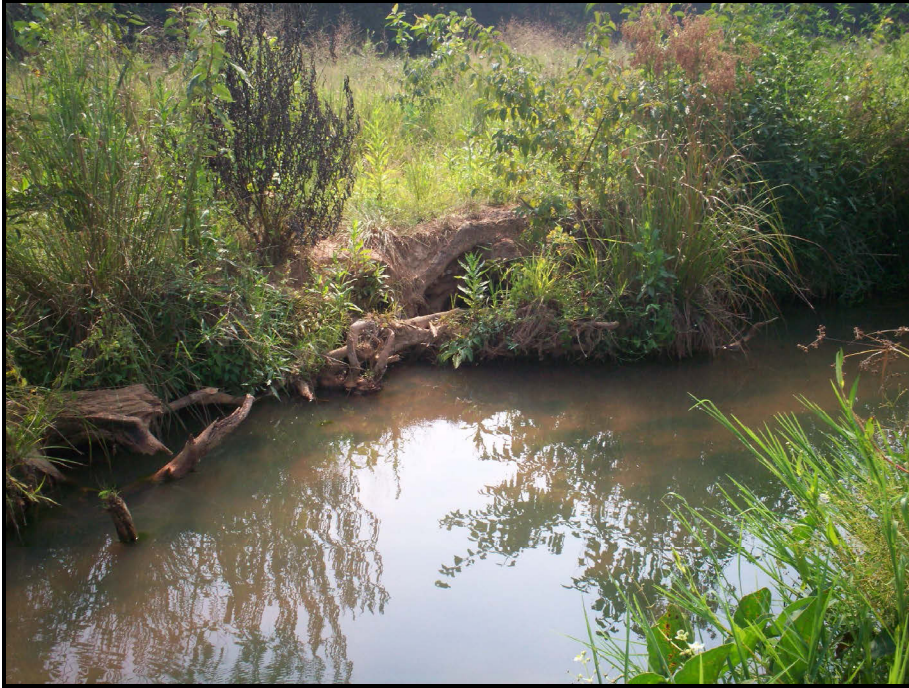
SPA 9. Minor erosion at root wad in UT1A North at STA 60+00.

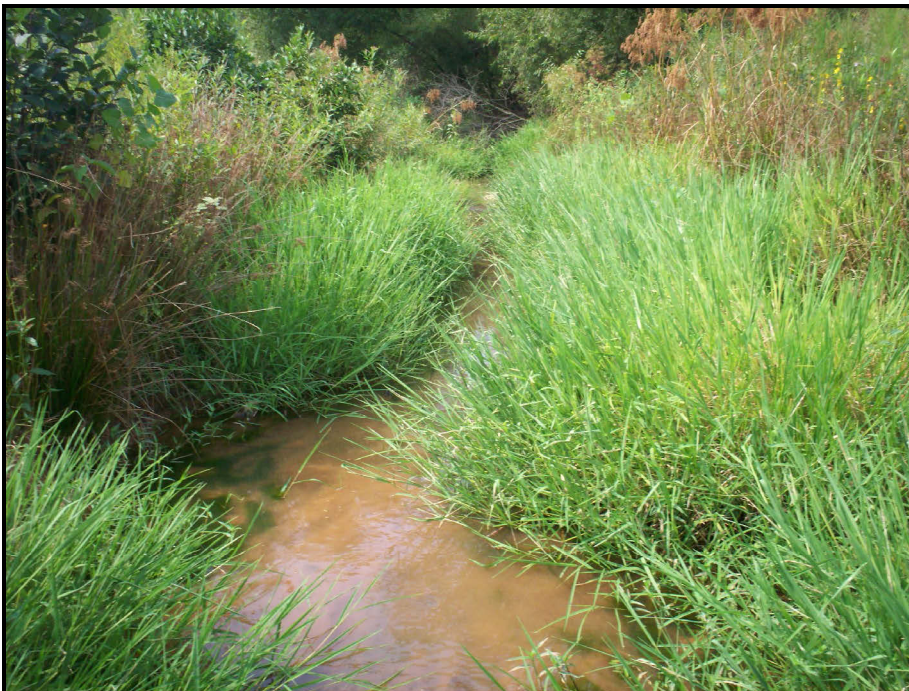
SPA 10. Upstream portion of constructed riffle buried in UT1A North at STA 67+50.

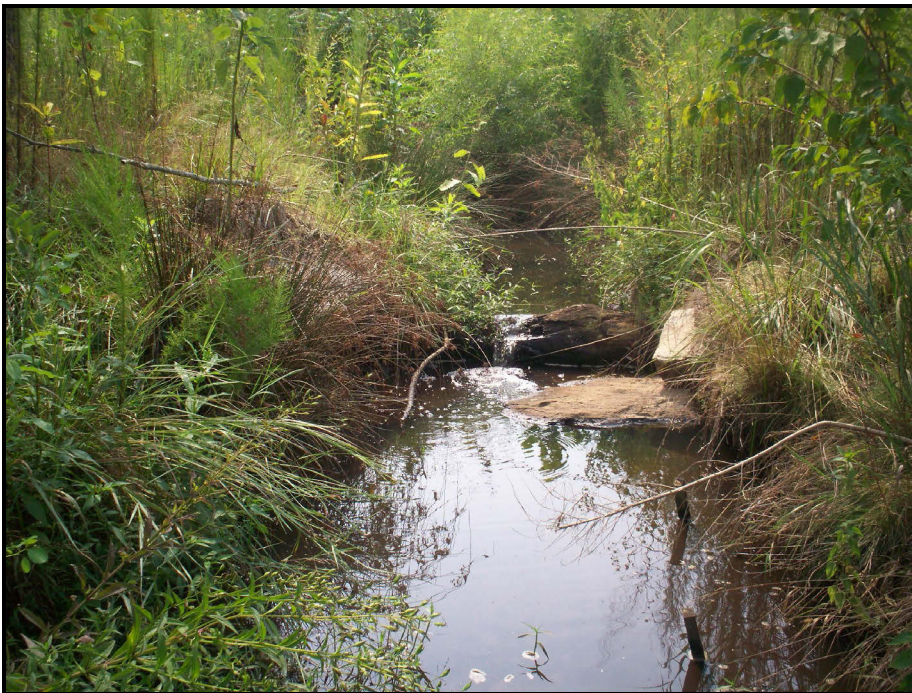
SPA 12. Water backing up below Log weir and over constructed riffle in M2 South at STA 31+00.

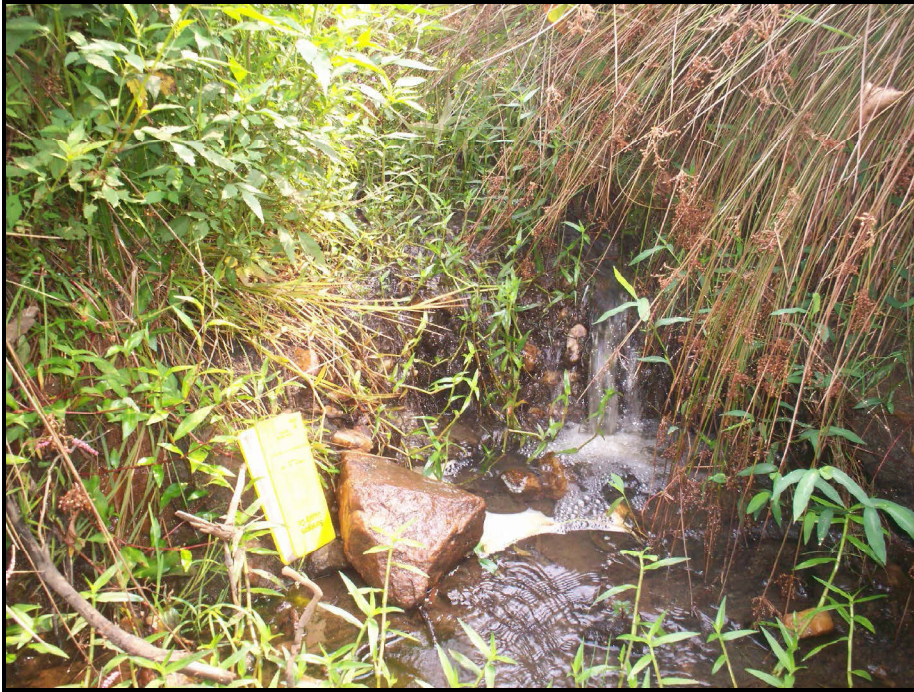
erosion around some of the root wads and in-stream structures. One concern is the step-pool feature in Reach M2. Significant erosion is occurring behind boulders placed in the step pool, and just upstream of the step pool a head cut is working its way upstream. Cows were observed in the easement in South Fork South. Repairs have been made to gates in order to prevent cows from entering the easement. Photos of problem areas and other structures taken during August 2007 are included in Appendix C.

SPA 13. Head cut in M2 South at STA 37+25.

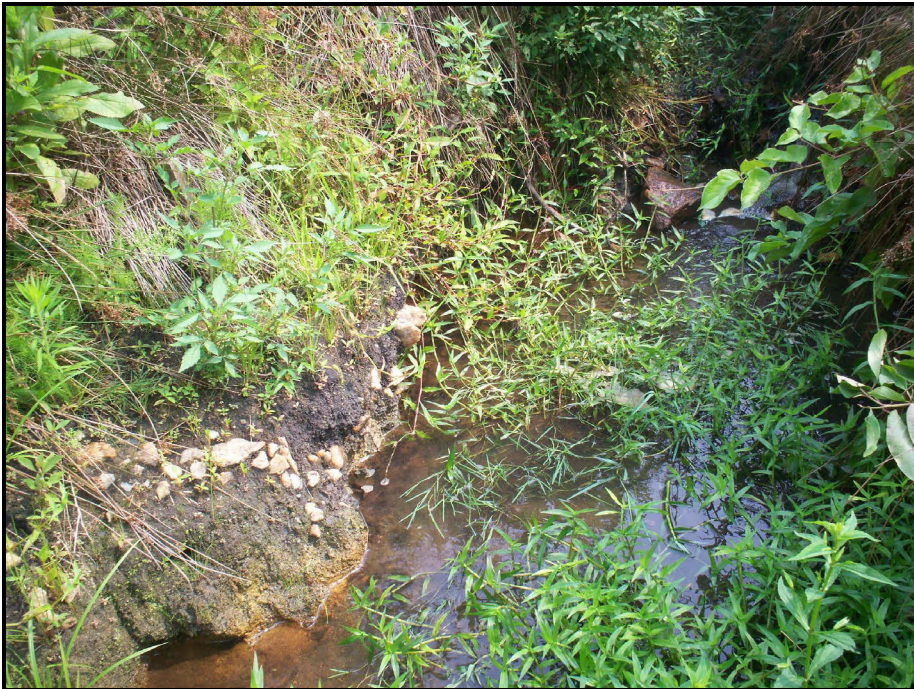
SPA 14. Bank incision downstream of head cut in M2 South at STA 37+50.

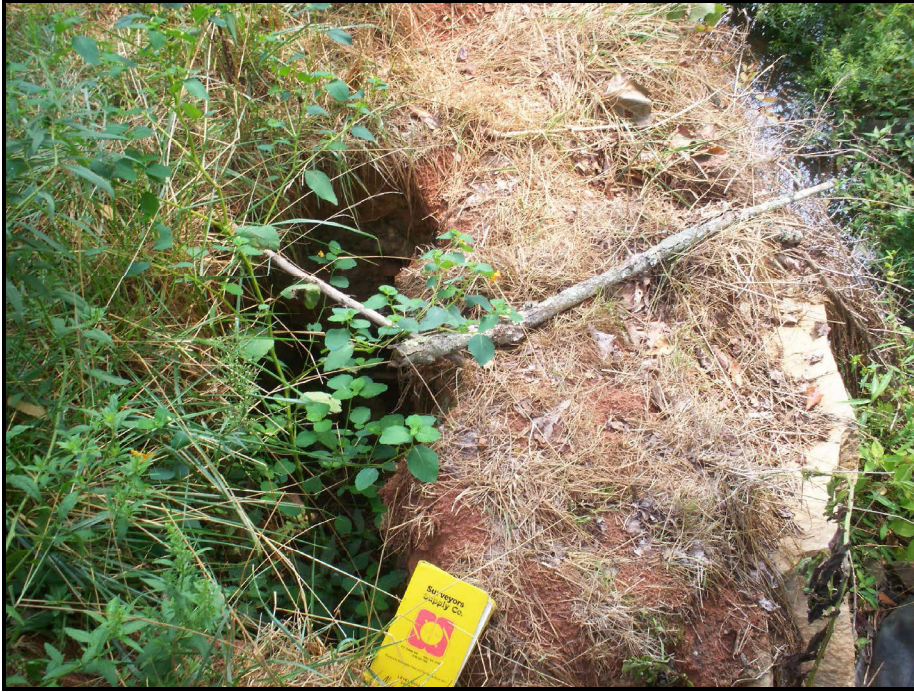
SPA 15. Erosion behind boulder at step pool in M2 South at STA 38+00
