**South Fork Mitigation Project
Catawba County, North Carolina**

Year 5 Monitoring Report

FINAL

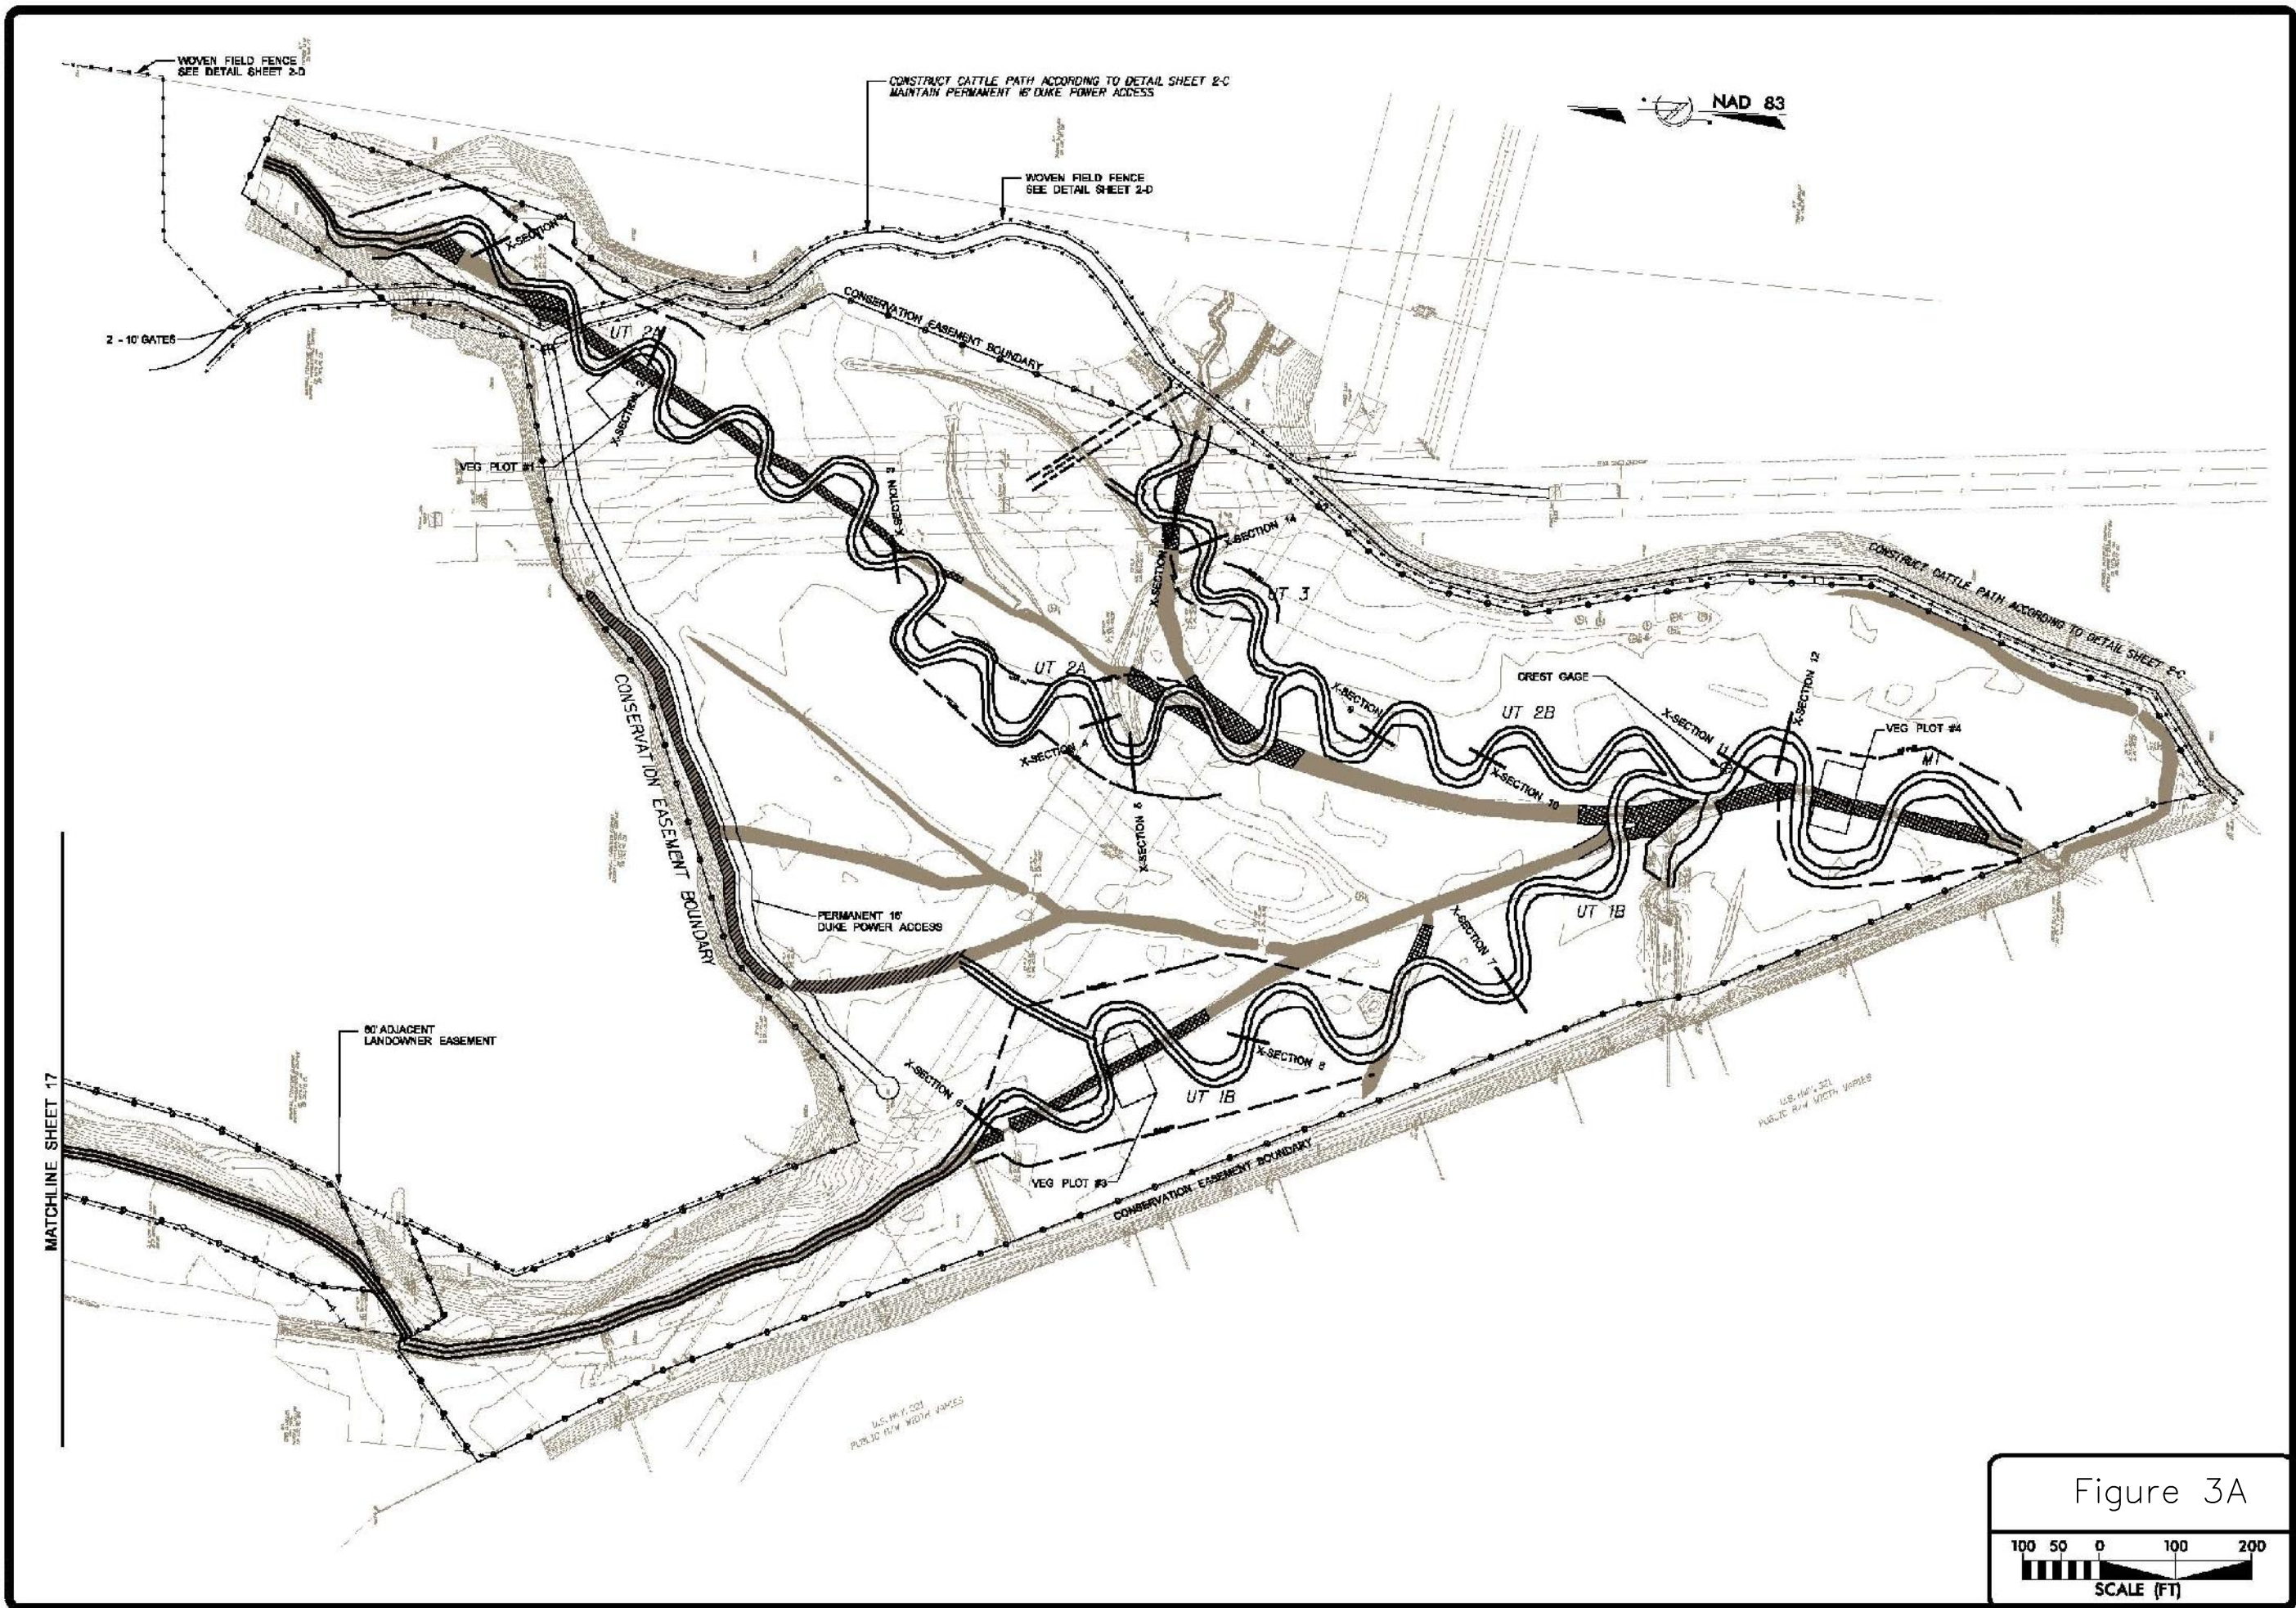
Figure 3A

Two crest gauges were installed on the site to document bankfull events. The gauges record the highest out-of-bank flow events that occurred and are checked monthly through the year. The gauges are located on reaches M1 and M2 (See Figures 3A and 3B). The gauge on reach M1 is located near stream station 61+25 (cross section 11). The gauge on reach M2 is located near stream station 28+50 (between cross section 4 and cross section 5).

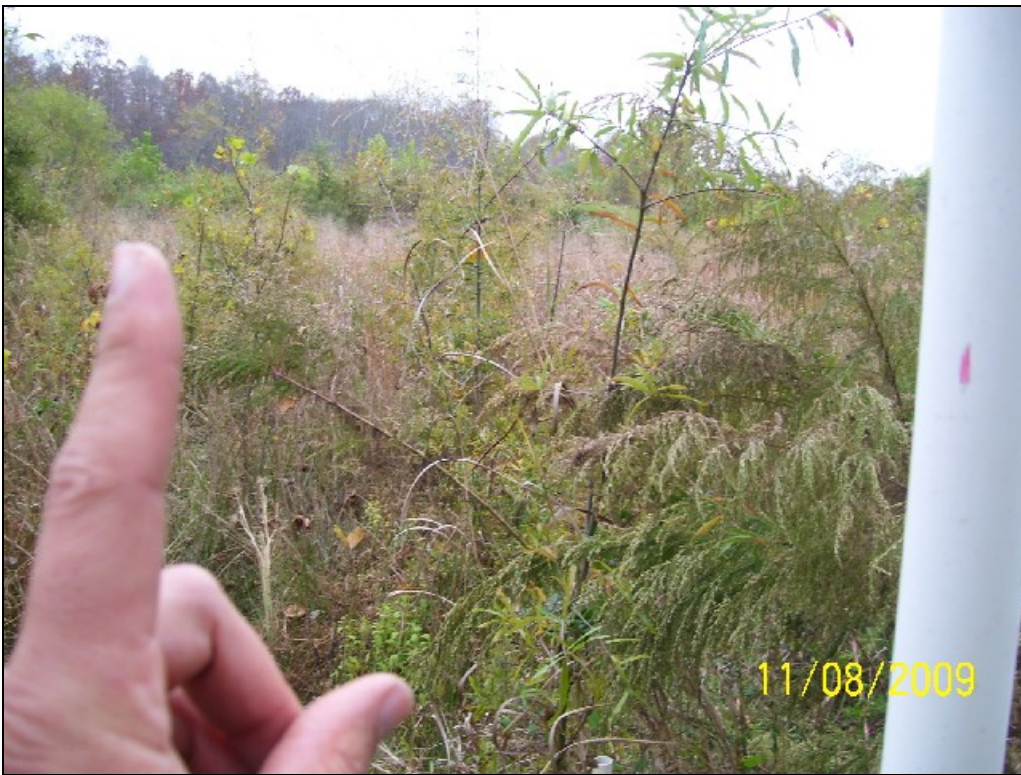
Typical stable and naturalized root wad
