# SOUTH FORK HOPPERS CREEK STREAM AND WETLAND RESTORATION PROJECT

## ANNUAL MONITORING REPORT FOR 2008 (YEAR 3)

Project Number: D04006-4

November 2008

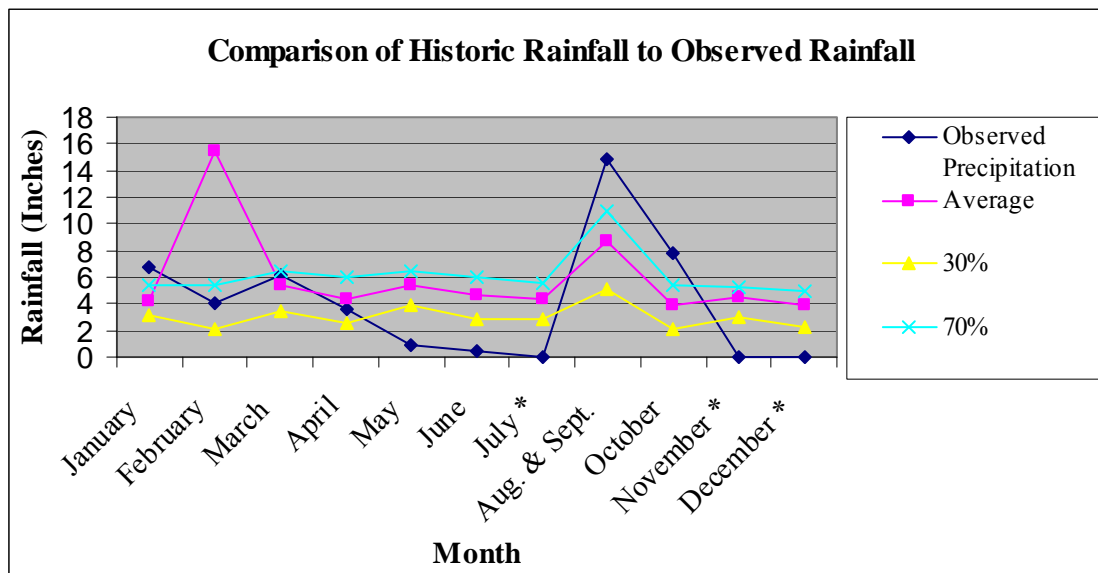
**Figure 5. Historic Average vs. Observed Rainfall**

\*Rainfall data is recorded as 0.00 because no rainfall data was observed onsite during the month.

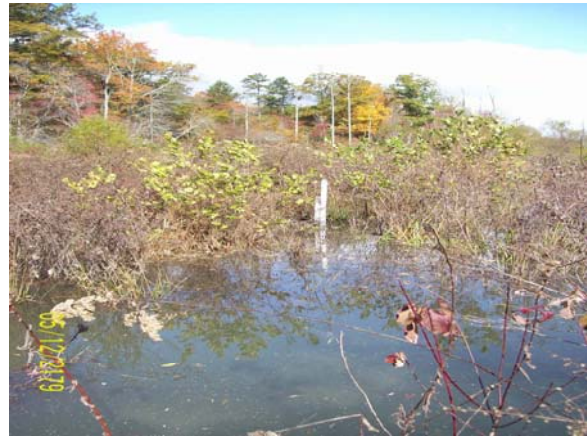
Crest gauge data was unable to be documented for the last site visit on 10/28/08 due to a recently built beaver dam just downstream of the gauge at approximately Station 176+50. The dam has backed up water and the gauge could not be accurately interpreted. The dam is scheduled for removal to restore normal stream flow conditions.

**Crest Gauge Underwater – 10/28/08**

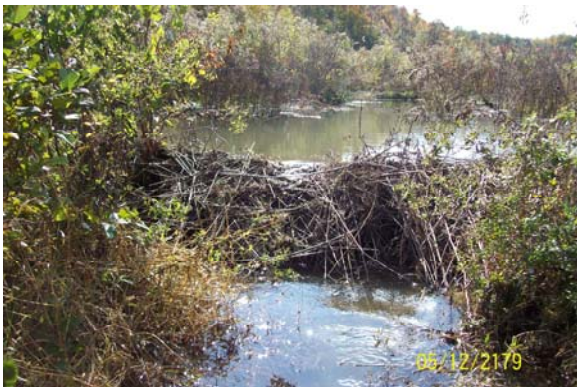
before vegetation established along the streambanks. These areas of minor scour were still visible during Year 3 monitoring, and do not appear to have changed. Also, a downstream beaver impoundment backed up water onto the site during Year 2 monitoring. Since then that impoundment was either removed or abandoned. A new beaver impoundment was noted at Station 176+50 during monitoring this year. This structure is backing up water into the floodplain and could threaten Vegetation Monitoring Plot #2. It is scheduled for removal.

Observations of deer and raccoon tracks are common on the Site. Beavers are present and have created a beaver dam within the Site around Station 176+50. During certain times of the year, frogs, turtles, snakes, and fish have also been observed.

**Beaver dam at Station 176+50**
