**Year 1 Monitoring Report for Stream Mitigation of South Muddy Creek
Tributaries
(Queen Property)**

South Muddy Creek Tributaries
McDowell County, NC
SCO # D04006-01

Submitted: September 2007

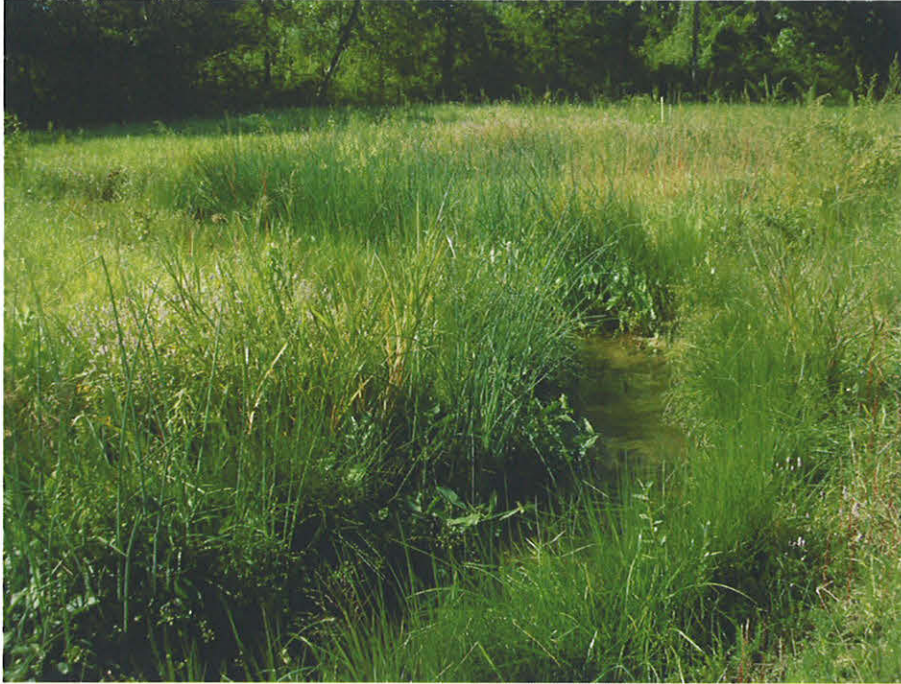
Fixed Station 1
Overview of Tributary A (upper), facing upstream.
(EMH&T, Inc. 9/20/06)

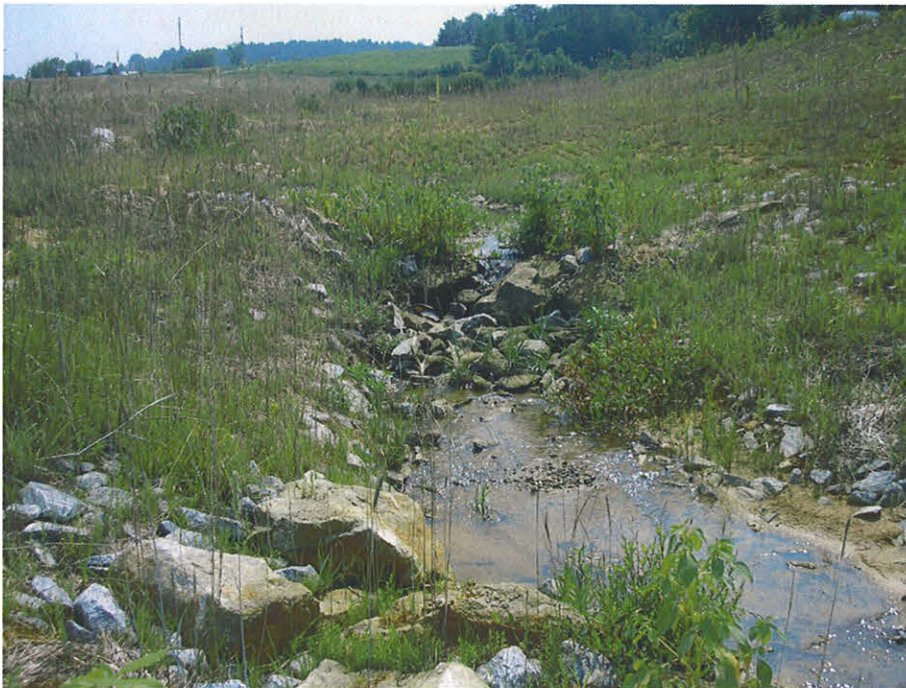
Fixed Station 2
Overview of valley along Tributary A2 at confluence with Tributary A, facing upstream.
(EMH&T, Inc. 97/11/06)

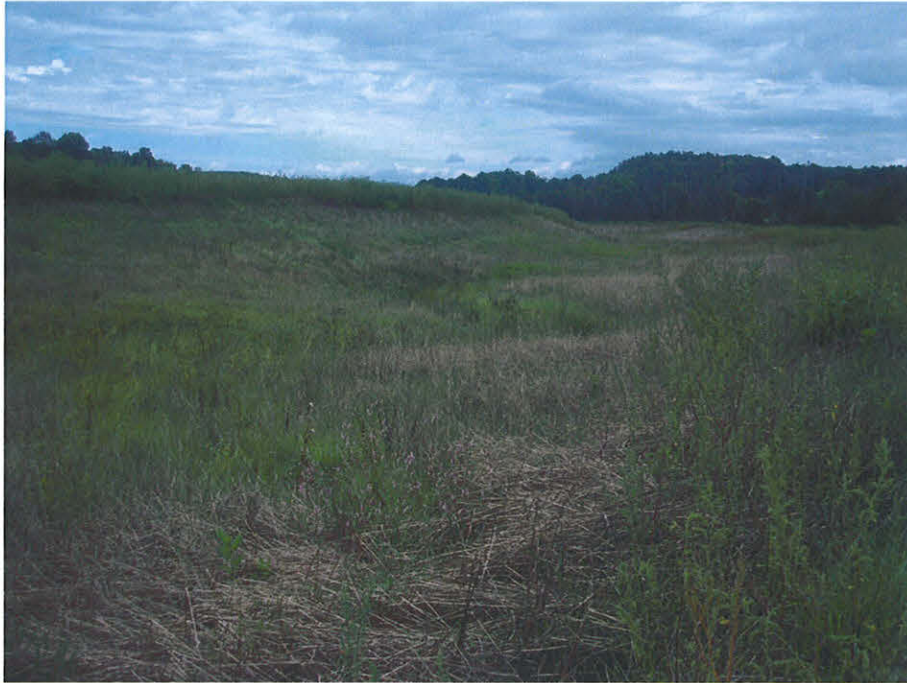
Fixed Station 3
Overview of valley along Tributary A (lower) near station 31+50, facing downstream.
(EMH&T, Inc. 9/19/06)

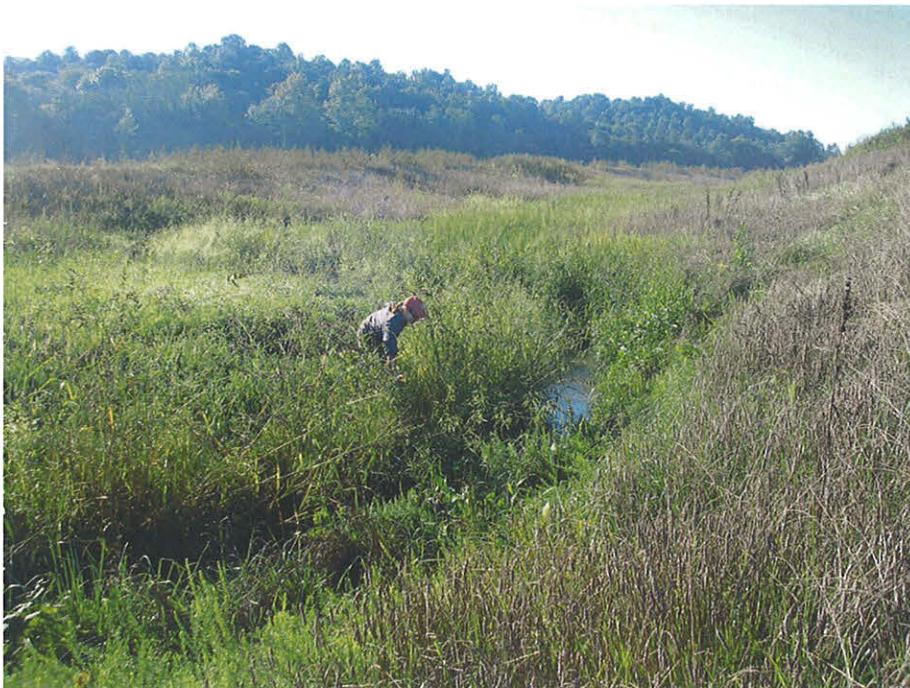
Fixed Station 4
Overview of valley along Tributary A (lower) near station 31+50, facing upstream.
(EMH&T, Inc. 9/20/06)

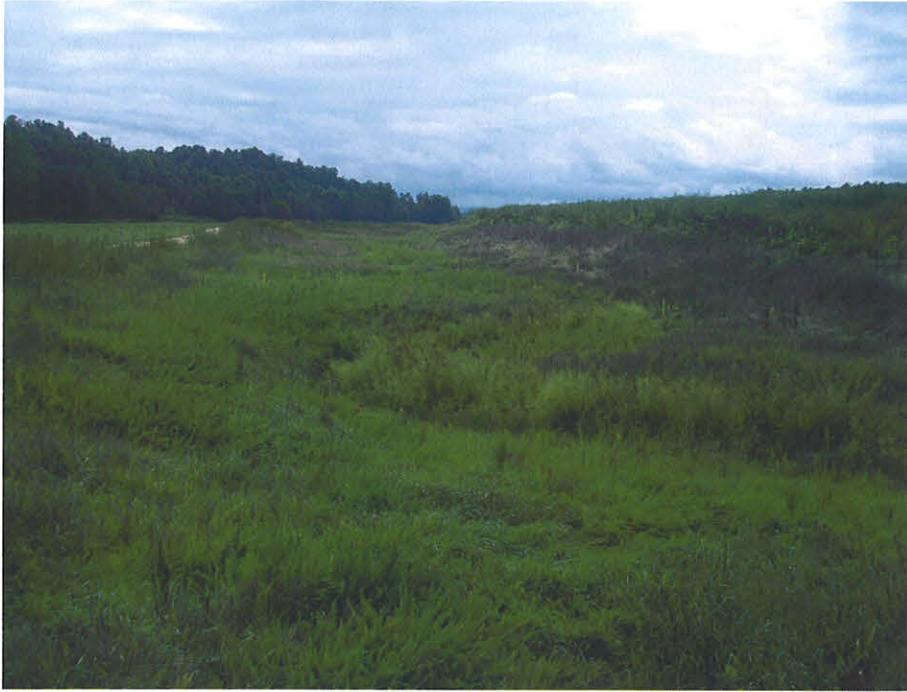
Fixed Station 5
Overview of valley on Tributary A (lower) at large culvert, facing upstream.
(EMH&T, Inc. 9/19/06)

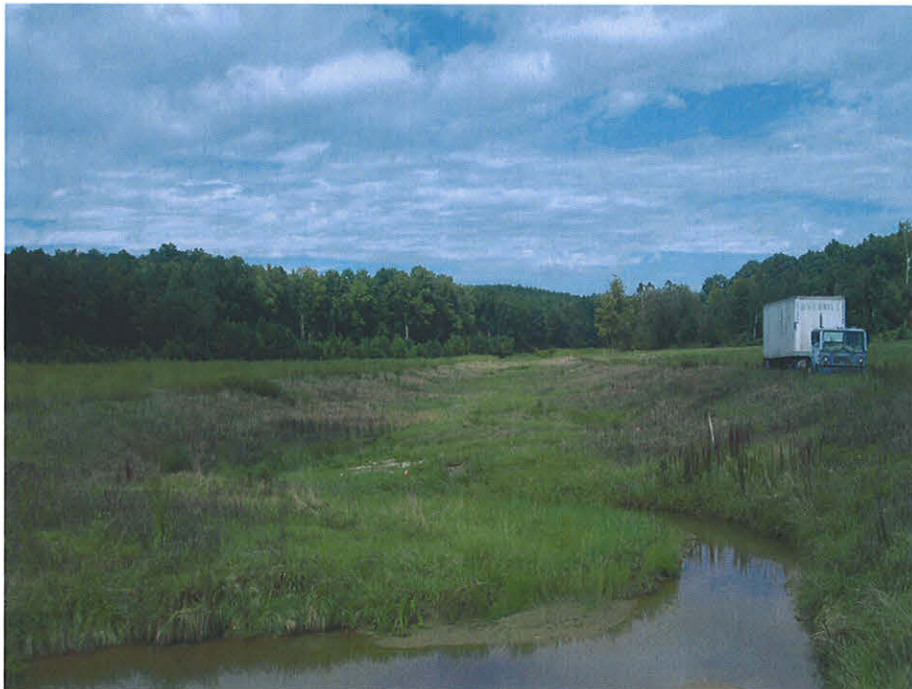
Fixed Station 6
Overview of valley on Tributary A (lower) at large culvert, facing downstream.
(EMH&T, Inc. 9/19/06)

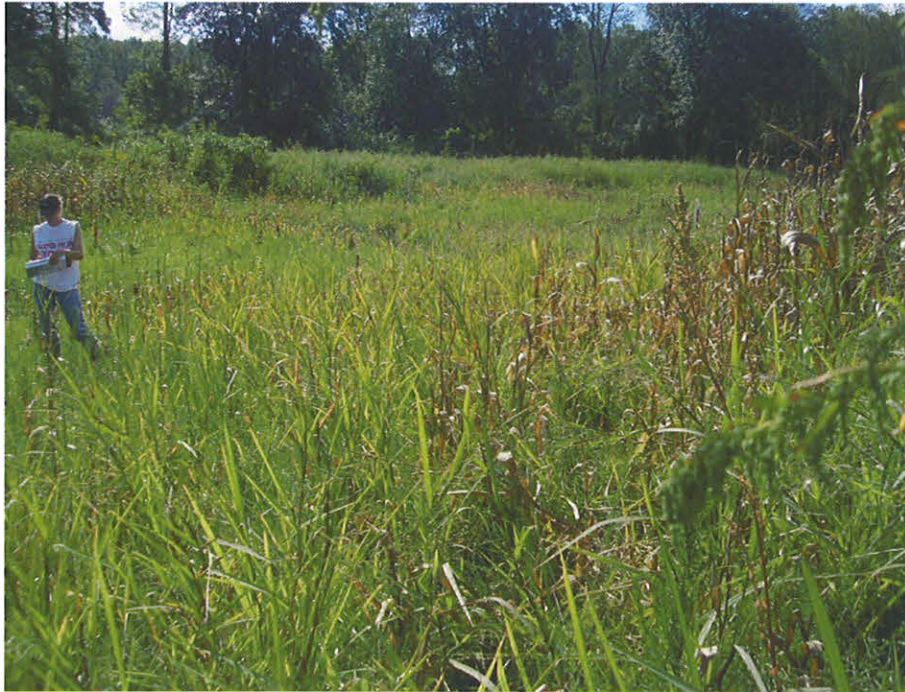
Fixed Station 7
Overview of valley along Tributary B, facing upstream.
(EMH&T, Inc. 9/19/06)

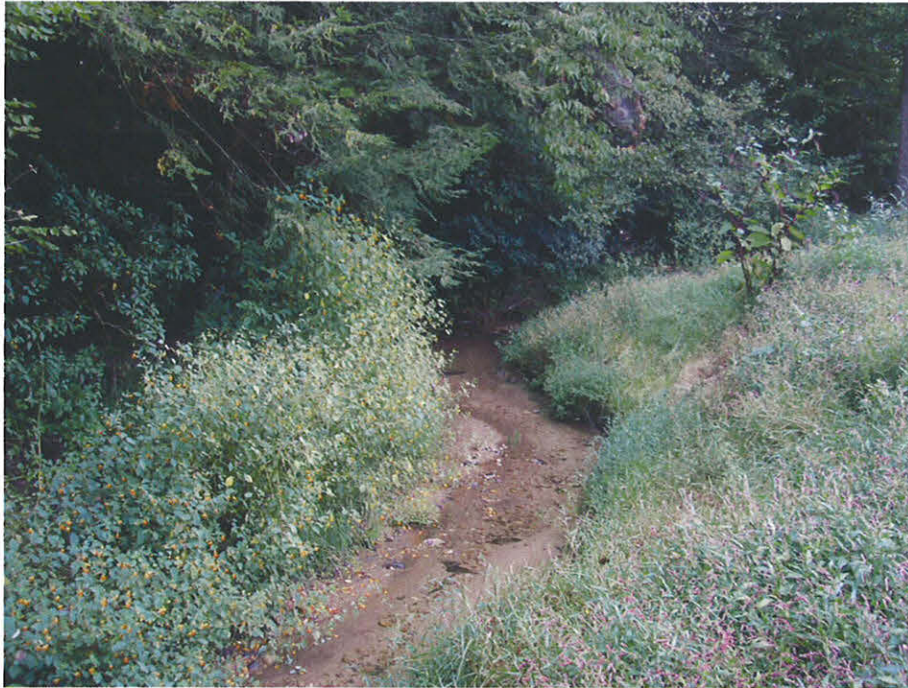
Fixed Station 9
Overview of Tributary C near station 6+50, facing downstream.
(EMH&T, Inc. 9/19/06)

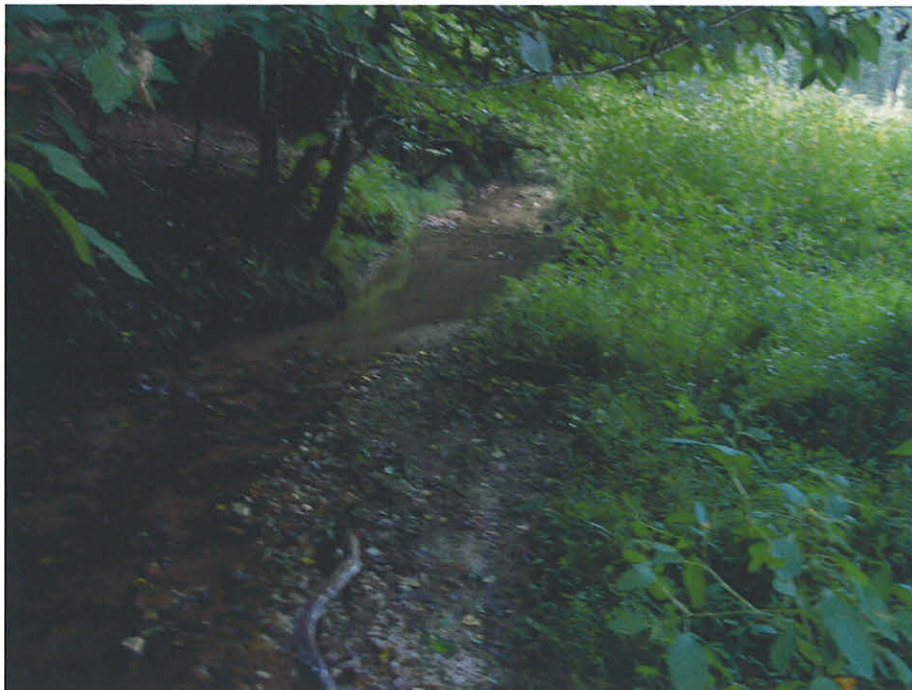
Fixed Station 10
Overview of Tributary C near station 8+60, facing downstream.
(EMH&T, Inc. 9/19/06)
