Year 4 Monitoring Report for South Muddy Creek Tributaries (Queen Properties)

South Muddy Creek Tributaries
McDowell County, NC
SCO # D04006-01

Submitted: December 2009

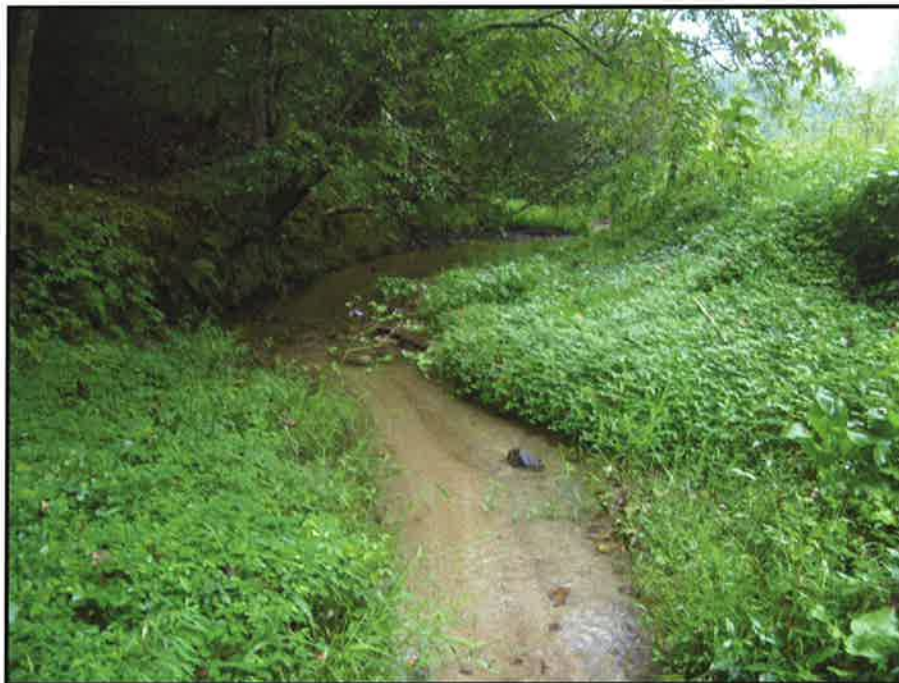
Fixed Station 10
Overview of valley along Tributary C near station 8+50, facing downstream.
The photograph for Fixed Station 10 should have been taken further upstream, nearer to station 8+60.
(EMH&T, Inc. 9/16/09)

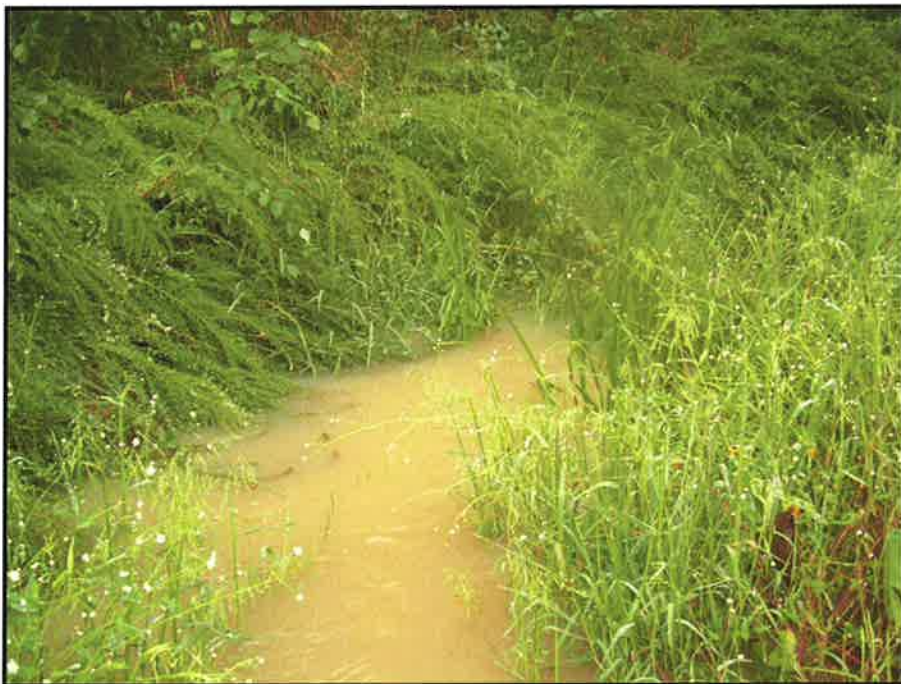
BF 4
Bankfull event in progress on Tributary A (Lower) near station 3+18, looking upstream.
(EMH&T, Inc. 9/11/08)

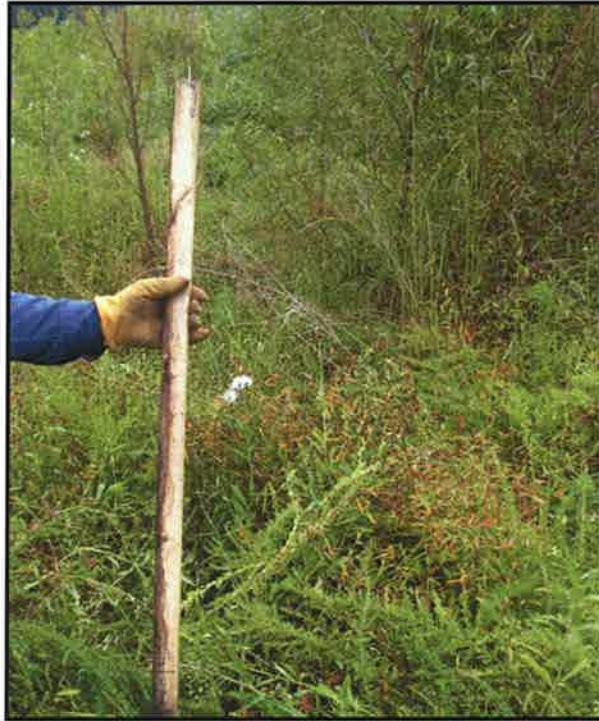
BF 11
Crest Gage on Tributary B.
(EMH&T, Inc. 9/21/09)

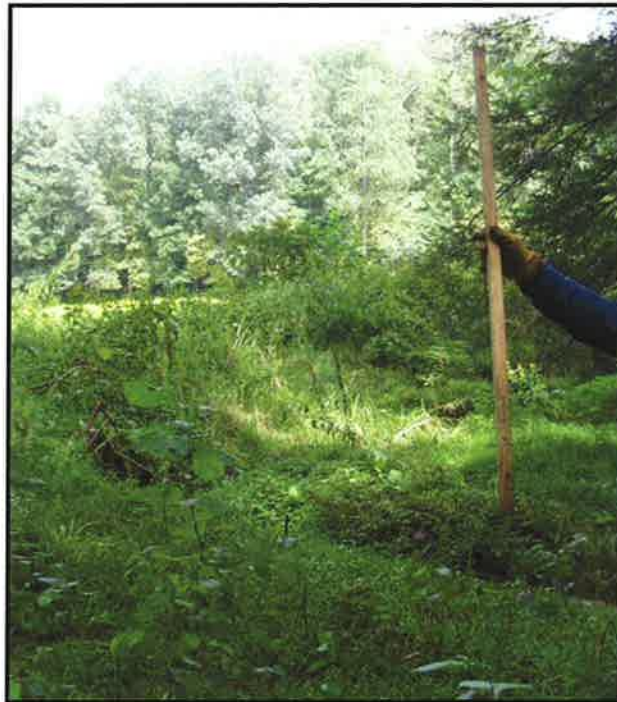
BF 12
Crest Gage on Tributary C.
(EMH&T, Inc. 9/21/09)
