Subject: Year 5 Monitoring Report for Stream Mitigation of South Muddy Creek Tributaries
SCO# D04006-01

Year 5 Monitoring Report for South Muddy Creek Tributaries (Queen Properties)

South Muddy Creek Tributaries
McDowell County, NC
SCO # D04006-01

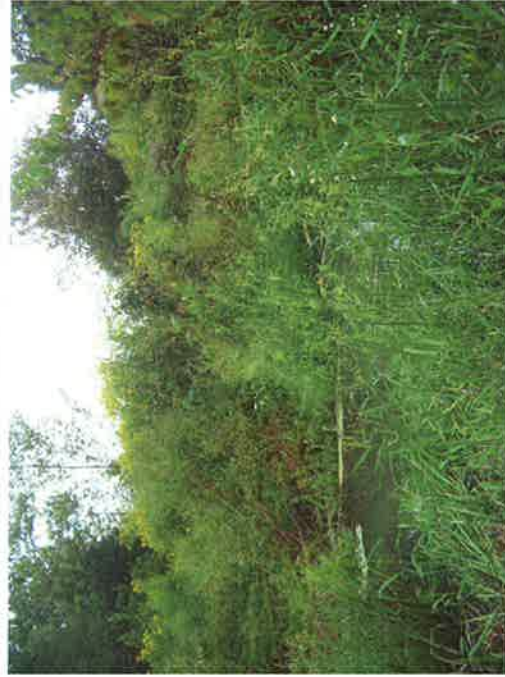
CROSS SECTION: 4+31
FEATURE: Pool

Cross section photo – looking downstream
 Note high water level.

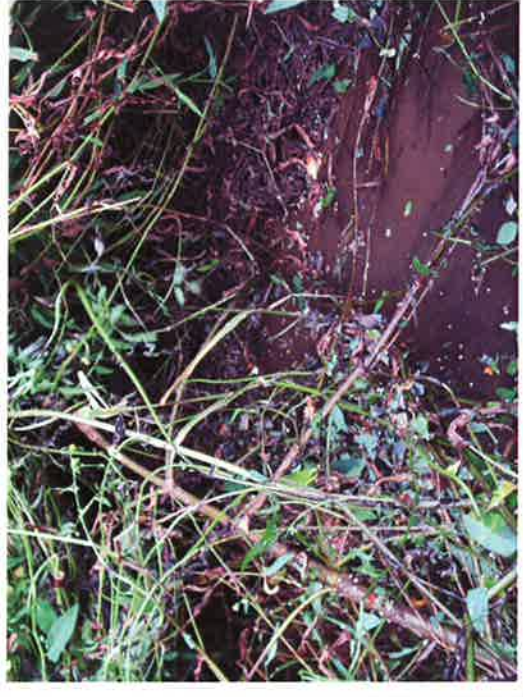
Pool

**Cross-section photo – looking downstream
 Channel completely obscured by vegetation.**

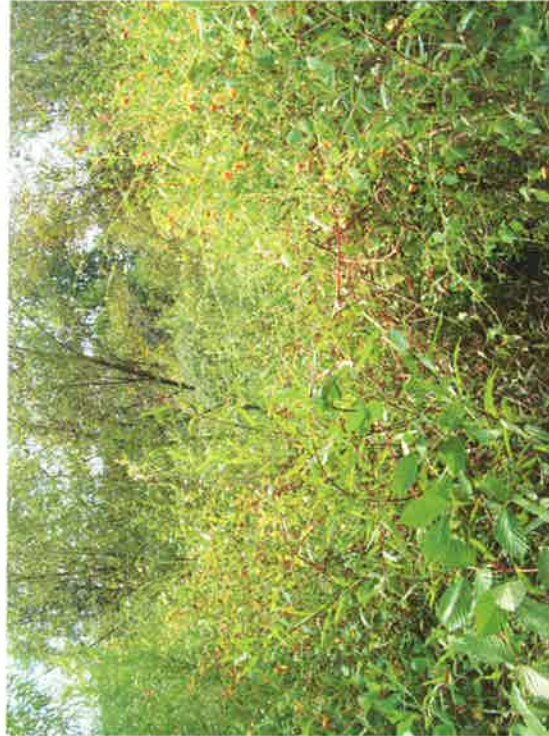
CROSS SECTION: 5+00.07
FEATURE: Riffle

Cross-section photo – looking left to right bank
 Channel totally obscured by vegetation.

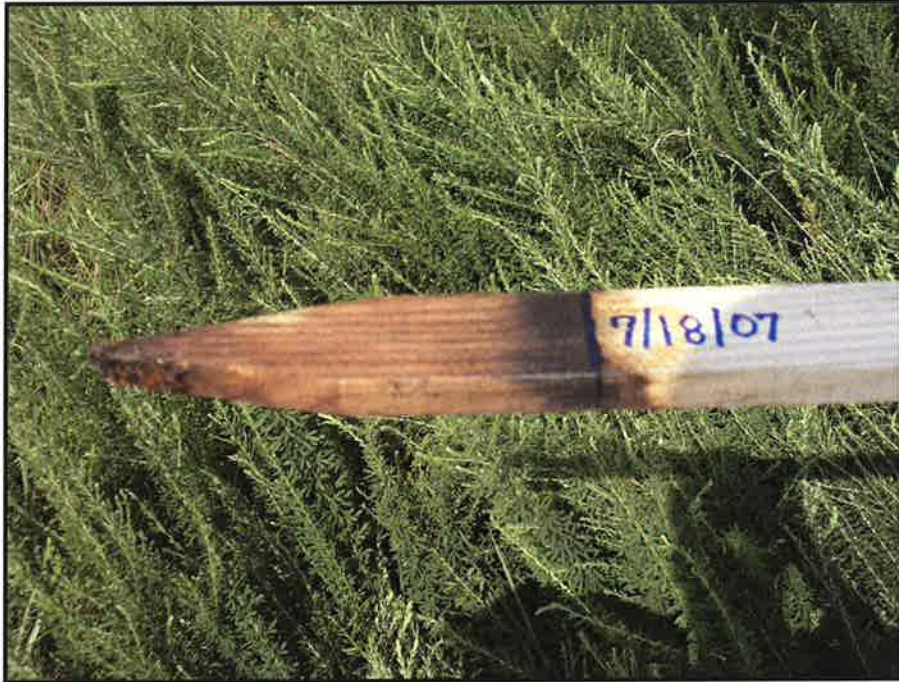
BF 1
Crest Gage at station 5+00 on Tributary B.
(EMH&T, Inc. 7/18/07)

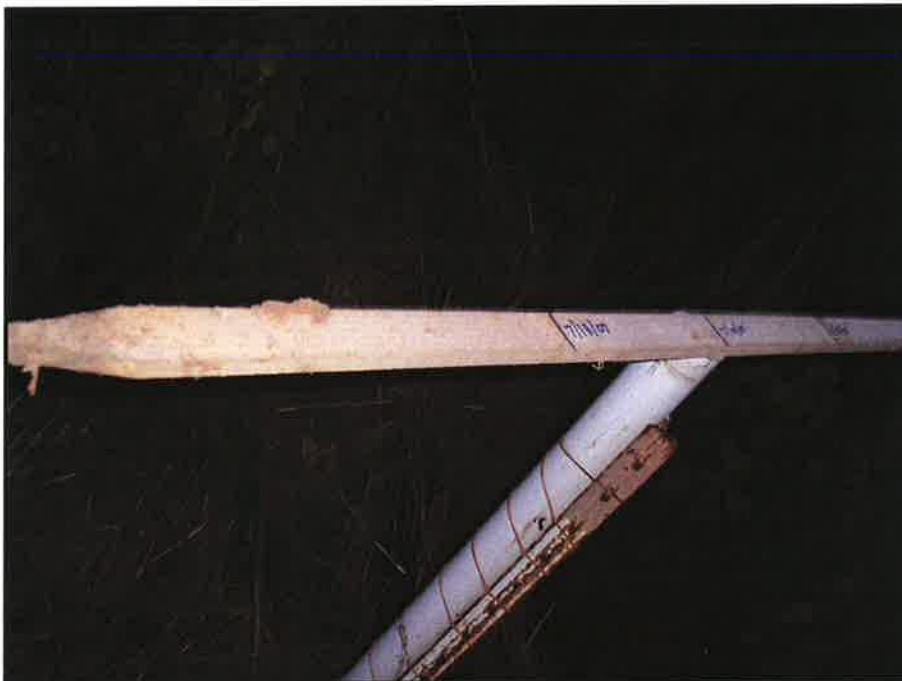
BF 2
Crest Gage at station 54+85 on Tributary A (lower).
(EMH&T, Inc. 7/18/07)

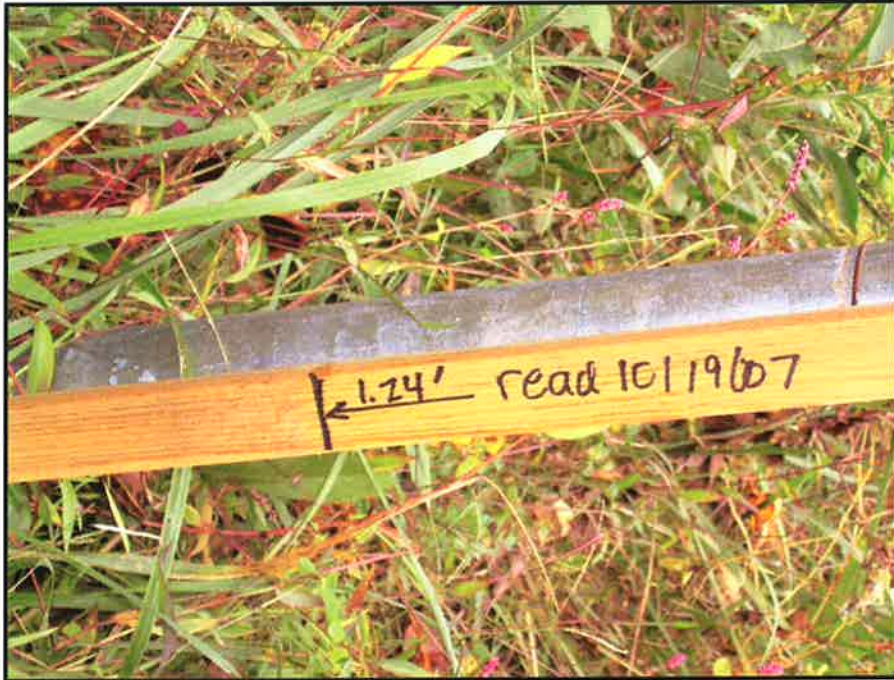
BF 3
Crest Gage at station 113+37 on Tributary A (upper).
(EMH&T, Inc. 10/19/07)

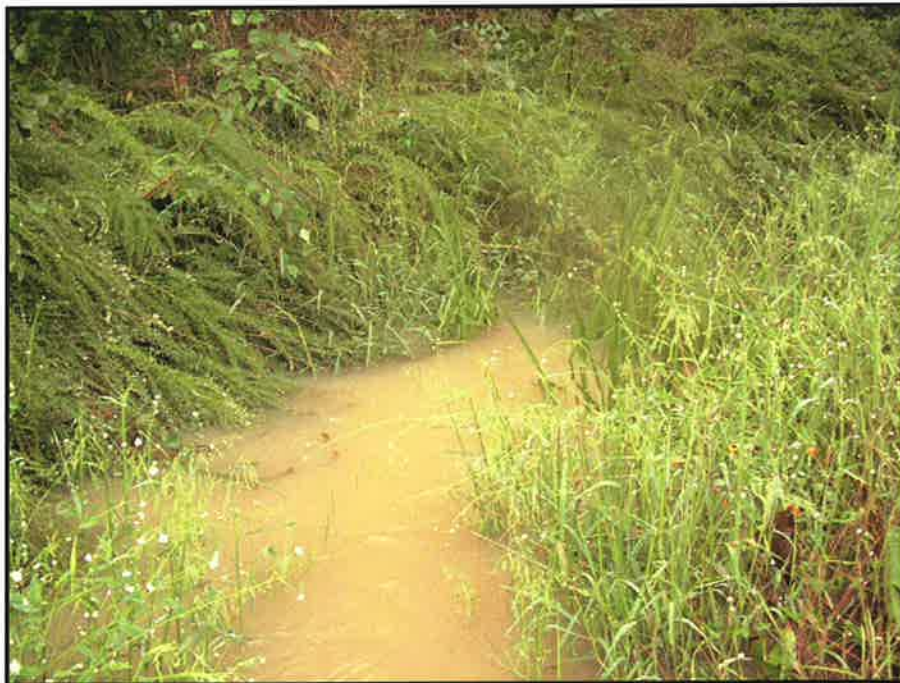
BF 4
Bankfull event in progress on Tributary A (Lower) near station 3+18, looking upstream.
(EMH&T, Inc. 9/11/08)

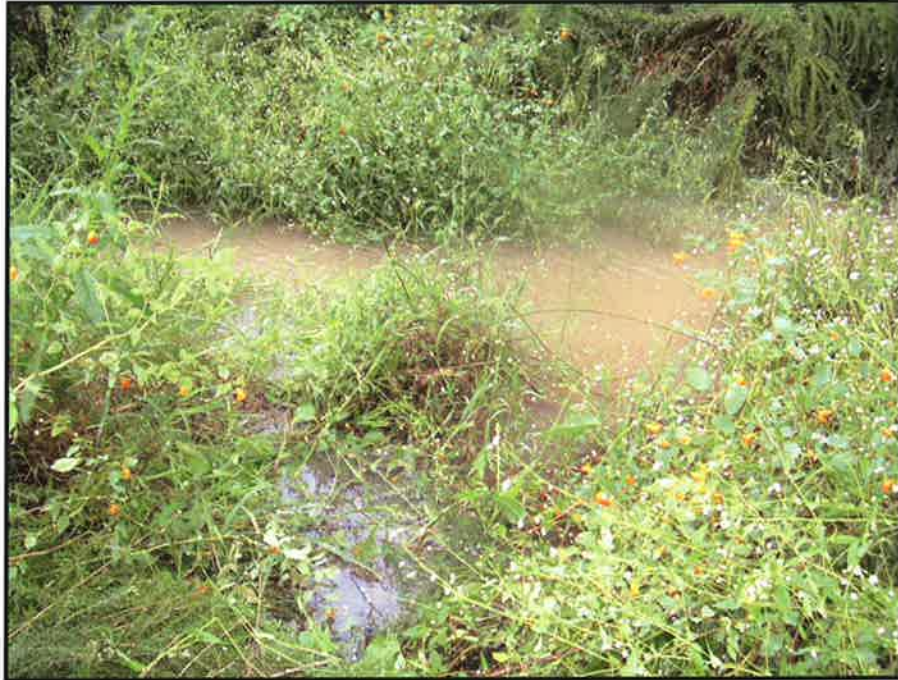
BF 5
Bankfull event in progress on Tributary A (Lower) near station 3+18, looking across the channel.
(EMH&T, Inc. 9/11/08)

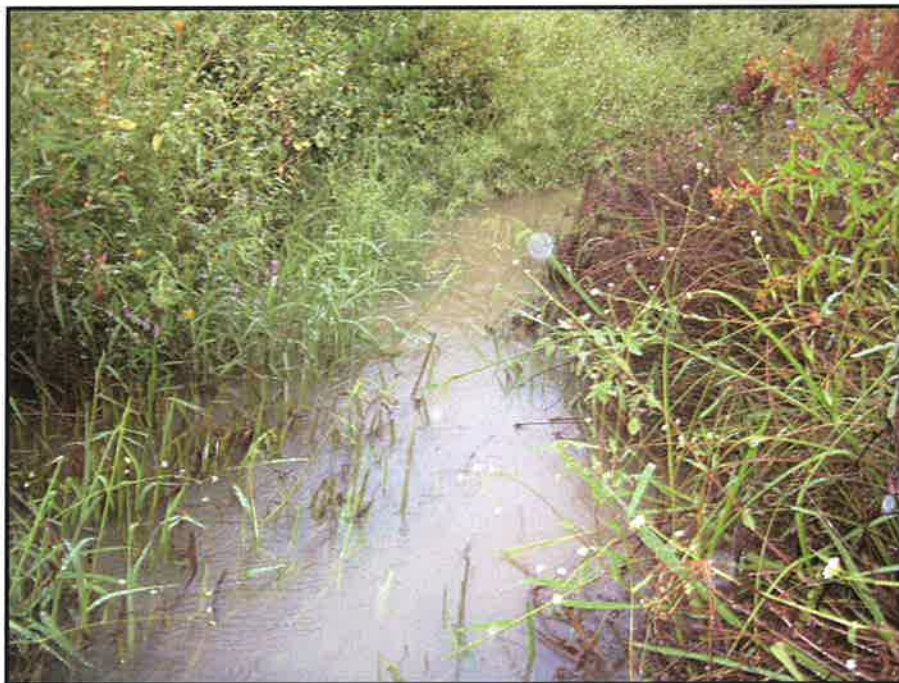
BF 6
Bankfull event in progress on Tributary A (Lower) near station 40+13, looking upstream.
(EMH&T, Inc. 9/11/08)

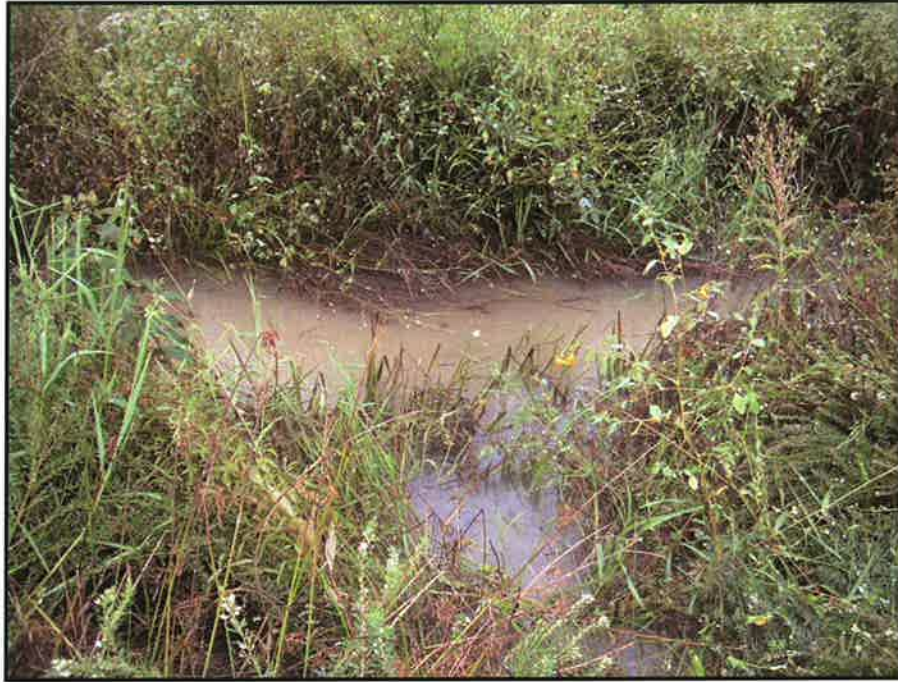
BF 7
Bankfull event in progress on Tributary A (Lower) near station 40+13, looking across the channel.
(EMH&T, Inc. 9/11/08)

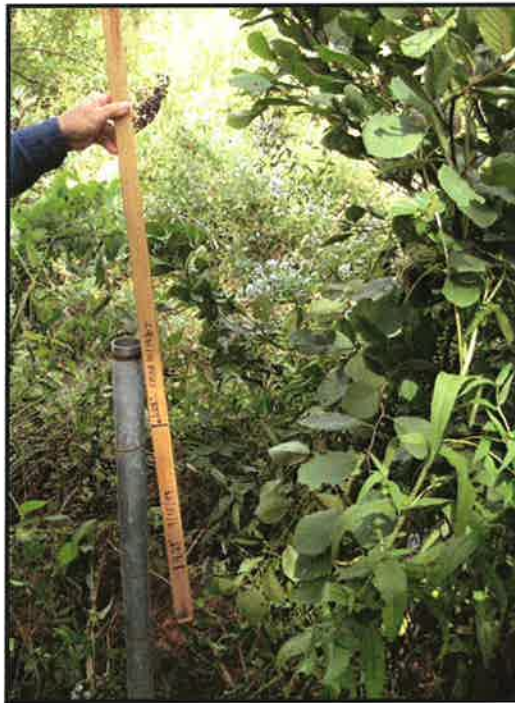
BF 8
Crest Gage on Tributary A (upper).
(EMH&T, Inc. 9/21/09)

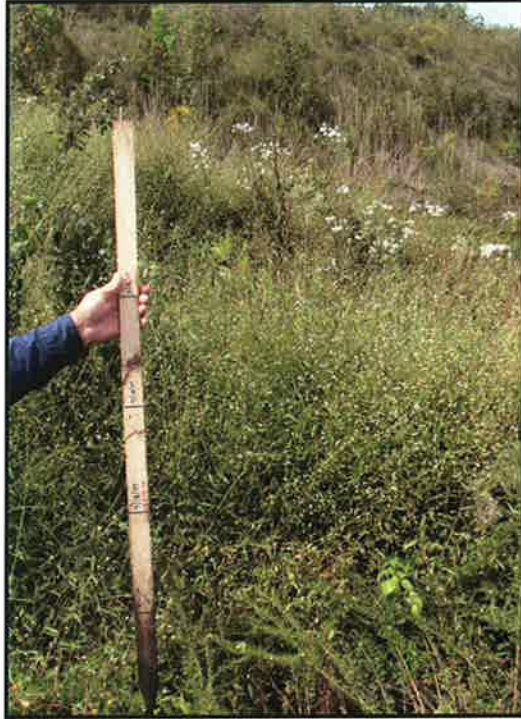
BF 9
Crest Gage on Tributary A (middle).
(EMH&T, Inc. 9/21/09)

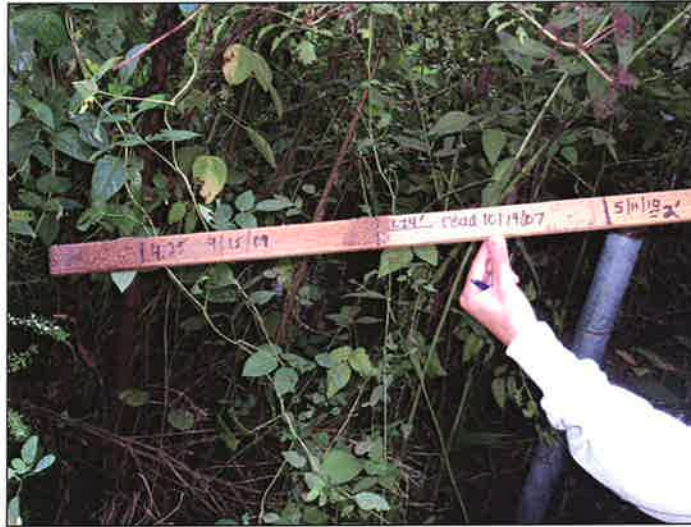
BF 13
Crest Gage at station 113+37 on Tributary A (upper).
(EMH&T, Inc. (documented, 5/11/10))

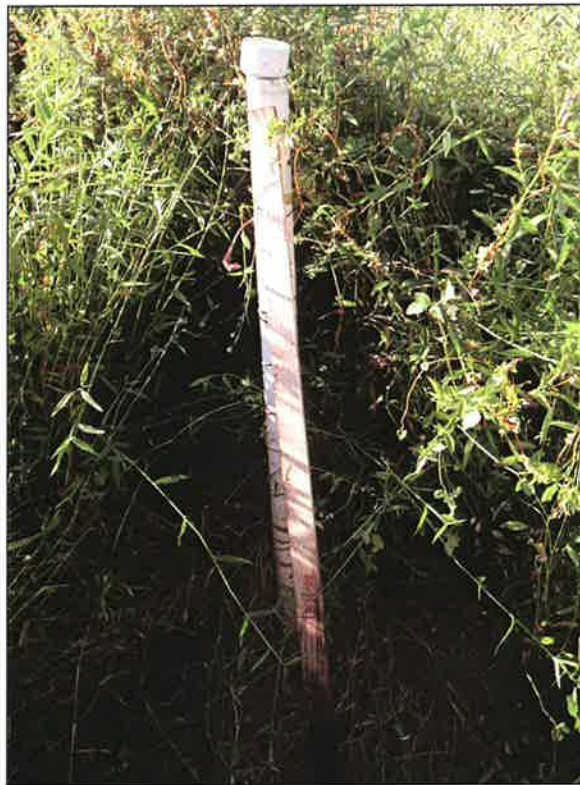
BF 14
Crest Gage at station 54+85 on Tributary A (lower).
(EMH&T, Inc. (documented, 5/11/10))

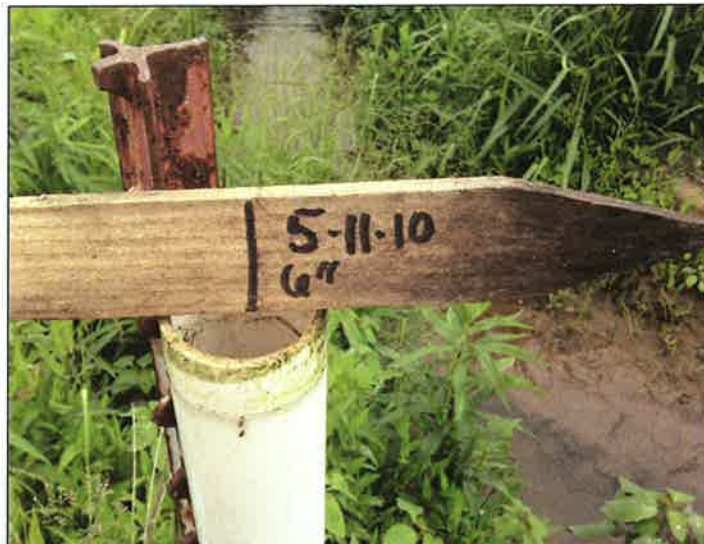
BF 16
Crest Gage on Tributary A2.
(EMH&T, Inc. (documented, 5/11/10))
