ANNUAL REPORT FOR 2006 (Year 3)

Spring Valley Park Stream Restoration Site
Greensboro, North Carolina
EEP Project No. 354

FINAL *Spring Valley Stream Mitigation Site*
Annual Monitoring Report for 2006 (Year 3)

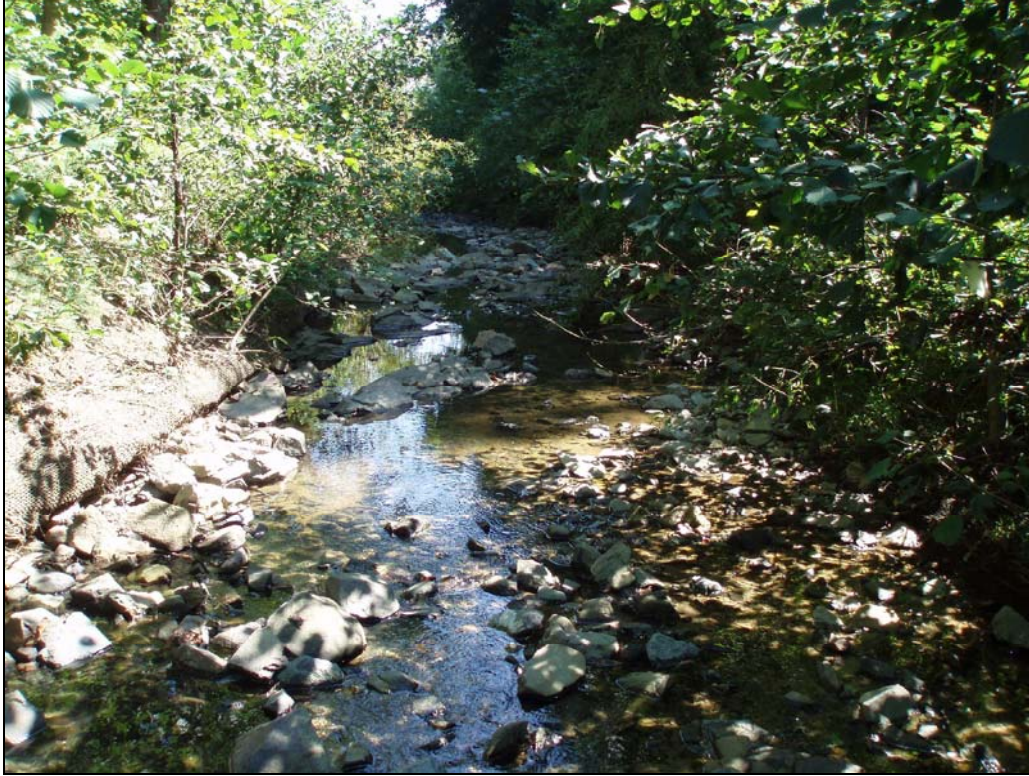
Spring Valley 2006, Problem Area 1

Station Numbers	Suspected Cause	Photo Number
Coir matting failure	11+00-12+00	Improper installation, unstable banks due to lack of rooted vegetation (50-100 foot sections in all cases)	PA #1
	13+20		PA #2
	14+40		
Headers on cross vanes are set too high	15+40	Improper installation, the header rock is set too high and water is flowing underneath	PA #4
	15+71		
Headers on cross vanes are set too high	16+80	Improper installation, the header rock is set too high and water is flowing underneath	PA #5
Left bank erosion	17+10	Unstable banks due to lack of rooted vegetation	PA #6
Header rock moved downstream from cross vane	17+15	Improper installation, header rock not set during construction	PA #7
Bank washed out behind root wad	17+40	Unstable banks due to lack of rooted vegetation	PA #8
Coir matting failure	17+50	Improper installation, unstable banks due to lack of rooted vegetation, erosion occurring from rootwad to cross vane	PA #9

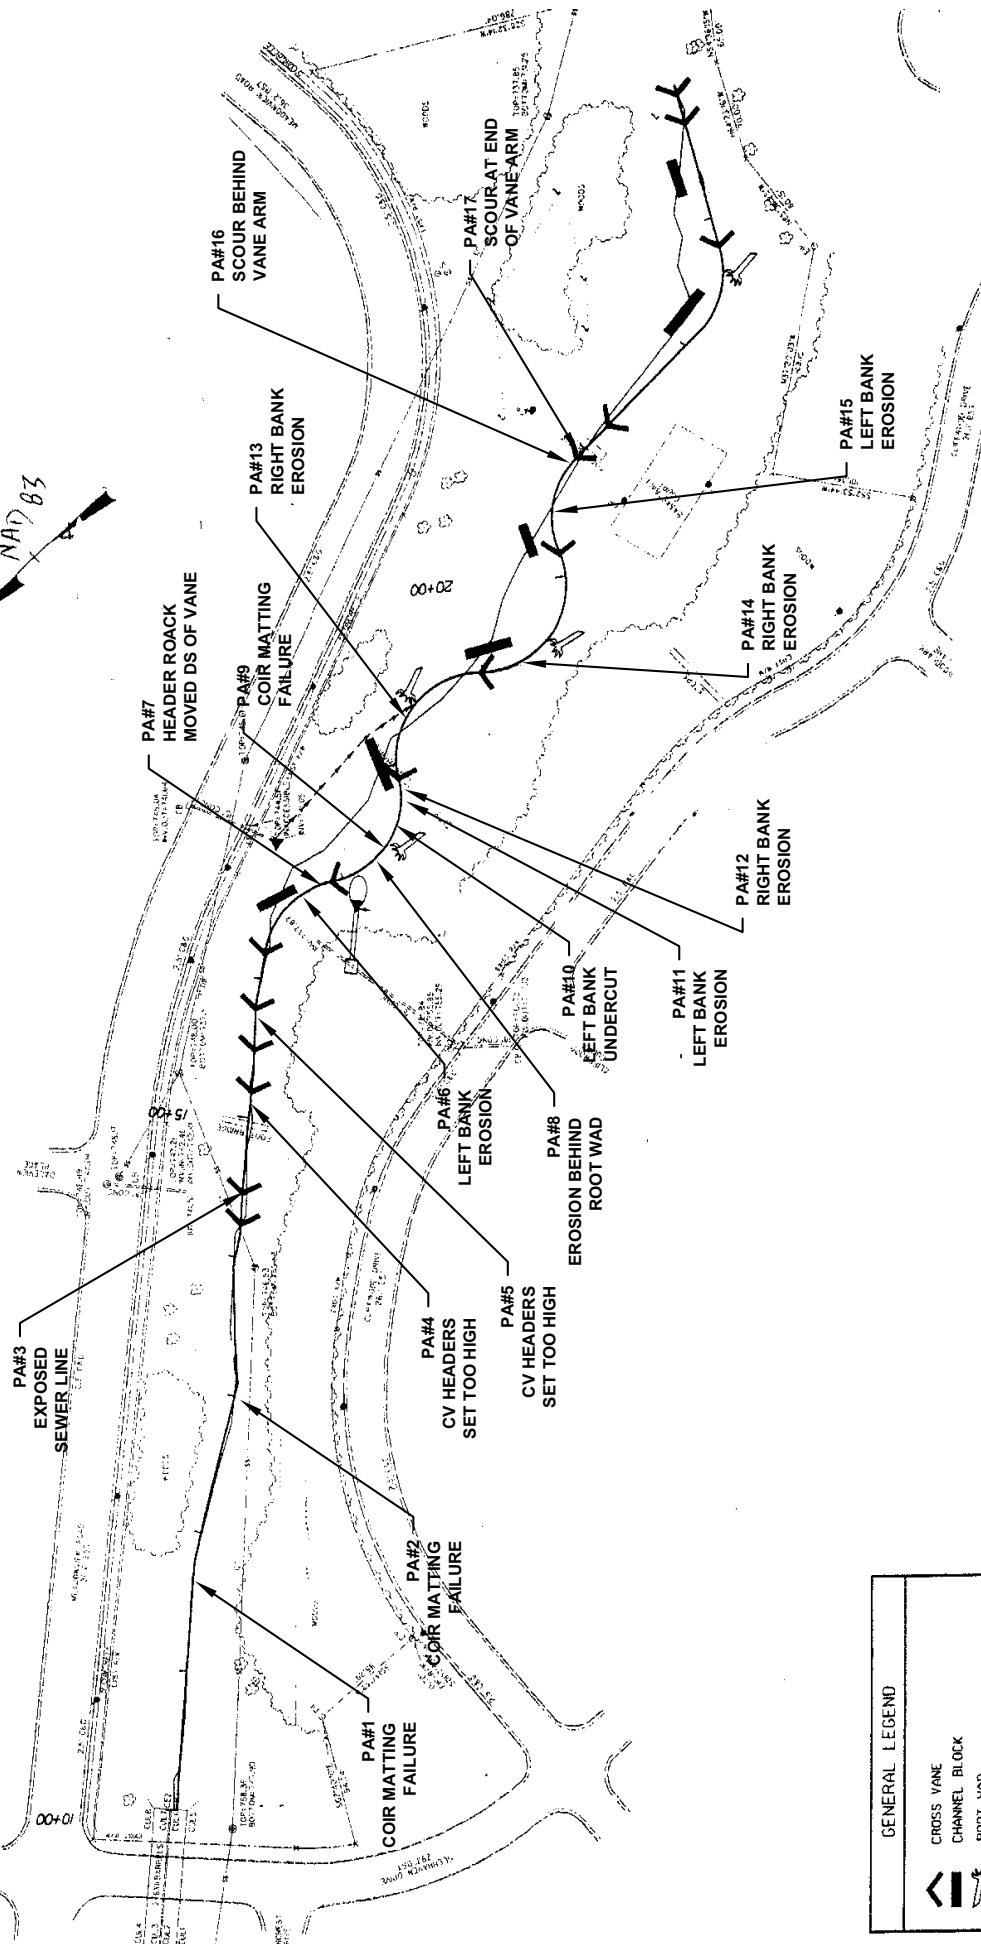
TITLE: INTEGRATED PROJECT PROBLEM AREAS
 2006 (YEAR 3) PLAN VIEW
 SPRING VALLEY
 GREENSBORO, NORTH CAROLINA

Table B Spring Valley Problem Areas			
Feature Issue	Station Numbers	Suspected Cause	Photo Number
Coir matting failure	11+00-12+00	Improper installation, unstable banks due to lack of rooted vegetation (50-100 foot sections in all cases)	PA #1
	13+20		
	14+40		
Exposed sewer line	15+15	Down cutting due to downstream structure failure	PA #3
Headers on cross vanes are set too high	15+40	Improper installation, the header rock is set too high and water is flowing underneath	PA #4
	15+71		
Headers on cross vanes are set too high	16+80	Improper installation, the header rock is set too high and water is flowing underneath	PA #5
Left bank erosion	17+10	Unstable banks due to lack of rooted vegetation	PA #6
Header rock moved downstream from cross vane	17+15	Improper installation, header rock not set during construction	PA #7
Bank washed out behind root wad	17+40	Unstable banks due to lack of rooted vegetation	PA #8

Coir matting failure	17+50	Improper installation, unstable banks due to lack of rooted vegetation, erosion occurring from rootwad to cross vane	PA #9
Undercutting bank	17+80	High flow events, unstable banks due to lack of rooted vegetation	PA #10
Left bank erosion	18+40	Unstable banks due to lack of rooted vegetation, eroding downstream of cross vane	PA #11
Right bank erosion	18+60	Unstable banks due to lack of rooted vegetation, bank washed out behind rootwad (STA 19+50)	PA #12
	19+20		PA #13
	20+50		PA #14
Left bank erosion	20+70	Unstable banks due to lack of rooted vegetation, mid-channel bars forming	PA #15
Scour behind vane arm	20+80	Improper installation, bank washing out behind vane arm, piping occurring around structure	PA #16
Scour at end of vane arm		Improper installation, vane arm set at too high an elevation	PA #17

- At this time, no repairs are recommended. The aforementioned problem areas discussed in Table V need to be monitored and if the problems worsen over time, then a remedial plan needs to be developed.
