# **St. Clair Creek Restoration Project Year 8 Monitoring Report FINAL**

Beaufort County, North Carolina

DMS Project ID No. 95015

Report Prepared and Submitted by Michael Baker International

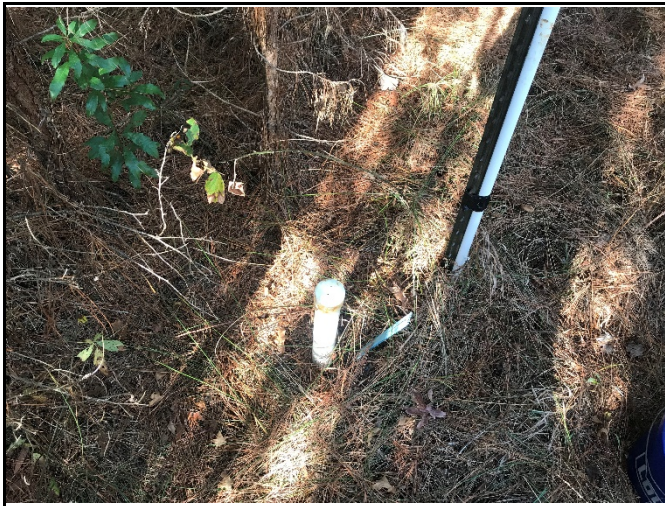
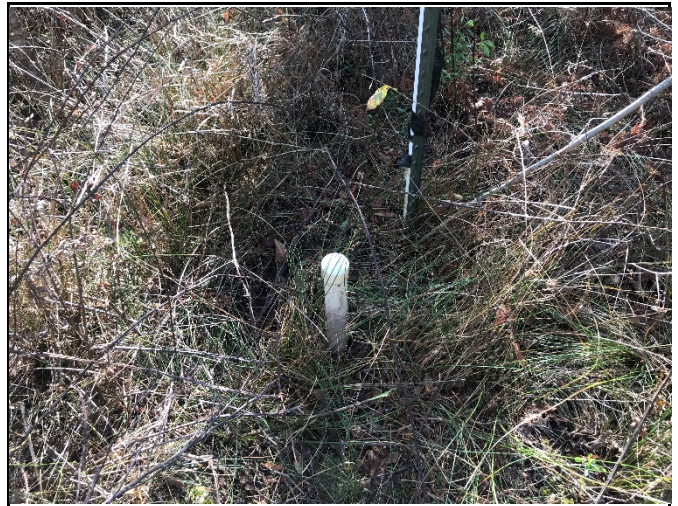
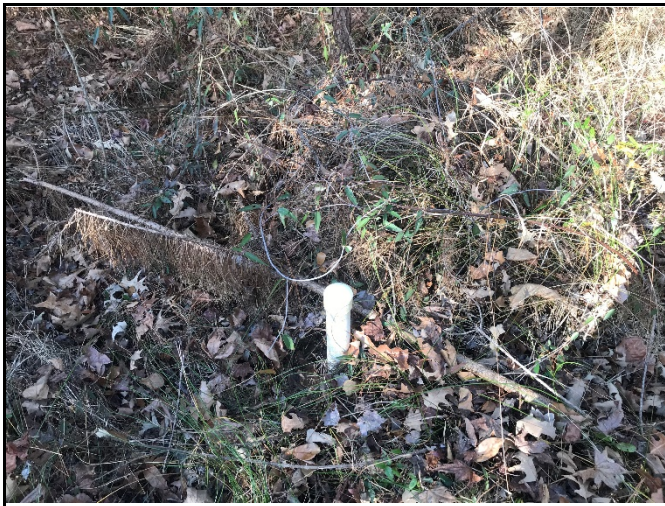
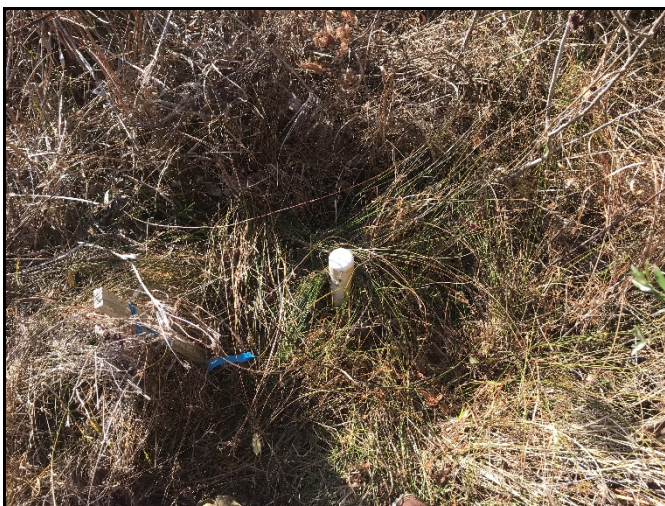
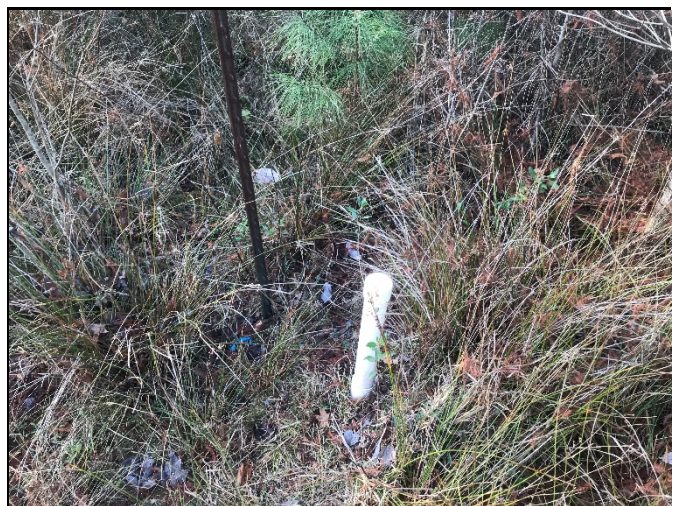
Note: Photos taken during a Level D2: Severe Drought

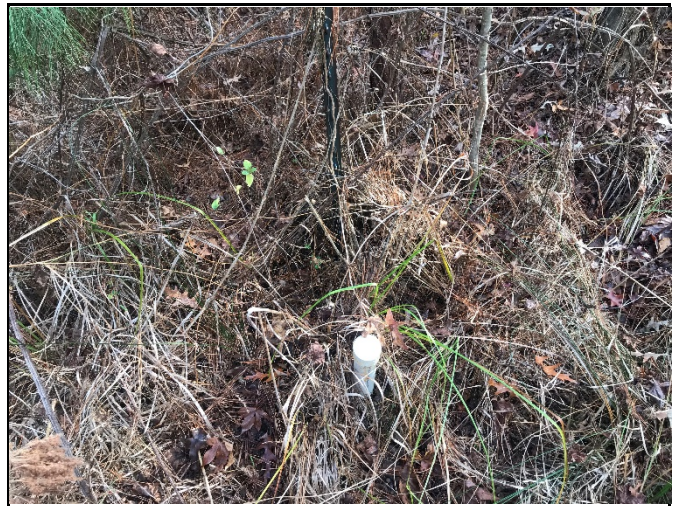
Auto Well – SCAW4

\*\*SCAW4 gauge died at the very beginning of the MY8 growing season and thus missed the crucial success period timeframe.

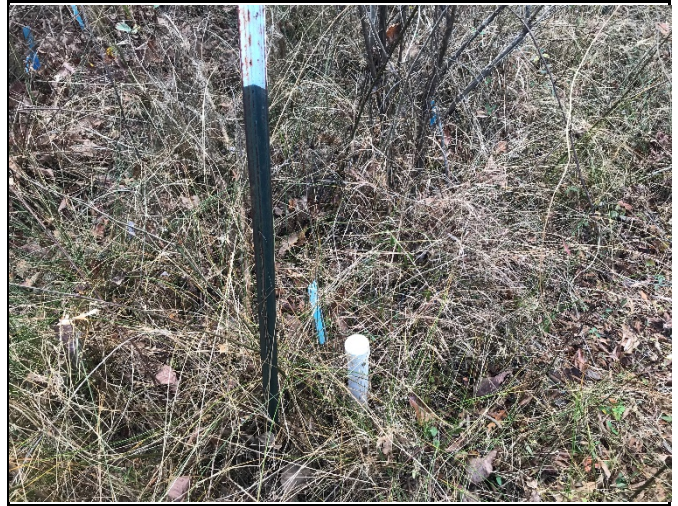
Supplemental Auto Well – SCAW8

**HIGHLIGHTED** indicates wells that *did not* meet the success criteria for the most consecutive number of days within the monitored Year 8 growing season with a water 12 inches or less from the soil surface. For Year 8 wetland monitoring, five of the eight wells located in currently credited wetland areas exhibited hydroperiods greater than 12% during the 2021 growing season. Well SCAW4 had gauge failure at the start of the growing season, and SCAW8 missed by 2 days.

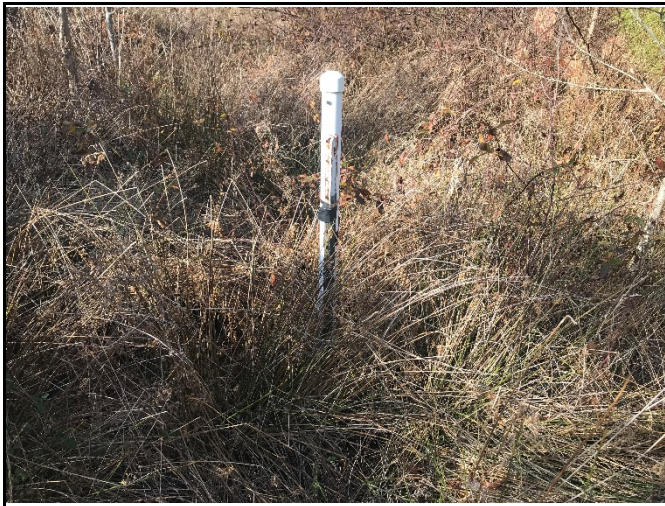
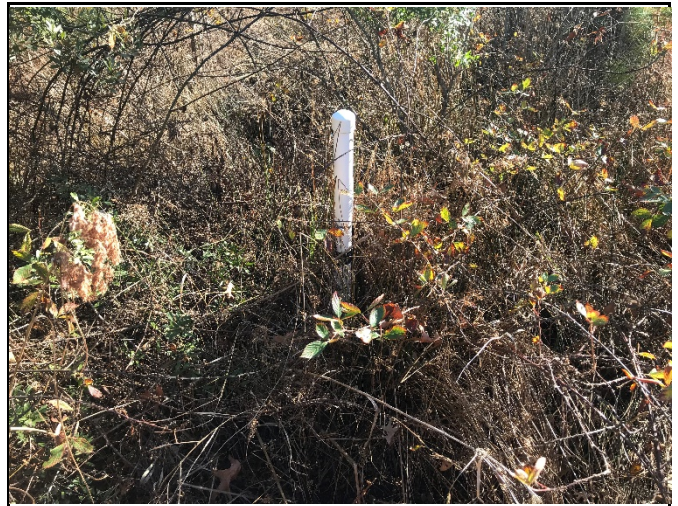
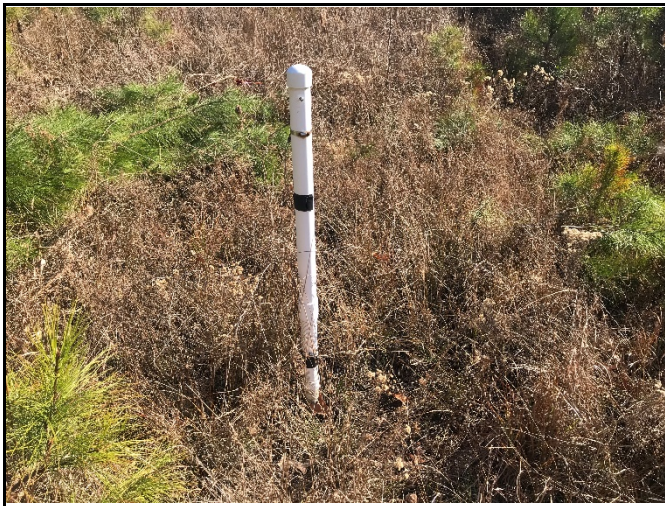
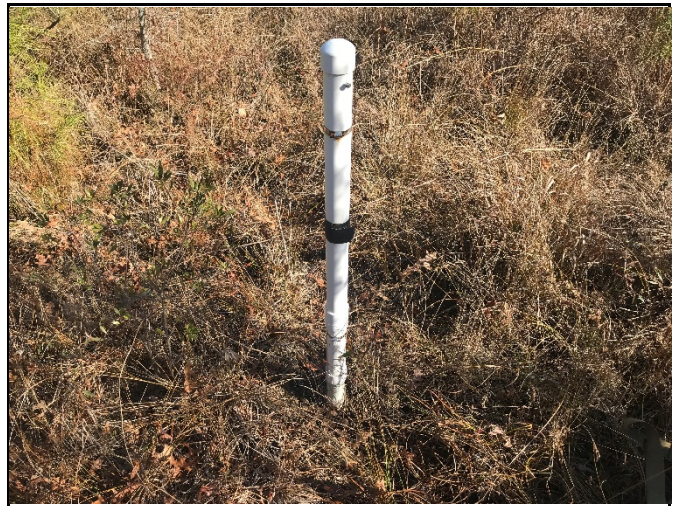
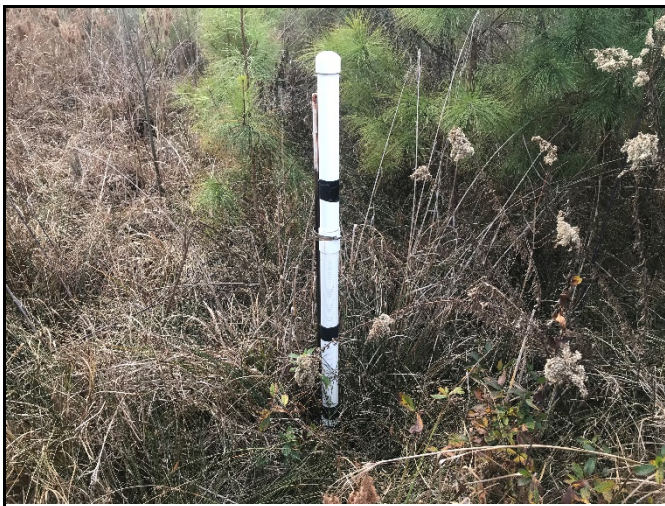
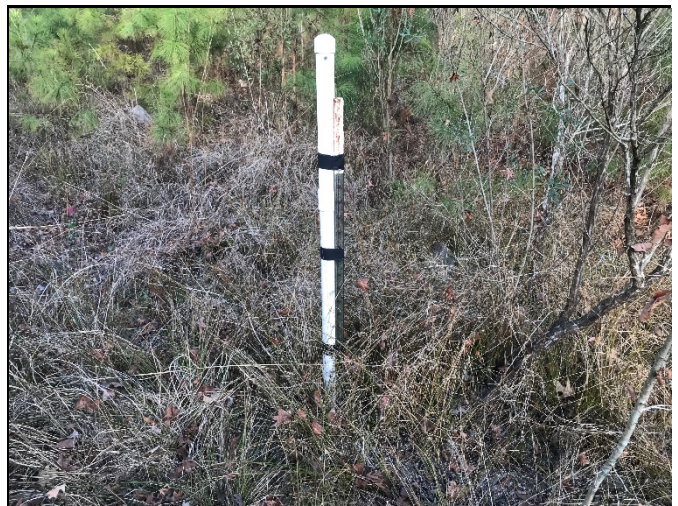
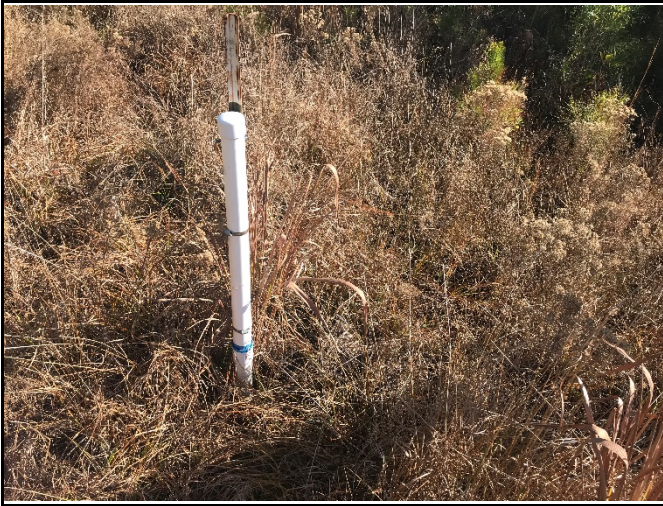
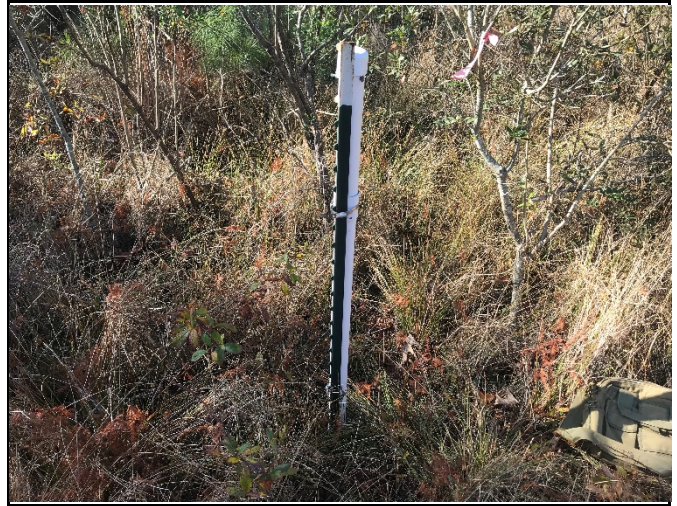
Note: Photos taken during a Level D2: Severe Drought

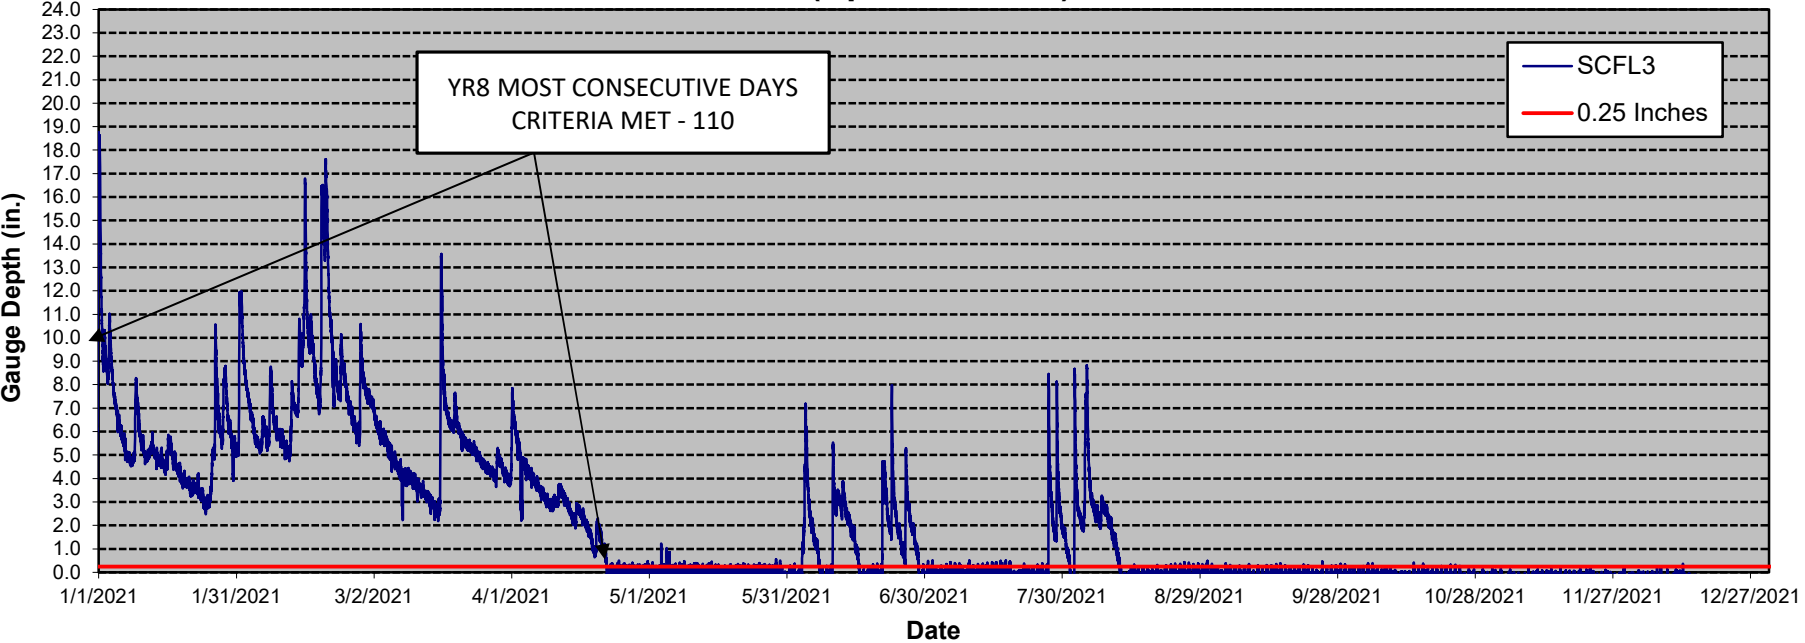
### St. Clair Creek Flow Gauge SCFL3 (Upstream UT2)

\*0.25 inches denotes level at which flow occurs along the UT2 valley thalweg

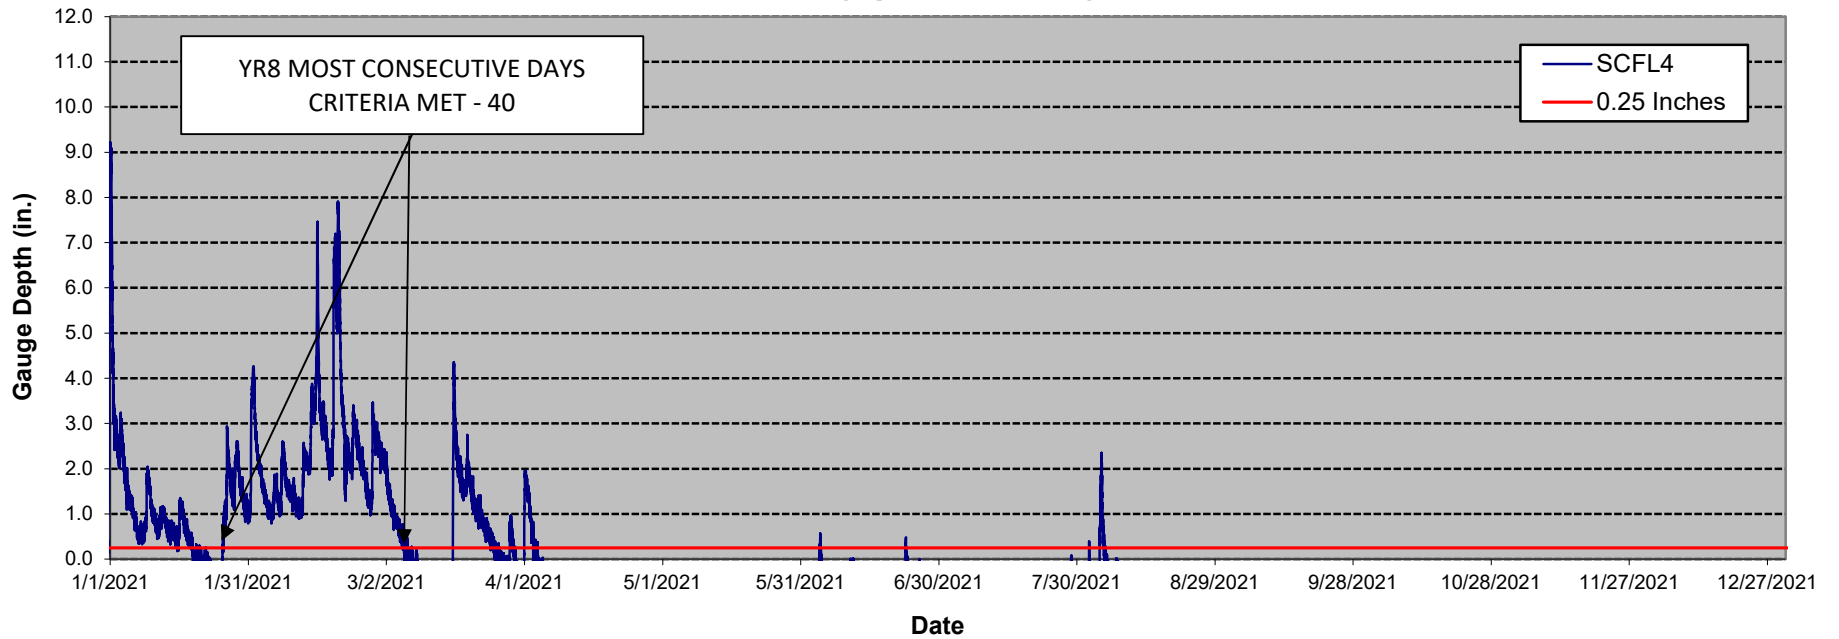
### St. Clair Creek Flow Gauge SCFL4 (Upstream UT2)

\*0.25 inches denotes level at which flow occurs along the UT2 valley thalweg

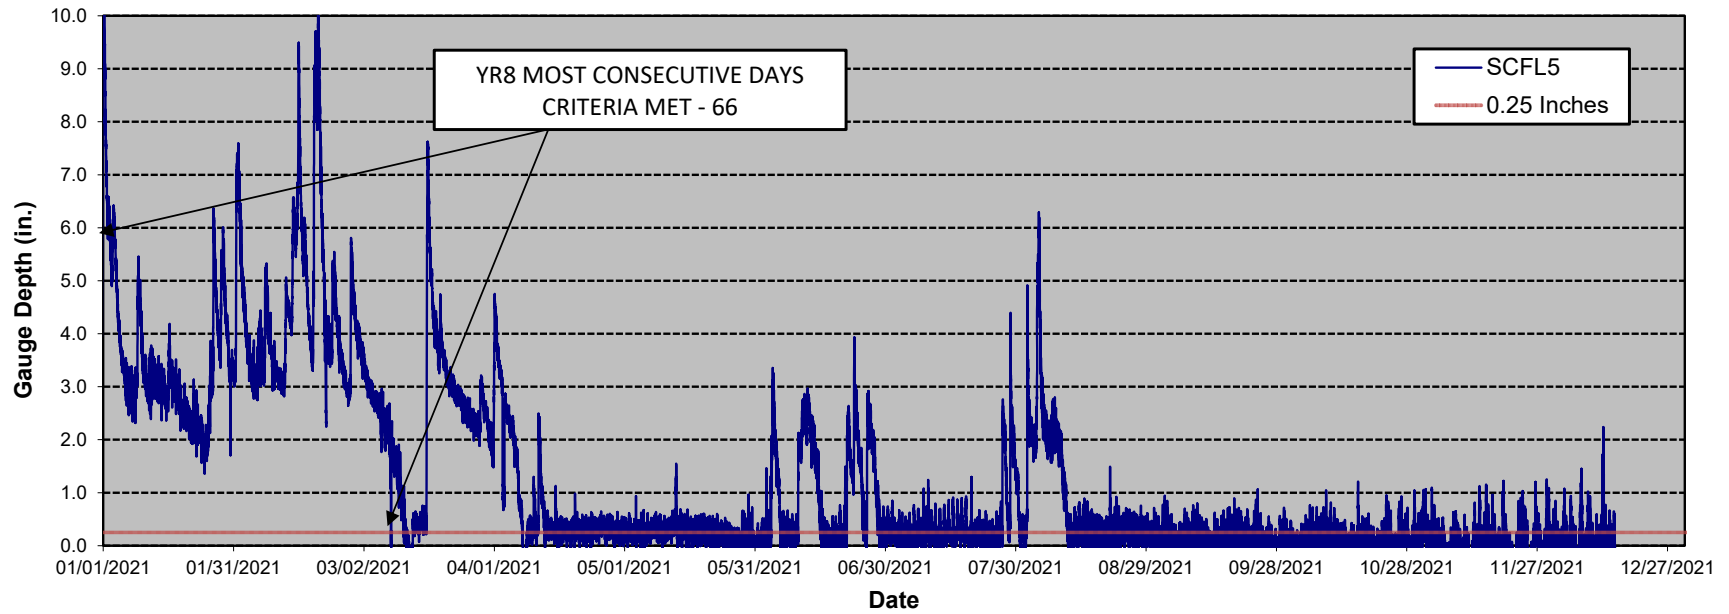
### St. Clair Creek Flow Gauge SCFL5 (Downstream UT3)

\*0.25 inches denotes level at which flow occurs along the UT3 valley thalweg

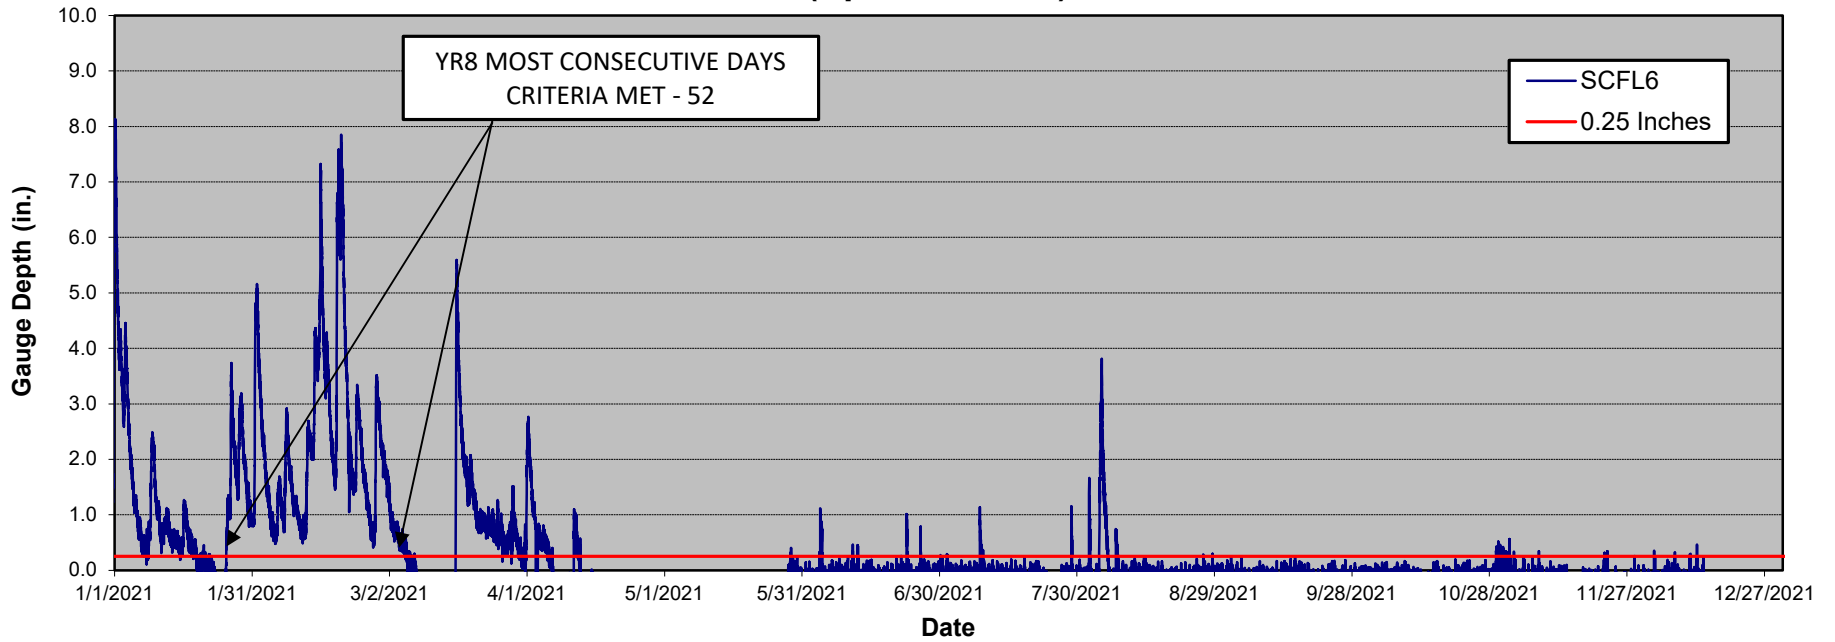
### St. Clair Creek Flow Gauge SCFL6 (Upstream UT3)

\*0.25 inches denotes level at which flow occurs along the UT3 valley thalweg

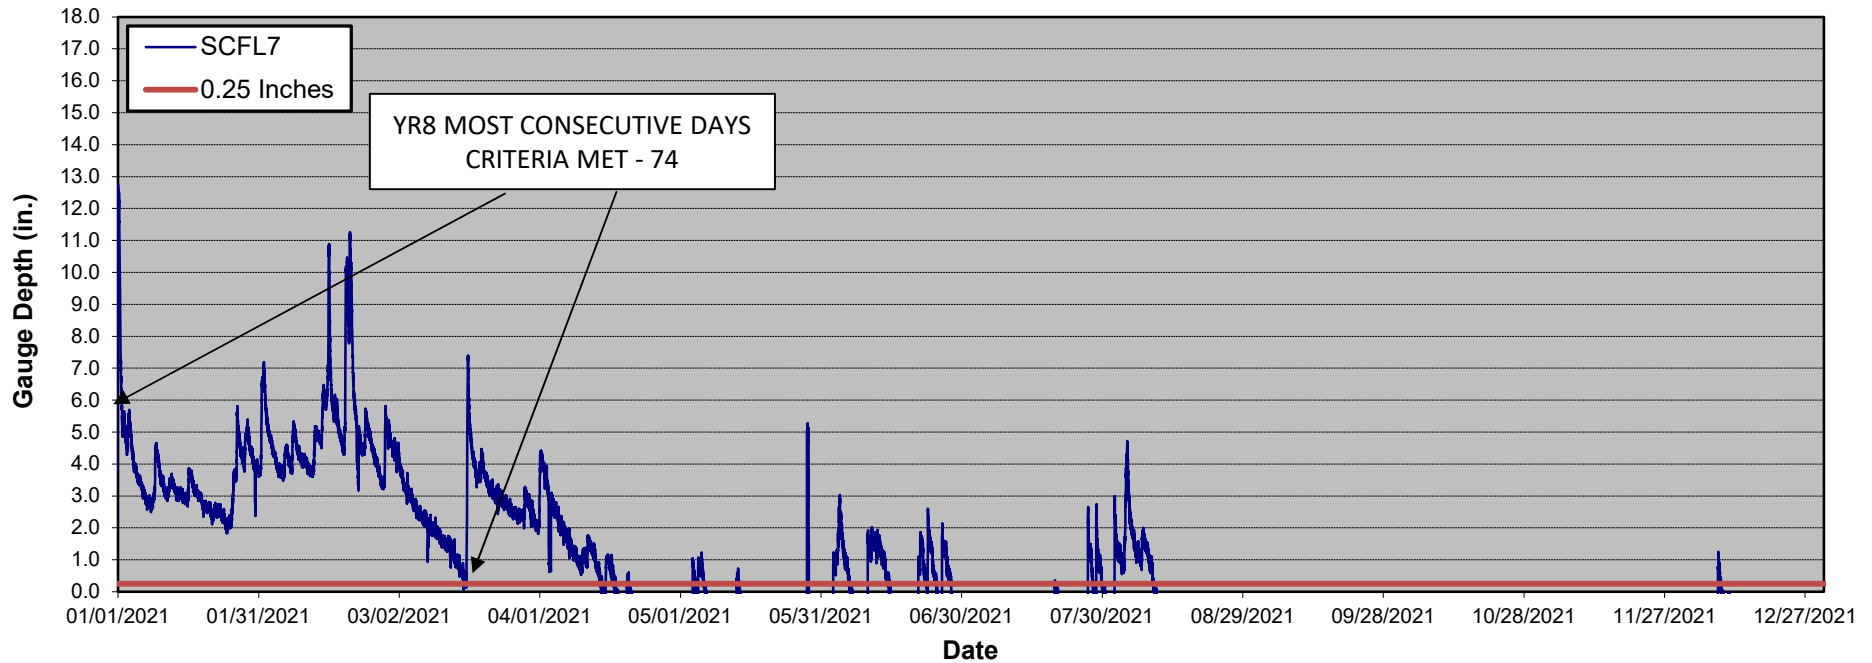
### St. Clair Creek Flow Gauge SCFL7 (Upstream UT2)

\*0.25 inches denotes level at which flow occurs along the UT2 valley thalweg

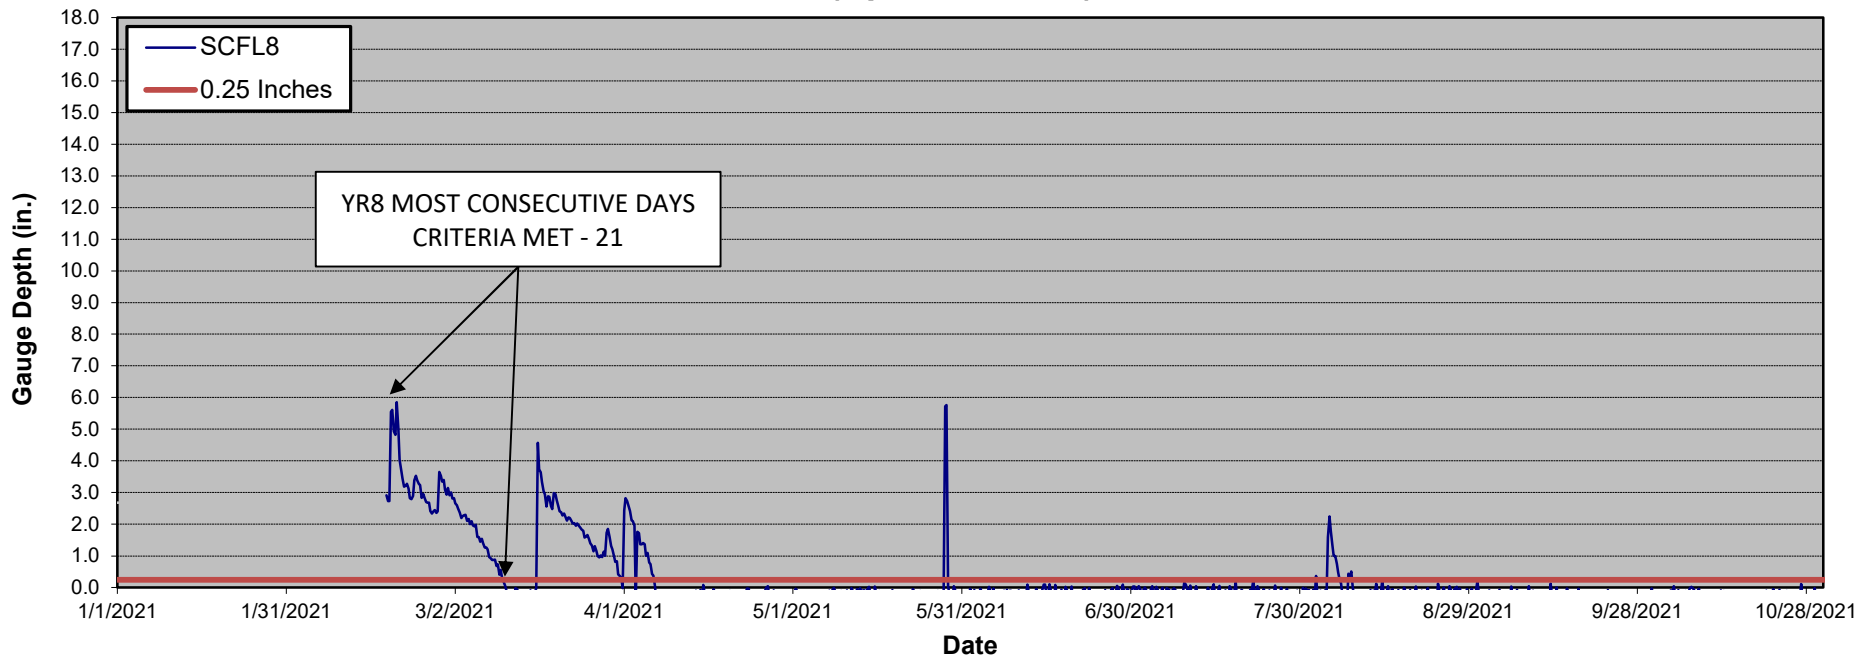
### St. Clair Creek Flow Gauge SCFL 8 (Upstream UT2)

\*0.25 inches denotes level at which flow occurs along the UT2 valley thalweg

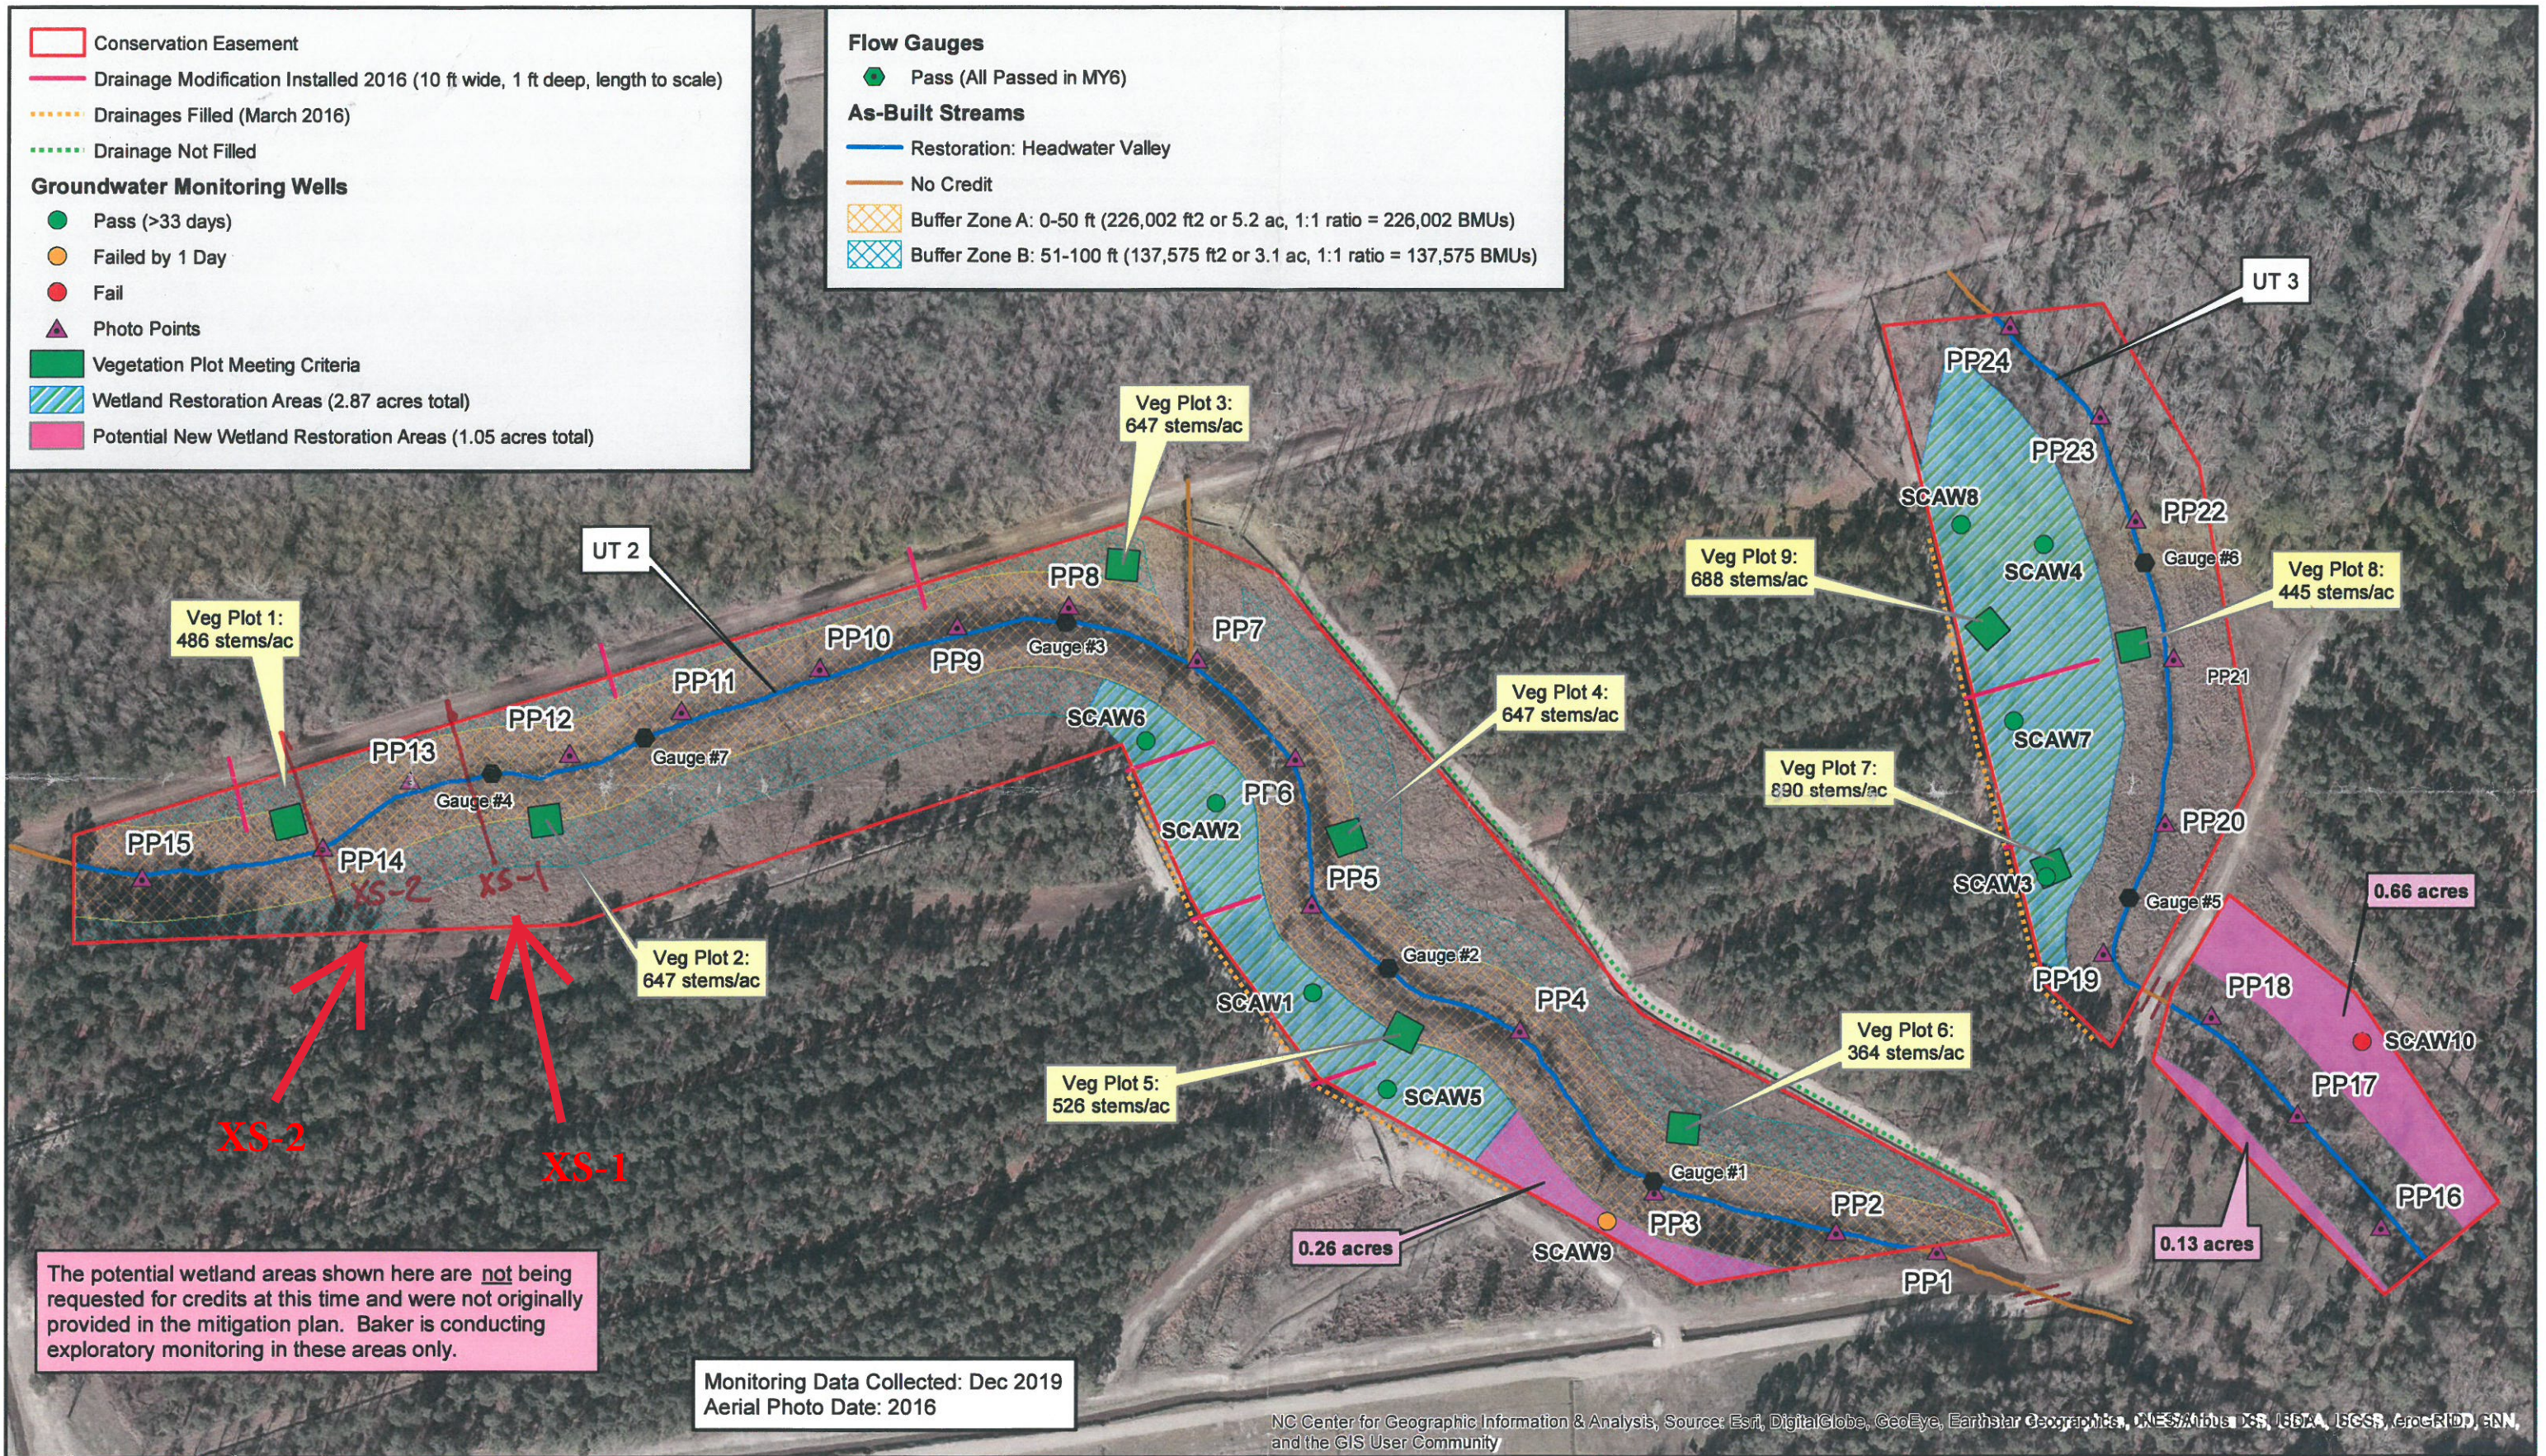
# Cross-Section / Transect Location Map:

Please find attached the results of these cross-sections. They reveal the presence of a distinct multi-thread channel with shallow water present in the two primary threads at the time of the survey in the upper transect, and larger channel development with shallow water present in the lower transect. Both transects show signs of channel scour and evolution, with rough, irregular rutting and scour found all across the transects, even along the relatively gentle adjacent side slopes draining into the channel.
