St. Clair Creek Restoration Project Year 3 Final Monitoring Report

DMS Project ID No. 95015

Submission Date: January 2017

Report Prepared and Submitted by Michael Baker International

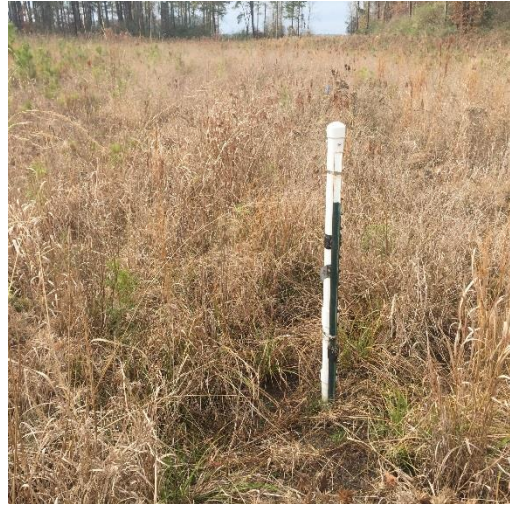
Flow Logger (UT2) – SCFL4, December 13, 2016
no flow present

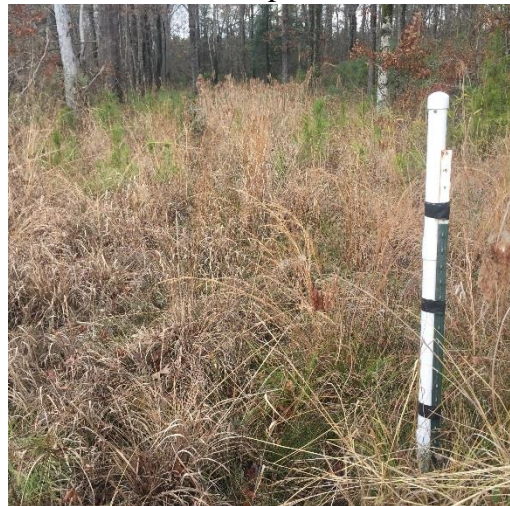
Flow Logger (UT3) – SCFL6, December 13, 2016
no flow present
