# St. Clair Creek Restoration Project Year 4 Final Monitoring Report

DMS Project ID No. 95015

Monitoring Year: 4 of 7

Report Prepared and Submitted by Michael Baker International

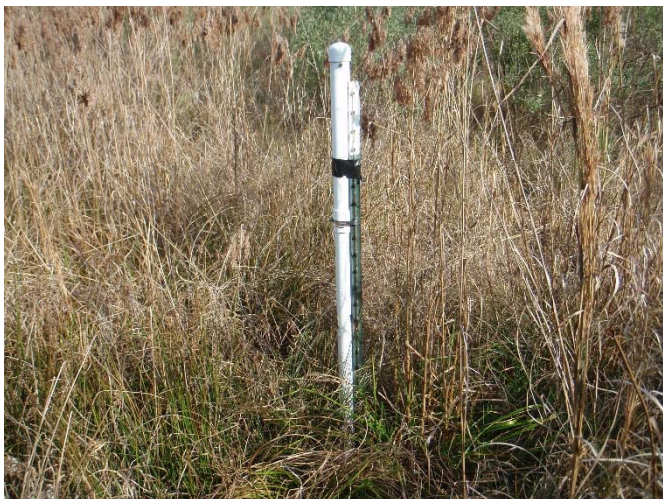
Flow Logger (UT3) – SCFL5

Note that flow gauge SCFL#5 located on the bottom of UT-3 did meet the success criteria early in 2017, but experienced a malfunction in early May and did not record data from that point forward. It has since been reprogrammed and reset and is now operating correctly. It will be very closely observed in the coming monitoring year. The complete flow data and observed rainfall graphs for each flow gauge, along with the flow gauge success summary Table 11 are all located in Appendix D.

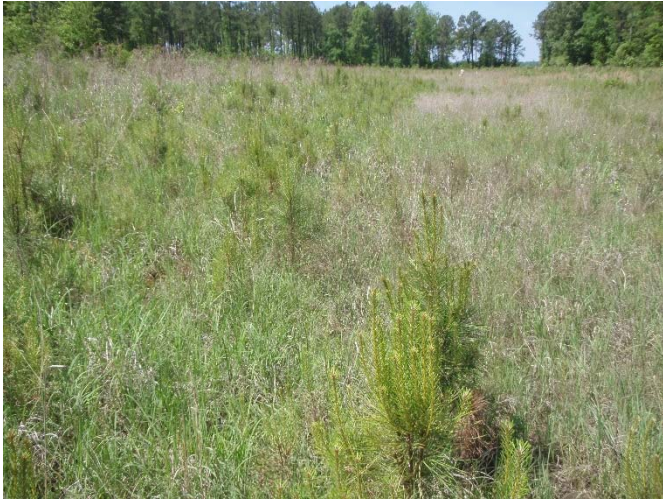
Loblolly Pines on UT2 (April 2017)

Following Year 3 monitoring, loblolly pine (*Pinus taeda*) seedlings were discovered scattered throughout the buffer of Reach UT-2 and a portion of UT-3. To prevent this nuisance species from affecting the planted stems, a thinning and removal effort took place in May of 2017 targeting the loblolly pines. The methods used were hand/power tools and some chemical application. A previous thinning effort had been conducted on UT-2 in March of 2016. During project monitoring work in October 2017, some small pines were still found scattered throughout the Site, but in clearly reduced numbers and sizes. The Site will be closely observed for pine growth throughout the remaining monitoring period. Additionally, a small area of Chinese privet (*Ligustrum sinense*) was treated on the upstream portion of UT-2 in May 2017 as well. The Vegetation Problem Area photolog found in Appendix B provides several before/after photographs of some of the treated areas.

Table 6b. Vegetation Problem Areas St. Clair Creek Restoration Project: DMS Project ID No. 95015				
Feature Issue	Station Number	Suspected Cause	Resolution	Photo Number
Loblolly Pine ( <i>Pinus taeda</i> )	Scattered throughout buffer on UT-2	Post-restoration seed source	Treated in March 2016 - hand/power tools and chemical application	Photos 1-4 in VPA Photolog
			Treated again in May 2017- hand/power tools and chemical application	
Chinese Privet ( <i>Ligustrum sinense</i> )	UT-2: 12+00 to 13+00	Post-restoration seed source	Treated in May 2017- hand/power tools and chemical application	Photos 5-6 in VPA Photolog
